HUSQVARNA TECHNICAL BULLETIN TB1503

January 28, 2015

Subject: Factory Direct Modification Campaign – Front Forks – Inspection for proper tightening torque of Piston Rod to Fork Cap

Affected 2015 Models: FE 350S, FE 501S

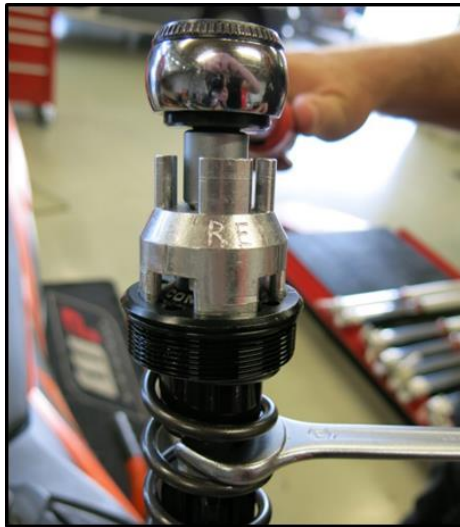
Photo 5

- It has been determined that the cause of the defect is due to a change in the production process at the fork supplier, resulting in improper tightening torque of the piston rod to the fork cap. To remedy this defect, the supplier has changed its torqueing procedure to achieve the proper tightening torque of the piston rod to the fork cap.

6. Using the special tool T14047 and a 19mm wrench, loosen the cap counter-clockwise from the piston rod nut.
7. Tighten the cap clockwise to the piston rod nut, torque to 18Nm / 13.3lb-ft. (Photo 5).
8. Using an automatic center punch only, place a "dot" on the nut indicating the repair is completed (Photo 6).
9. Steps 4-8 must be performed on both forks before assembling in reverse order of disassembly.
