TO: Mercedes-Benz Dealer Principals, General Managers, Sales Managers, Service Managers, Parts Managers	FROM: Thomas Brunner, Department Manager, Vehicle Compliance and Analysis, Engineering Services
RE: Recall Campaign 201502003-Retrofit Headlamp Adjustment Screw Caps. Model 205 (C-Class Sedan) Model Year 2015	DATE: May 6, 2016

Campaign No. 2015020003, May 2016

SUBJECT: **Model 205 (C-Class), Model Year 2015**
Retrofit Headlamp Adjustment Screw Caps

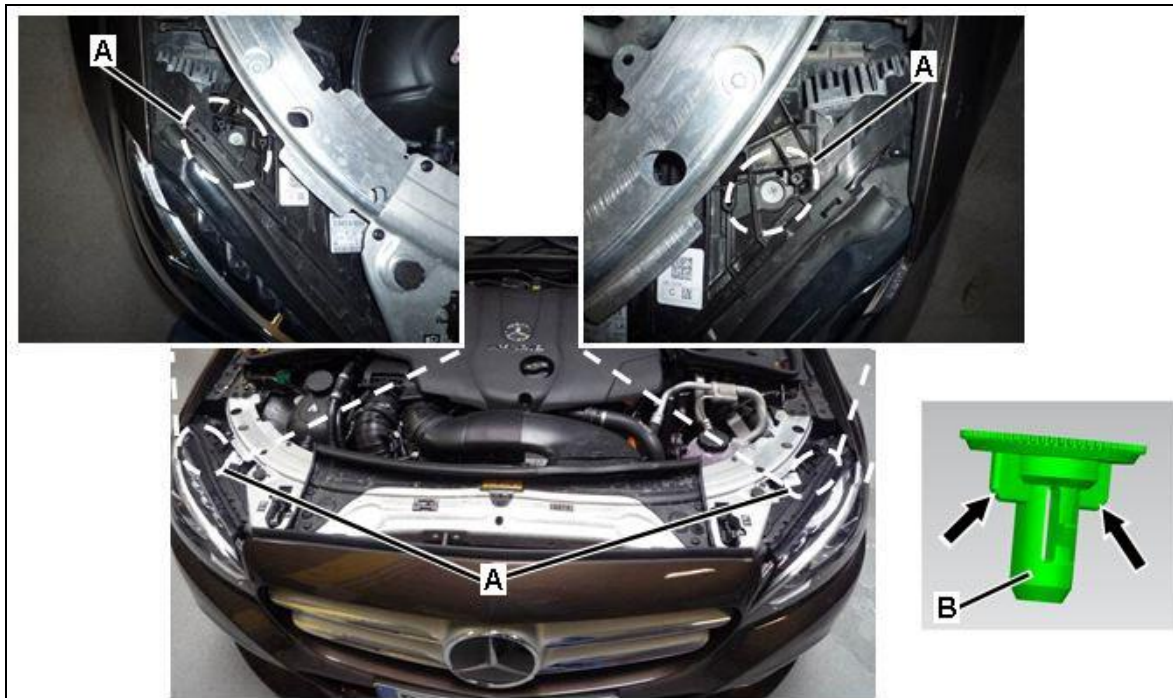
Figure 1

Daimler AG (DAG), the manufacturer of Mercedes-Benz vehicles, has determined that the headlamps might not meet the requirements of Federal Motor Vehicle Safety Standard (FMVSS) 108, which requires that headlamps with low beams must not have a horizontal adjustment mechanism. The subject vehicles are designed to meet this requirement by sealing off the headlamp horizontal adjustment screw with a non-removable sealing cap after initial adjustment in the manufacturing plant. The sealing cap may not have been installed on these vehicles. An authorized Mercedes-Benz dealer will retrofit the two sealing caps.

1. Open hood.
2. Retrofit cap (B, Figure 1) for headlamp adjustment screws (A) at left and right:
 - Position cap (B, Figure 1) on headlamp adjuster (A) so that the tabs (arrows) on the cap (B) align with the grooves in the adjuster (A).
 - Press the cap (B) into adjuster (A) by hand until it locks into position.

An audible click will be heard when the cap (B) is properly seated into the adjuster (A).
