Subject: Bosch Hydro-Max Park Brake Interlock Switch

Models Affected: Specific Freightliner Business Class M2 vehicles manufactured June 4, 2014, through December 1, 2014, and equipped with a Bosch Hydro-Max Brake Booster.

April 2015
FL677A
NHTSA #15V-094
Transport Canada #15-068

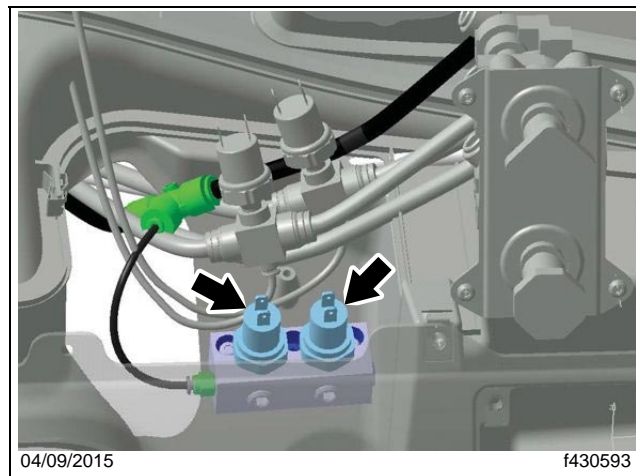
Fig. 1, Optional Park Switch Location

Certain vehicles equipped with hydraulic brakes and a Bosch Hydro-Max brake boost pump may have an incorrect switch specified, such that certain instrument display brake warnings may not illuminate correctly when required. Without certain warnings a driver may be unaware that the available braking force is reduced and therefore, increase the risk of a crash.

6. Find and remove the switch connected to circuits 81C* and 81C (FSC 1749 2134, normally closed).
7. Install the new switch (FSC 1749 1121, normally open) and connect circuits 81C* and 81C.
8. Connect the batteries.
9. Build air pressure. Using a soap solution, verify that there are no leaks at the pressure switch.
10. Confirm that the backup pump motor does not run when the engine is running. The backup pump motor should not make any noise.
11. Shut the engine off. Press on the brake pedal several times to make sure the pedal feels normal in the backup pump mode.
