Subject: Freightliner Cascadia SAM Chassis

INT FL679

NHTSA #15V-127

INTERIM RECALL BULLETIN

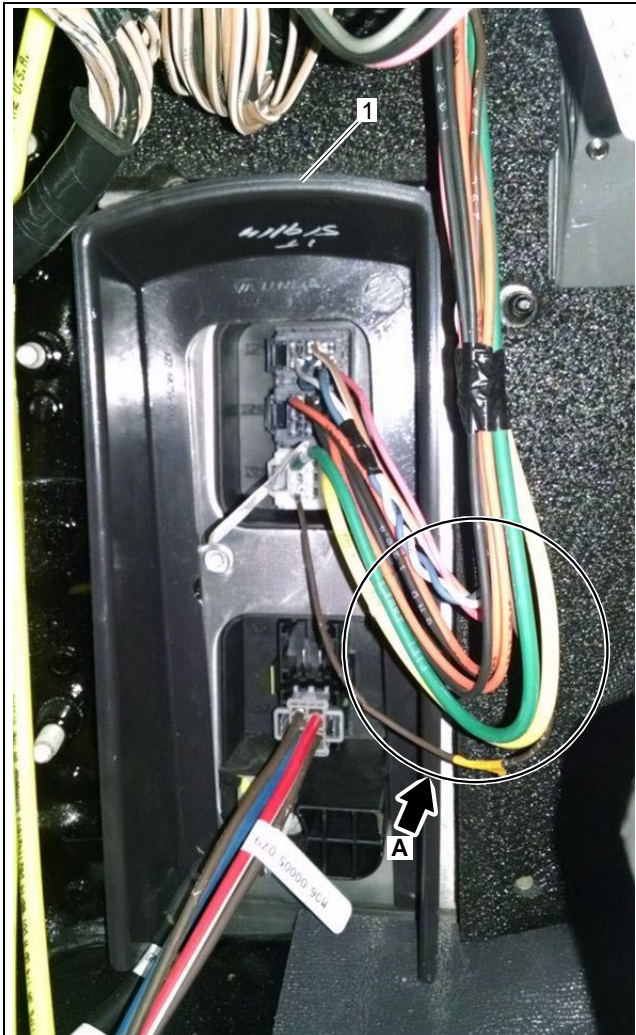
Fig. 1, SAM Chassis with a Drip Shield and a Drip Loop

Under certain conditions water may enter the SAM Chassis causing corrosion which may result in electrical shorts or possible intermittent operation of the tail lamps. Intermittent operation of the tail lamps may provide an inaccurate signal to other drivers which could increase the risk of a crash. An electrical short in the chassis SAM may also cause melting in the SAM or other electrical components which may lead to an electrical fire.

A. A drip loop prevents water from collecting at the connectors.

5. Replace the SAM Chassis. Refer to **Section 54.02, Subject 100** in the *Cascadia Workshop Manual* for replacement instructions.
6. Remove the liner on the back of the drip shield to expose the adhesive, then position the drip shield over the SAM Chassis connectors and press securely. Ensure that there is sufficient clearance at the frontwall for the drip shield to stick directly to the metal and not to any other material. See **Fig. 1**. (if a drip shield is already present, skip this step.)

- 1. Drip Shield

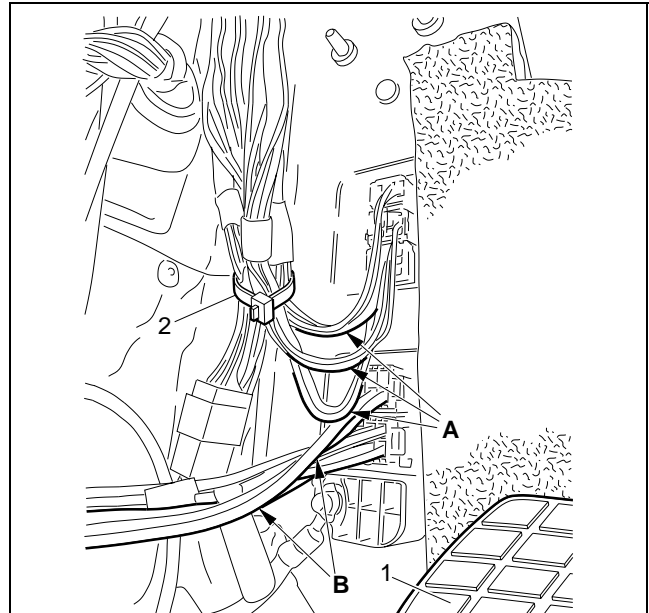
Fig. 2, SAM Chassis Wiring with a Drip Loop

A. Harnesses formed into a drip loop.

B. Wiring is routed down and away from the SAM Chassis.

7. Create a drip loop for the SAM Chassis wiring harness. See **Fig. 2**. Attach a jumper harness (06-73835-000) if necessary to create additional length. Once the drip loop is created, use a tie strap to secure the harnesses. (If a drip loop is already present, skip this step.)

8. As previously marked, connect the cab wiring to the SAM Chassis. Make sure that the wiring is routed down and away from the SAM Chassis to prevent the entrance of moisture.
