Mercedes-Benz

Campaign No. 2015020004, February 2015

SUBJECT: **Model 906 (Sprinter), Model Year 2015
B-Pillar Abutting Wedge**

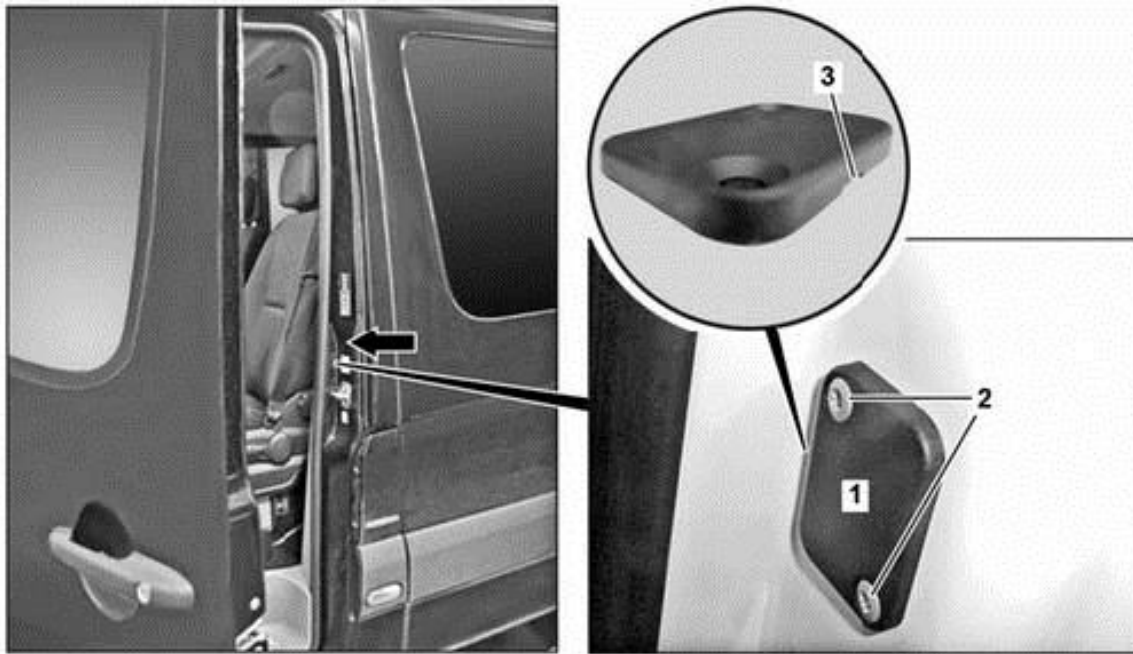
Figure 1

Check installation position of wedge-type stop (1, Figure 1) on B-pillar of driver and passenger side of vehicle:
 - The cutout (3) of the wedge-type stop (1) must face towards the vehicle's interior (arrow). If installation position of wedge-type stop (1) on B-pillar of driver **and** passenger side is **correct (OK)**: Procedure is complete.
 - If installation position of wedge-type stop (1) on B-pillar of driver and/or passenger side is **not correct (NOT OK)**, proceed to step 2.
2. Correct the installation position of wedge-type stop (1, Figure 1) on B-pillar of driver **and/or** passenger side of vehicle:

Correct the installation position of either **1 or both** wedge type stops (1) depending on results of step 1.

Remove bolts (2) of wedge-type stop (1) and remove wedge-type stop (1).
-

Reinstall the wedge-type stop (1) with cutout (3) facing **towards the vehicle's interior** (arrow).
-

Torque bolts (2) to 5 Nm.

The bolts (2) must be replaced (do not reuse bolts).
