Michael A. Berardi
Director
Service Engineering Operations
Ford Customer Service Division

SUBJECT: DEMONSTRATION / DELIVERY HOLD - Safety Recall 15S11 – Supplement #1
Certain 2011 - 2013 Model Year Explorer and 2013 Model Year Police Interceptor
Utility Vehicles
Interior Door Handle Inspection and Repair

CERTAIN 2011-2013 MODEL YEAR EXPLORER AND 2013 MODEL YEAR POLICE INTERCEPTOR UTILITY VEHICLES — INTERIOR DOOR HANDLE INSPECTION AND REPAIR

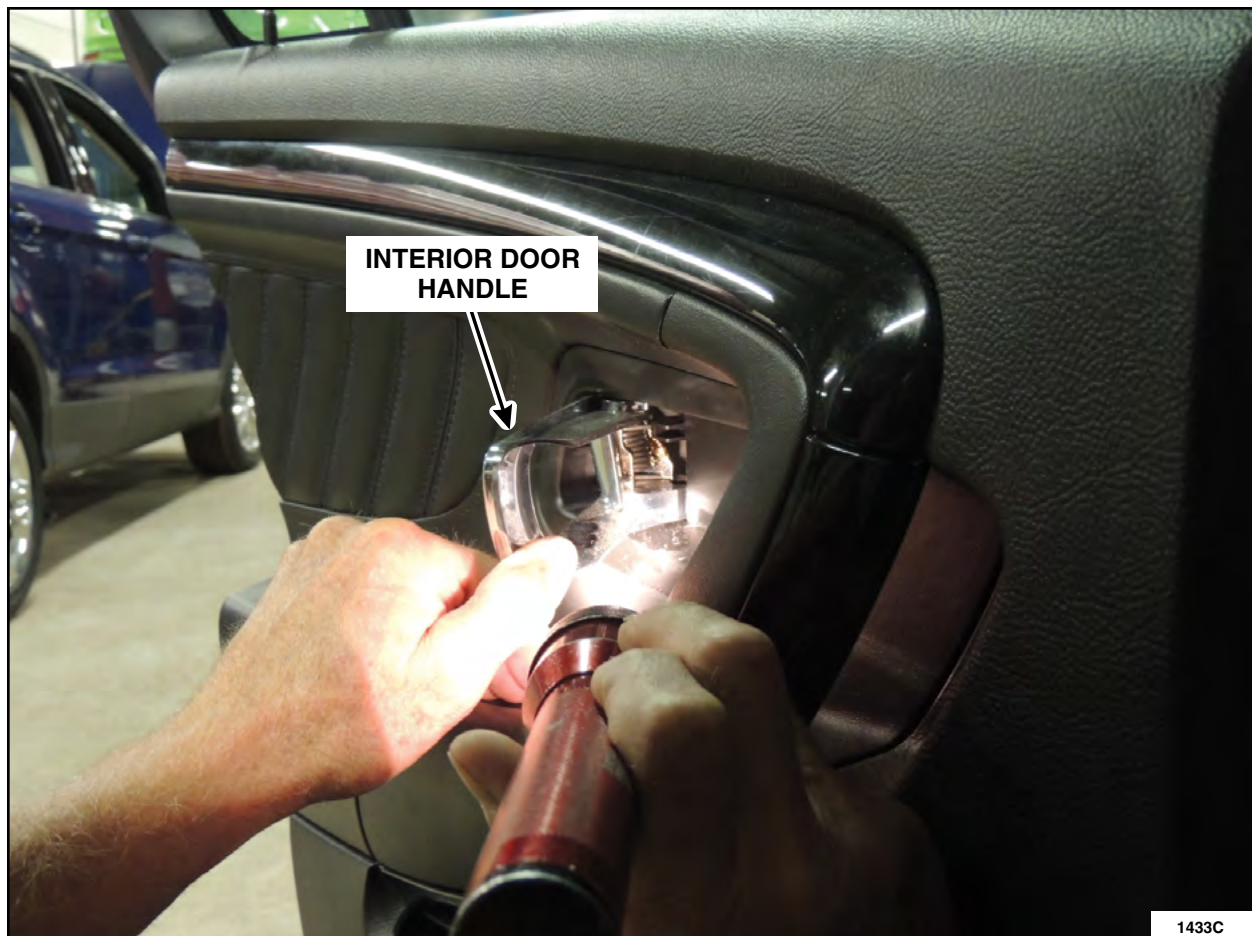
FIGURE 1

1. Hold the interior door handle in the open position. Using a flashlight, locate the return spring and return spring retainer wall. See Figure 1 below and Figure 2 on Page 2.

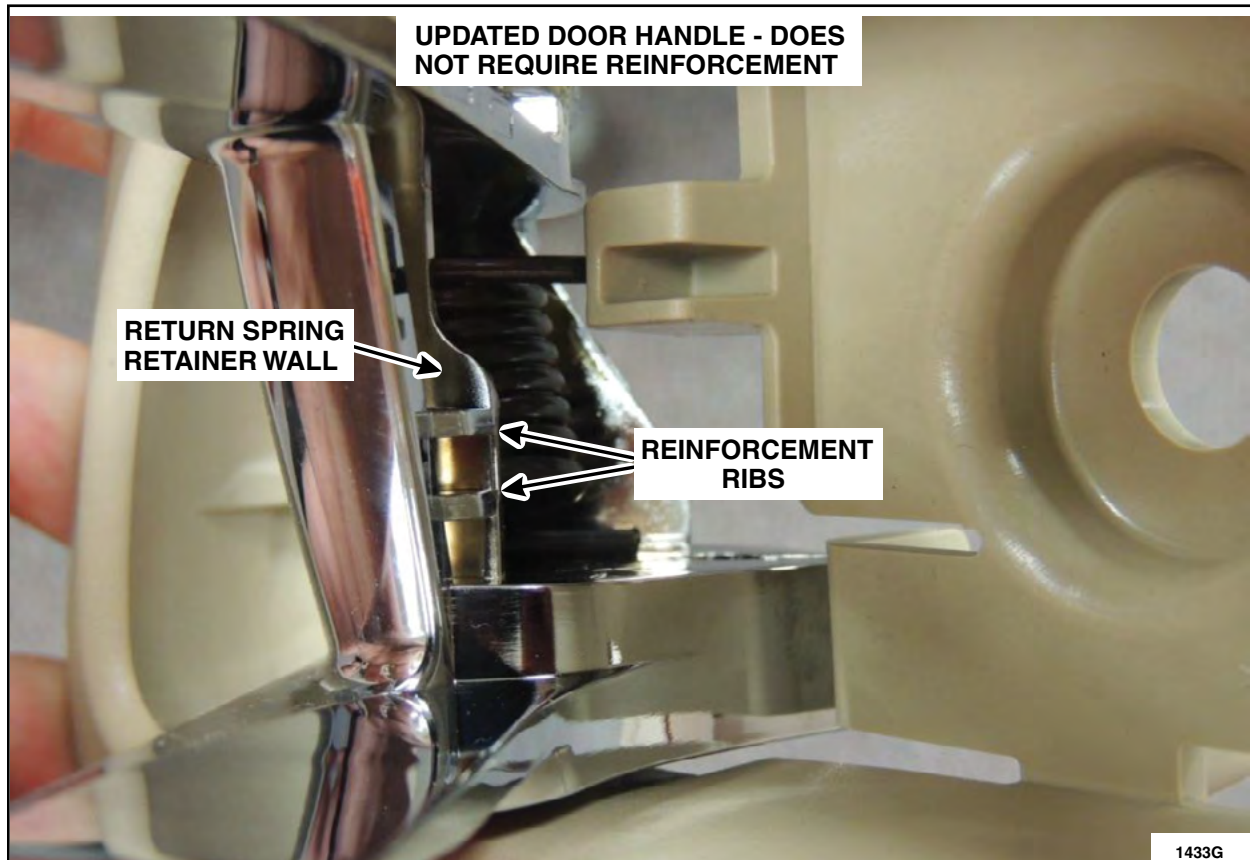
FIGURE 3

3. Interior door handle is equipped with two (2) reinforcement ribs on the return spring retainer wall. See Figure 3.

- No service is required on this interior door handle design.

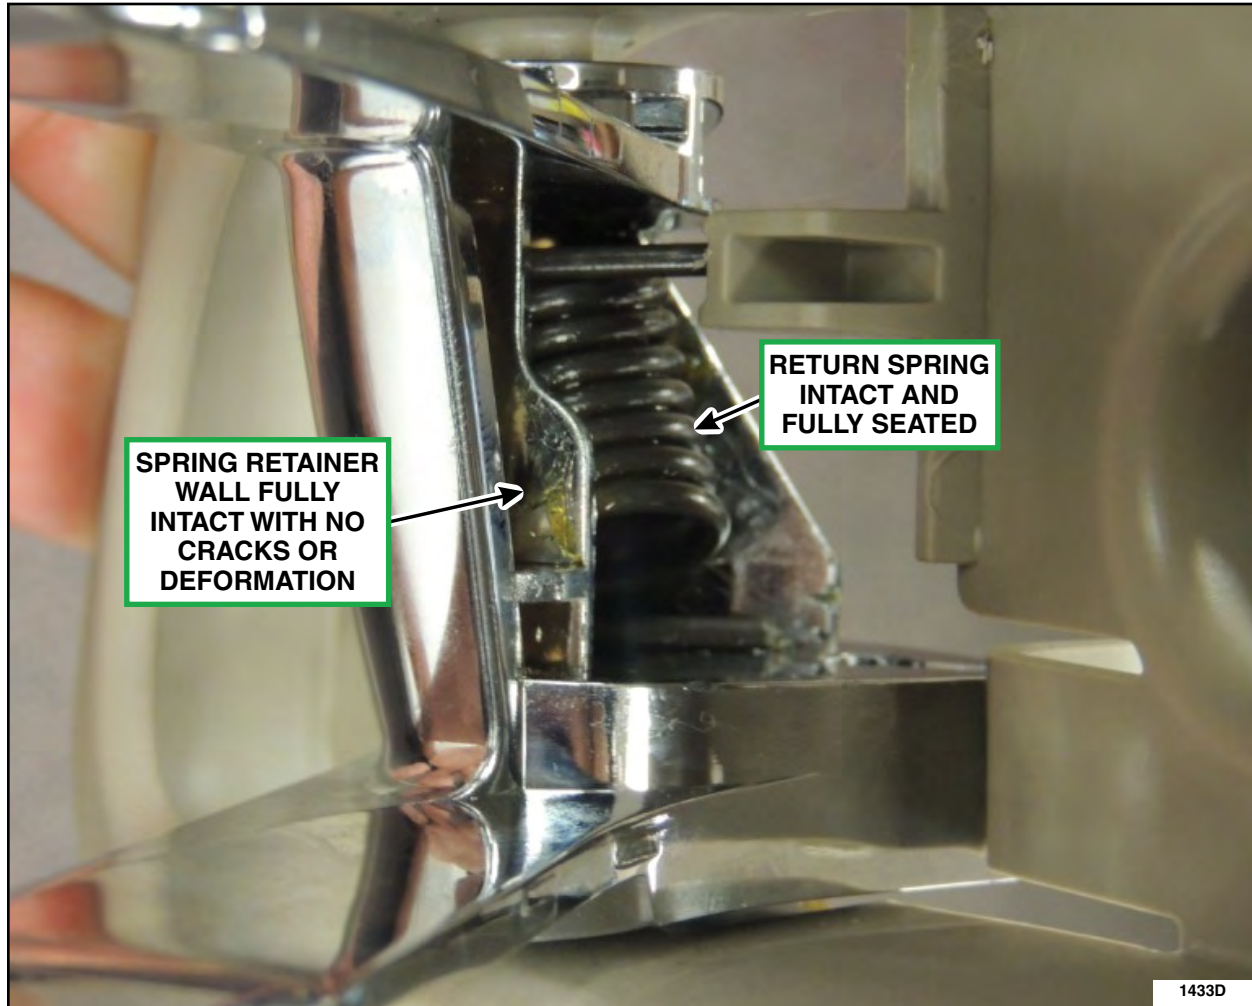
FIGURE 4

4. Return spring is intact and fully seated. The spring retainer wall is not deformed and is fully intact with no cracks. See Figure 4.

- Proceed to step 8.

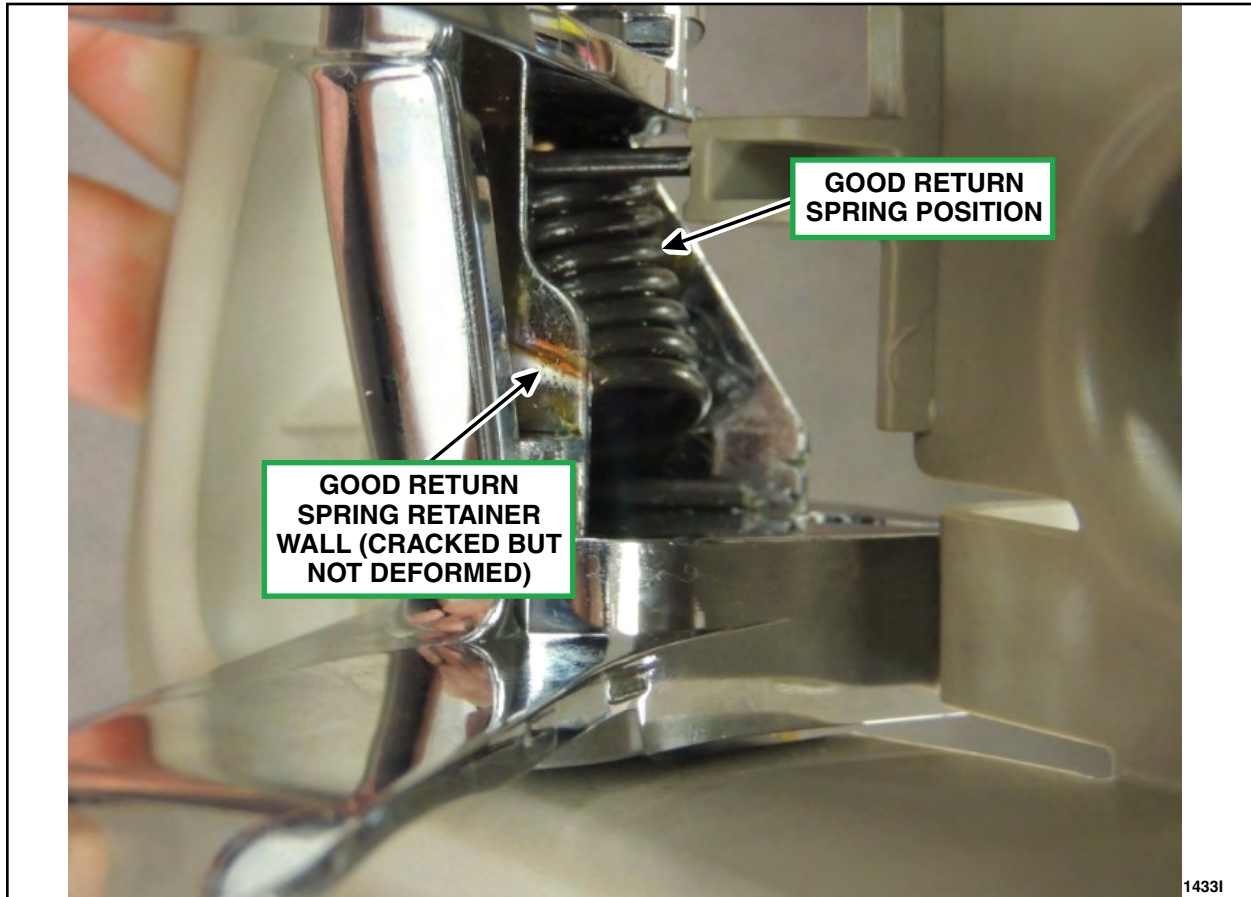
FIGURE 5

5. Return spring is intact and fully seated. The spring retainer wall has a single crack, but is not deformed and is fully intact. See Figure 5.

- Proceed to step 8.

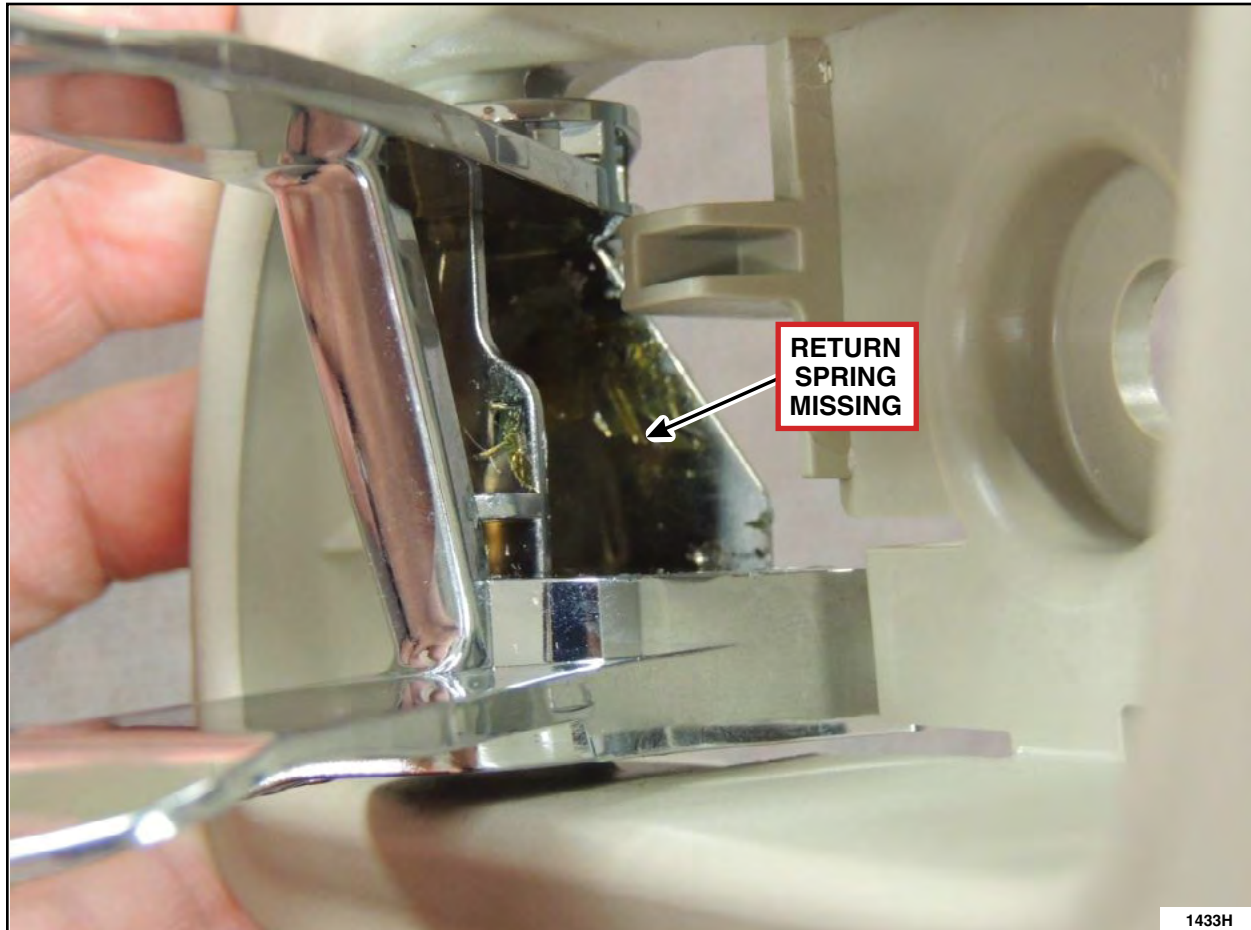
FIGURE 6

6. Return spring is loose, out of position, or missing. See Figure 6.

- Replace the interior door handle. Please follow the Workshop Manual (WSM) procedures in Section 501-14.

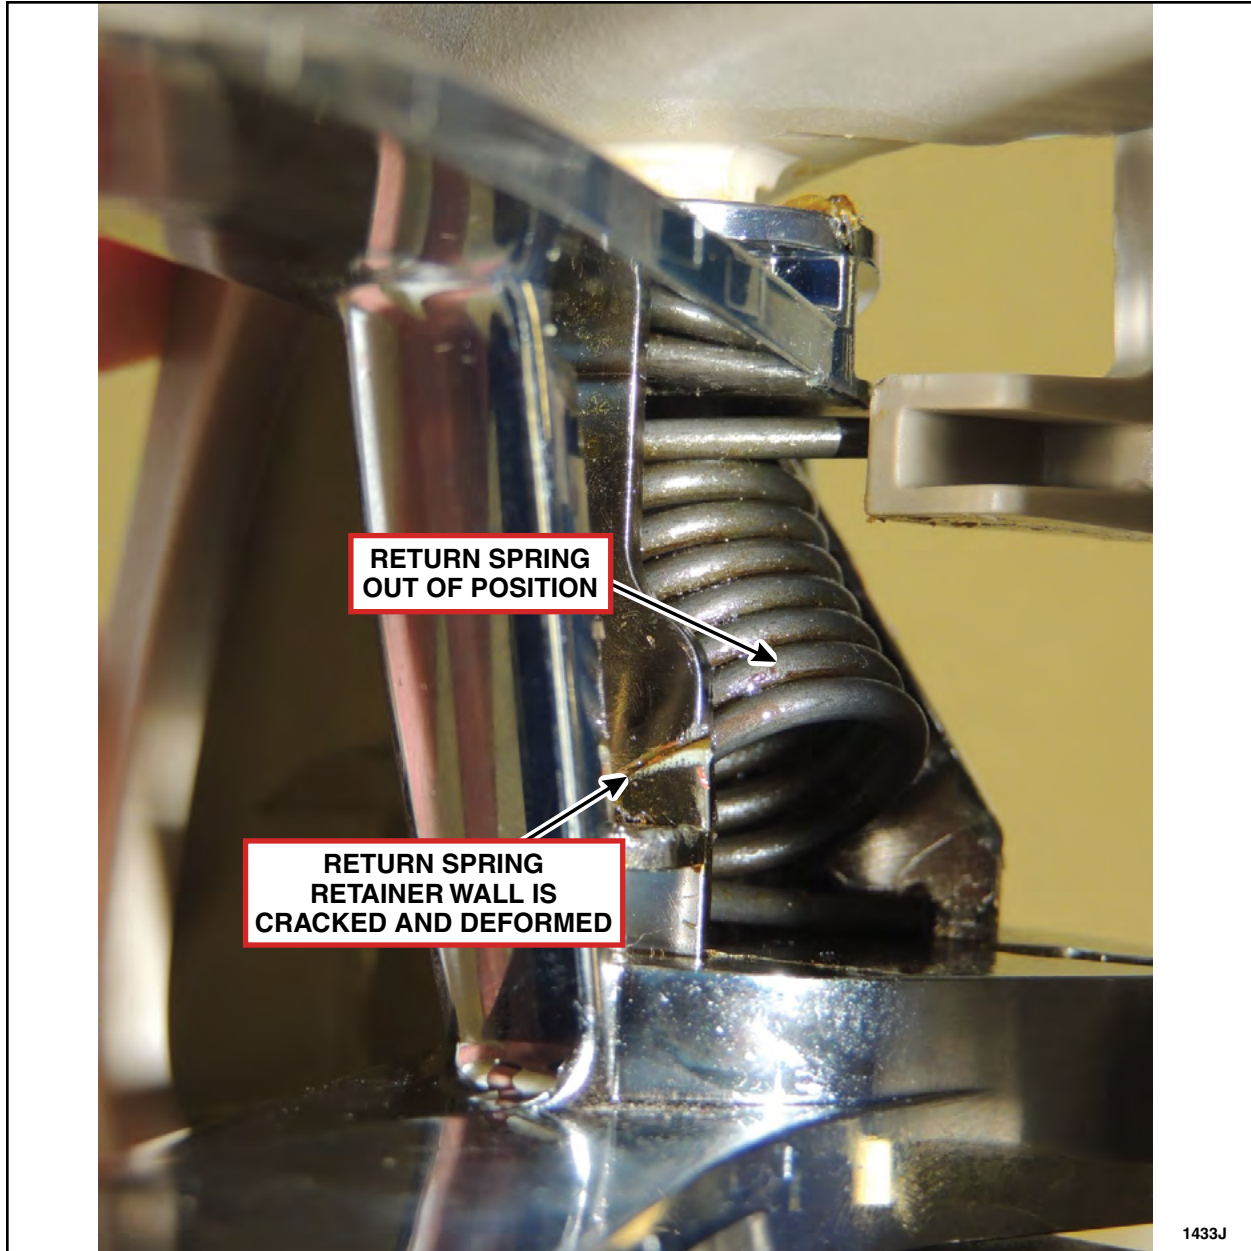
FIGURE 7

7. Spring retainer wall is missing, deformed, or broken. See Figure 7.

- Replace the interior door handle. Please follow the WSM procedures in Section 501-14.
