Subject: Safety Recall 15R1 – **Remedy Notice**  
Certain 2015 Toyota Sienna vehicles equipped with  
Non-Toyota Rear Seat Entertainment Package

**SAFETY RECALL CAMPAIGN 15R1**

**Certain 2015 Toyota Sienna Vehicles Equipped  
with Non-Toyota Rear Seat Entertainment Package**

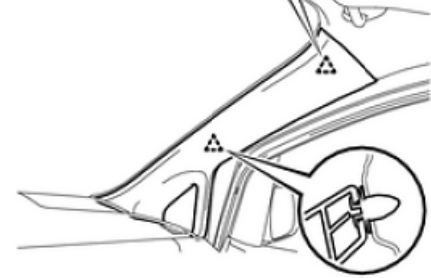
Figure 1

*1	Front Pillar Garnish Clip (P/N 62217-52120)
----	--

- a) Carefully separate passenger front door opening trim weather strip from panel. Separate the Front Pillar Garnish Clip from the Front Pillar (Figure 1).

- b) Disengage the clip located in the center of the garnish.
