**SUBJECT: DEMONSTRATION / DELIVERY HOLD - Safety Recall 15S17**  
Certain 2015 Model Year F-150 Vehicles  
Upper Intermediate Steering Shaft Rivet Inspection

## CERTAIN 2015 MODEL YEAR F-150 VEHICLES — UPPER INTERMEDIATE STEERING SHAFT RIVET INSPECTION

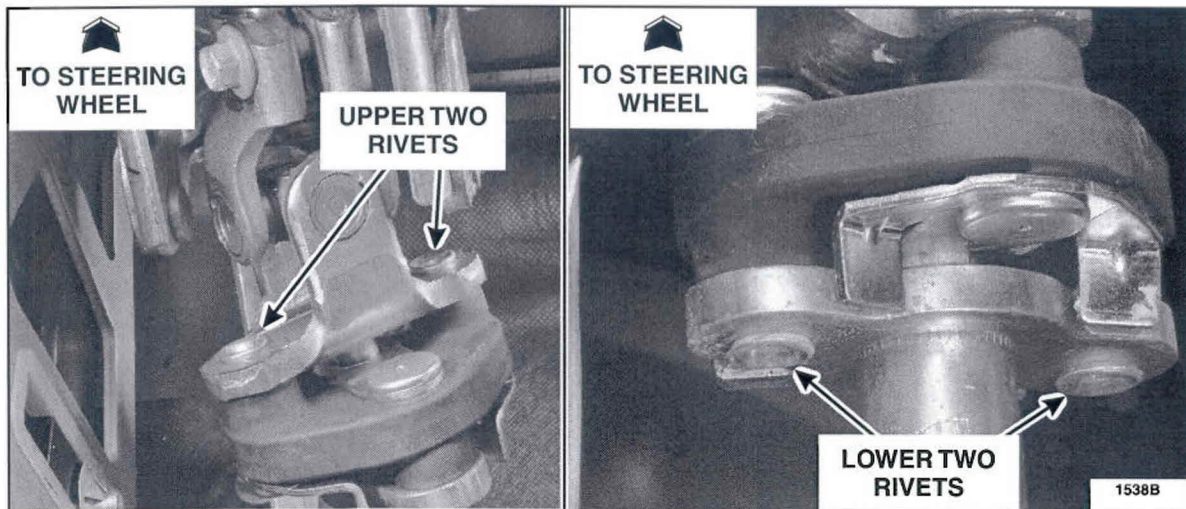
FIGURE 1

1. While looking upward from the driver's floorboard, locate the steering column upper intermediate shaft under the instrument panel (between the accelerator and brake pedals).
2. Locate the staked end of the two (2) upper and two (2) lower rivets in the upper intermediate steering shaft. See Figure 1.

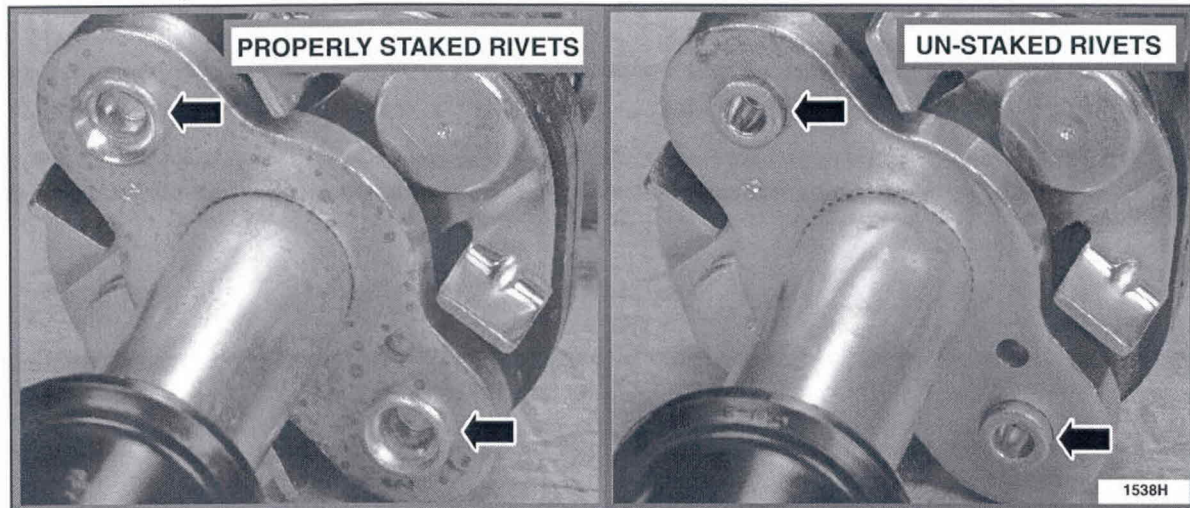
FIGURE 2

3. Inspect the four rivets both visually and using a 10 mm (3/8 in) wrench as a gauge to determine if they are staked:
- A rivet that is properly staked will have a pressed/convex shape at the tail end of the rivet and will not allow the 10 mm (3/8 in) open-end wrench to fit over the staked (tail) end. See Figures 2 and 3.
  - A rivet that is not staked will have a cylindrical or barrel shape at the tail end, may not be fully seated, and will allow the 10 mm (3/8 in) open-end wrench to fit over the (tail) end. See Figures 2 and 3.

4. If any of the upper intermediate steering shaft rivets are not staked properly (inspection failed), replace the upper intermediate steering shaft. Please follow the Workshop Manual (WSM) procedures in Section 211-04.

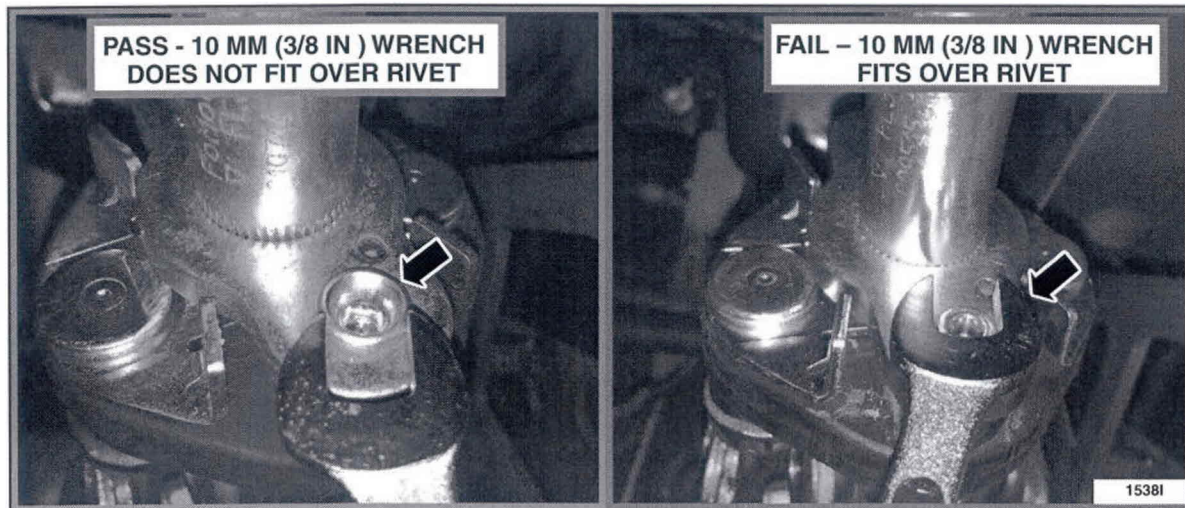
FIGURE 3

To confirm that the upper intermediate steering shaft needs replacement, dealers must email a photo similar to Figure 3 in Attachment III showing details of the failed inspection part to the SSSC at [15S17@Renkim.com](mailto:15S17@Renkim.com). In the email please include dealer P&A code, VIN, dealer contact name and phone number. The SSSC will contact the dealer with any questions or to advise the part has been ordered.

**NOTE:** A photo showing details of the failed inspection part similar to Figure 3 above is required if a *new* upper intermediate steering shaft is needed. See dealer bulletin "Attachment II" for further information.
