IMMEDIATE VEHICLE INSPECTION PRIOR TO SALE REQUIRED

Re: Delivery Action D89599: Inspect SIPS Airbag Wiring

Re: XC90 Front Seat SIPS Airbag Wiring Inspection Required Prior to Vehicle Delivery

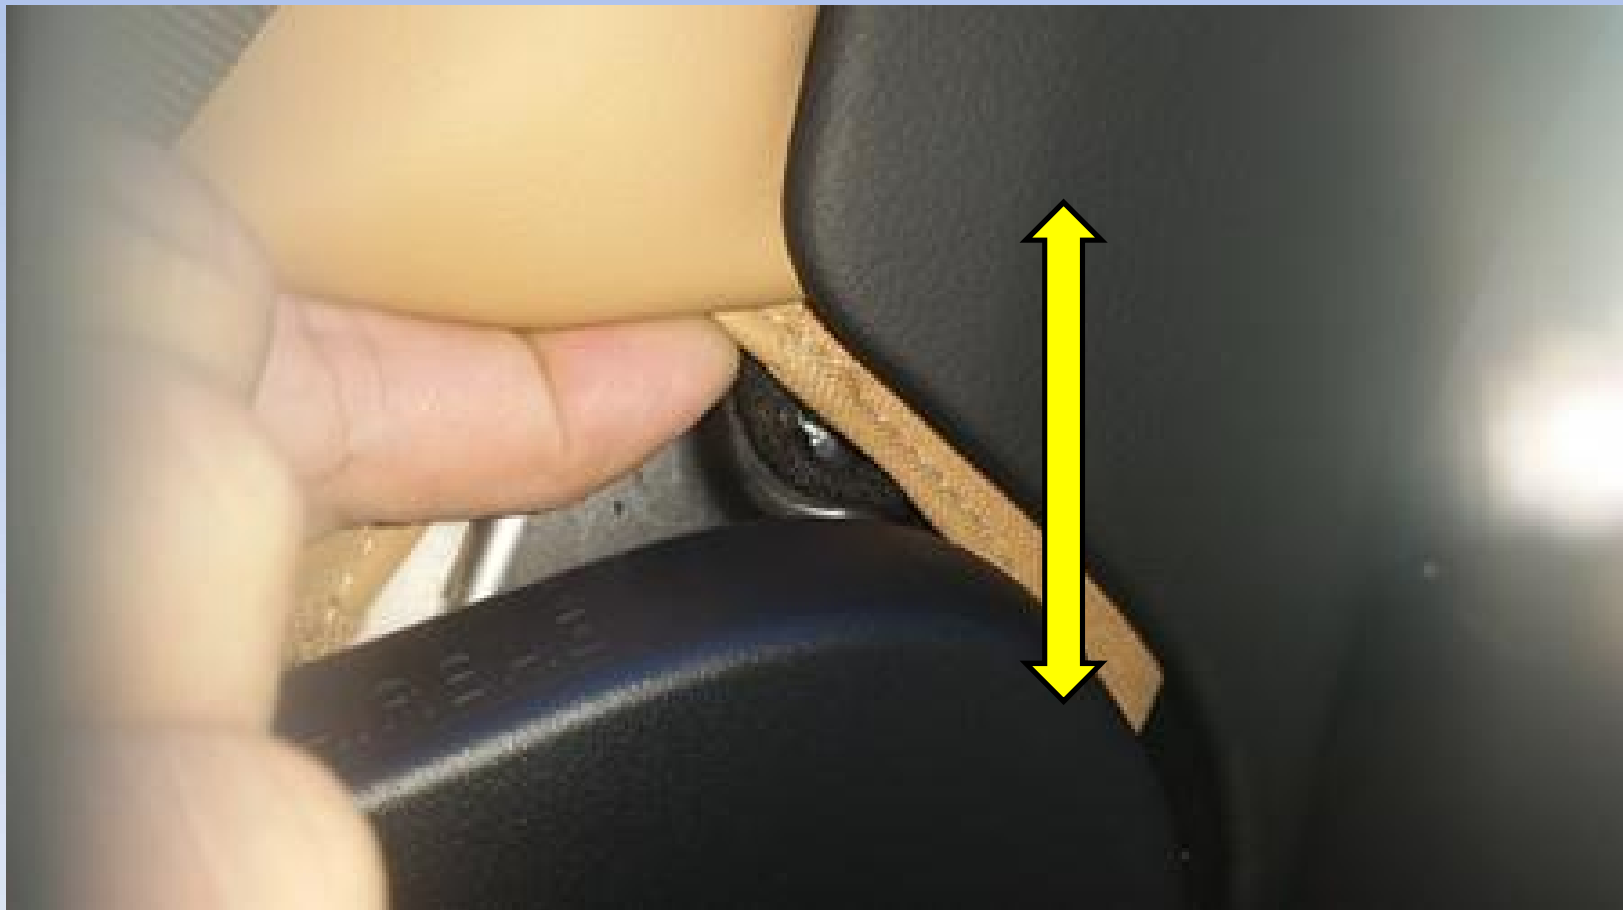
6. Check that the cable to the airbag is visible and free. Run the finger along the harness to make sure is not pinched.

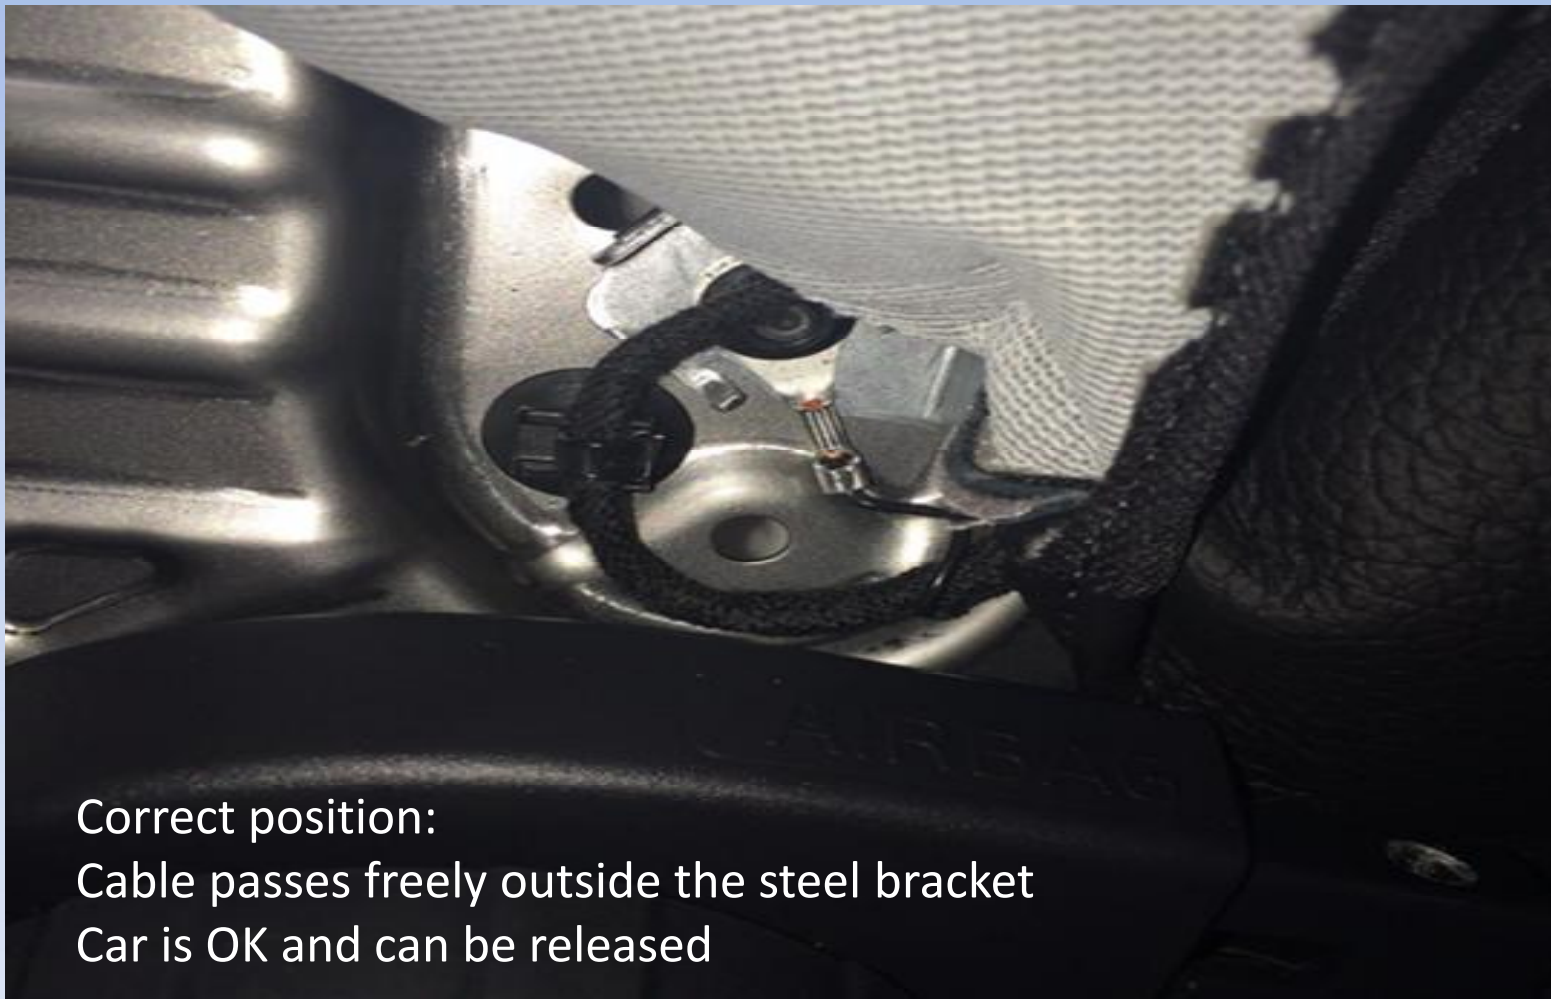
Correct routing

Correct position:
Cable passes freely outside the steel bracket
Car is OK and can be released

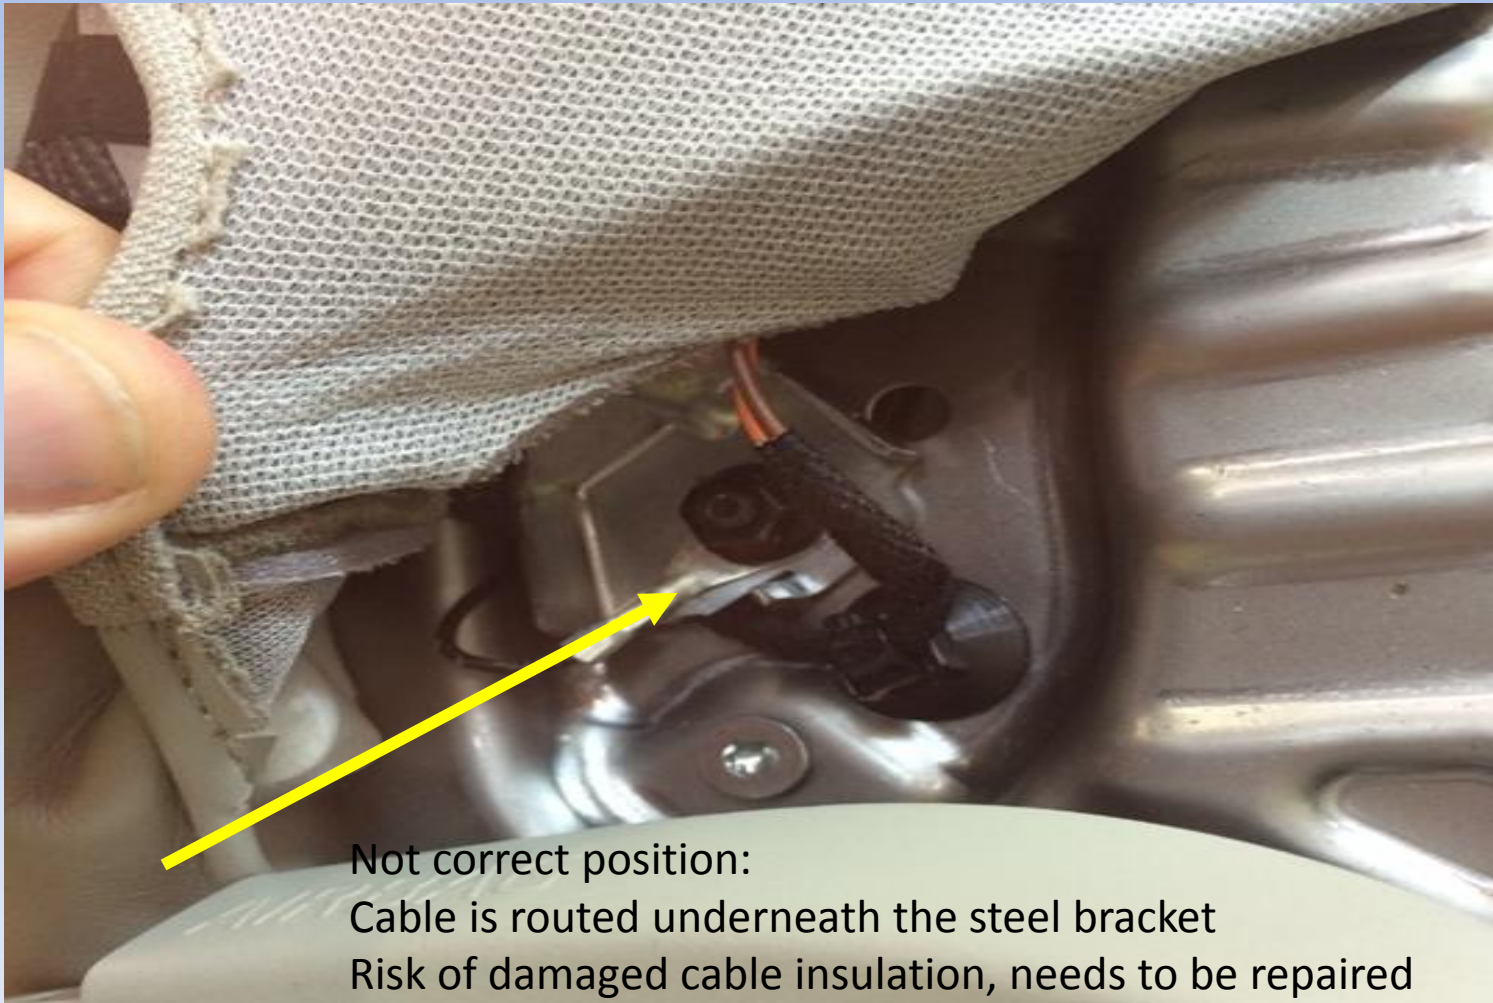
Incorrect routing

The wiring to the front SIPS airbags may have been incorrectly assembled at the supplier. If the wiring to the SIPS airbags is incorrectly routed, (clamped between the front seat back frame and SIPS bracket, there is a risk of damage to the wiring insulation.

Not correct position:
Cable is routed underneath the steel bracket
Risk of damaged cable insulation, needs to be repaired

All vehicles must be inspected prior to retail sale according to the attached method. If the inspection identifies an incorrectly routed SIPS airbag wiring harness, the vehicle will need to be quarantined and not available for customer delivery until further repair instructions are communicated. If the vehicle inspection indicates the SIPS airbag wiring harness is routed correctly, the vehicle is ok to release for delivery. Claim instructions for the inspection only are below.
