## Subject: Takata Driver Side Airbags

**Models Affected:** Specific model year 2008-2009 Sterling Bullet vehicles manufactured October 15, 2007, through November 10, 2008, with Takata Corporation driver side air bags.

# Recall Campaign

October 2015  
FL684A  
NHTSA #15V-361  
Transport Canada #15-257

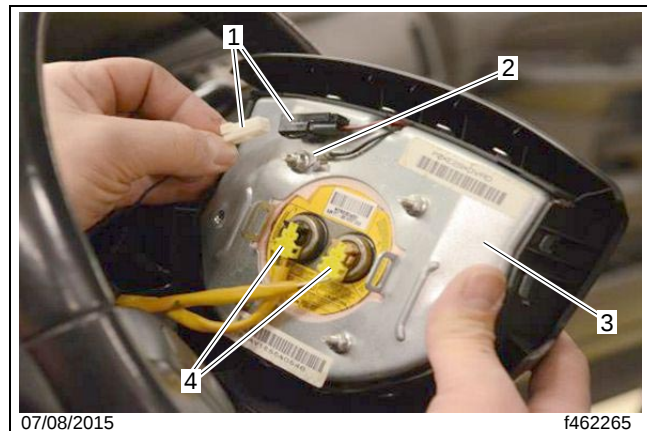
Fig. 2, Driver Air Bag Electrical Connections

1. Horn Switch Connectors
2. Ground Eyelet
3. Inflator
4. Driver Air Bag Squib Connectors

5. Pull the driver air bag away from the steering wheel, far enough to access the three electrical connections on the back of the driver air bag housing.
6. Disconnect the horn switch connector, located on the back of the driver air bag housing. See **Fig. 2**.

19. Connect the steering wheel wire harness connector for the horn switch to the horn switch connector, located on the back of the inflator assembly (Figure 2)

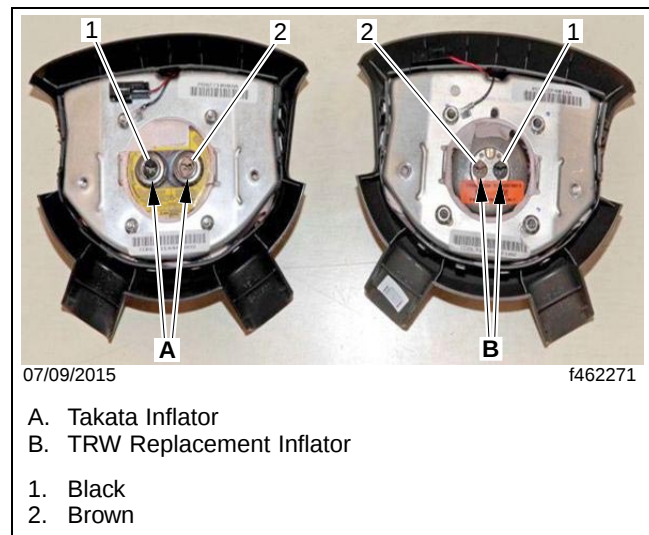
**Fig. 8, Squib Connector Receptacles**

- NOTE: The squib connector receptacle locations on the driver air bag inflators are switched between the original Takata inflator and the TRW replacement inflator kits. Squib connectors are keyed and color coded for error proofing. See **Fig. 8**.

18. Connect the two driver air bag squib connectors to the driver air bag inflator assembly connector receptacles by pressing straight in on the connector. Make sure to engage each keyed and color-coded connector to the matching connector receptacle. Make sure that each connector is fully engaged in its receptacle by listening carefully for a distinct, audible click as the connector latches snap into place.
