SERVICE BULLETIN

SAFETY RECALL P068 KEYLESS VEHICLE MODULE PROGRAMMING ISSUE

21-JUL-15

NO.: SA15RE-01

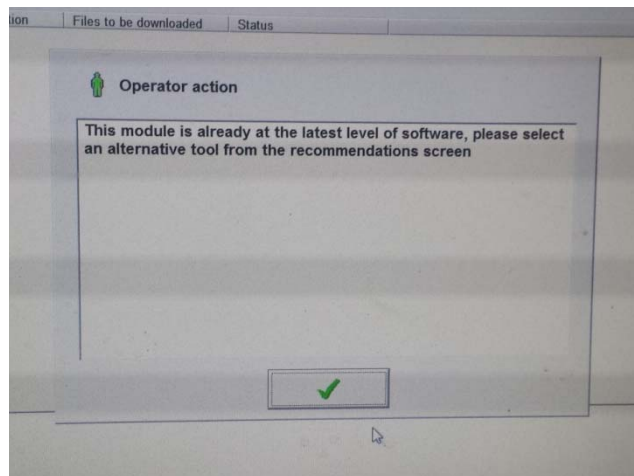
Some retailers have reported a concern where technicians, when trying to update a vehicle as part of Safety Recall P068, *Vehicle Door Will Not Latch*, are unable to update the Keyless Vehicle Module (KVM) software on Range Rover Sport and Range Rover vehicles fitted with (Gen 3) KVM hardware version '**FK72**'. When this occurs, the following pop up message may appear on the SDD screen:

Customer vehicles within the above VIN range cannot have Recall P068 performed at this time.

Any customer vehicle in for service with a complaint relating to the concern of Recall P068 **MUST** be held until new software becomes available.
