SAFETY RECALL P068 KEYLESS VEHICLE MODULE PROGRAMMING ISSUE-UPDATE

SERVICE BULLETIN

NO.: SA15RE-01
(issue 2)

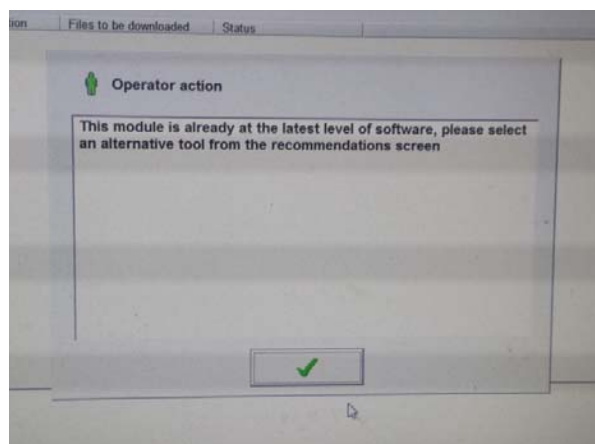
Some retailers have reported a concern where technicians, when trying to update a vehicle as part of Safety Recall P068, *Vehicle Door Will Not Latch*, are unable to update the Keyless Vehicle Module (KVM) software on Range Rover Sport and Range Rover vehicles fitted with (Gen 3) KVM hardware version 'FK72'. When this occurs, the following pop up message may appear on the SDD screen:

Software for the (Gen 3) KVM equipped vehicles is not currently available. We will update you with a further communication once the software becomes available. We apologize for any inconvenience this may cause.
