GM CUSTOMER CARE AND AFTERSALES
DCS3763
URGENT - DISTRIBUTE IMMEDIATELY

Subject: Update to Upcoming Safety Recall 15042
HVAC Connector Wire Failure

Models: 2006-2010 Hummer H3
2009-2010 Hummer H3T

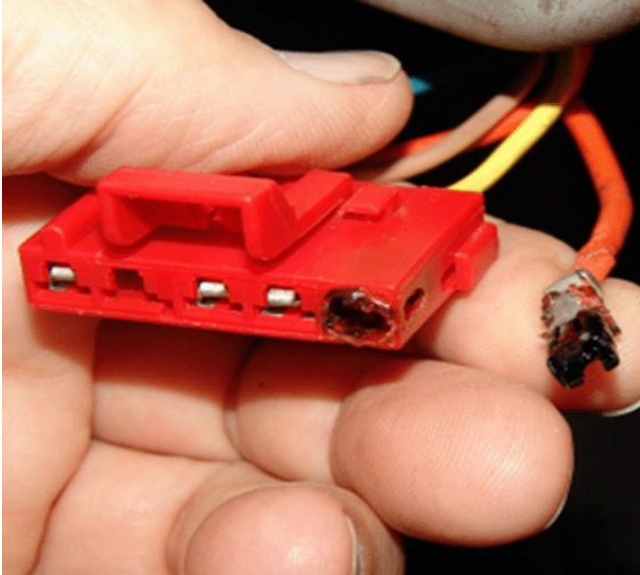
The connector module that controls the blower motor speed in the heat/vent/air conditioning (HVAC) system may overheat under extended operational periods at high and medium-high blower speeds. If this condition occurs, there is the risk that the heat generated could melt the plastic surrounding the connector module, which increases the risk of a fire.

If the female connector to the Blower Motor Resistor assembly exhibits a previous overheat condition, (see photo) replace the harness and resistor assembly with the current replacement parts.
