GM CUSTOMER CARE AND AFTERSALES  
DCS3827  
URGENT - DISTRIBUTE IMMEDIATELY

Subject: Update to Upcoming Safety Recall 15042  
HVAC Connector Wire Failure

Models: 2006-2010 Hummer H3  
2009-2010 Hummer H3T

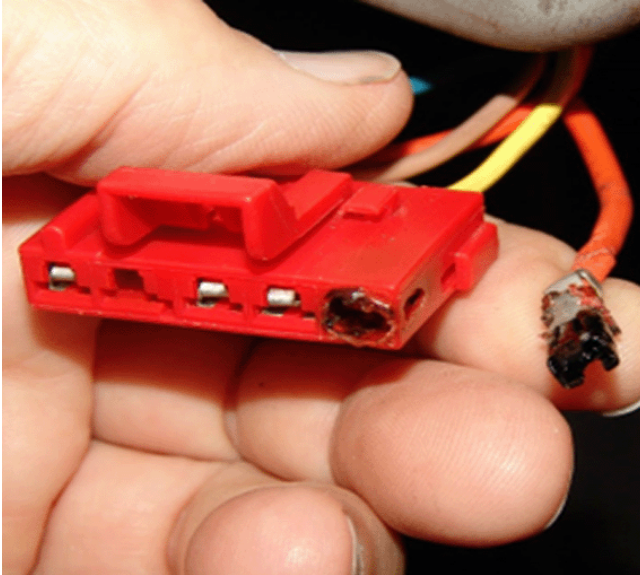
On June 26, 2015, all General Motors dealers were advised via General Motors Global Connect message GCUS-3-235 of upcoming safety recall 15042. This recall relates to a condition in the connector module that controls the blower motor speed in the heat/vent/air conditioning (HVAC) system. The module may overheat under extended operational periods at high and medium-high blower speeds. If this condition occurs, there is the risk that the heat generated could melt the plastic surrounding the connector module, which increases the risk of a fire.

If the female connector to the Blower Motor Resistor assembly exhibits a previous overheat condition, (see photo) replace the harness and resistor assembly with the current replacement parts.
