newschannel update

то: Mercedes-Benz Dealer Principals, General	FROM: Thomas Brunner, Department Manager,
Managers, Sales Managers, Service Managers,	Vehicle Compliance and Analysis, Engineering
Parts Managers	Services
RE:Recall Campaign 2015060007-Check Fuse	
Box, Replace if Necessary. Model 117 (CLA).	DATE: July 14, 2015
Model Year 2014

Campaign No. 2015060007, July 2015

Check Fuses (Mini Fuses) and Replace Fuse Box if Necessary

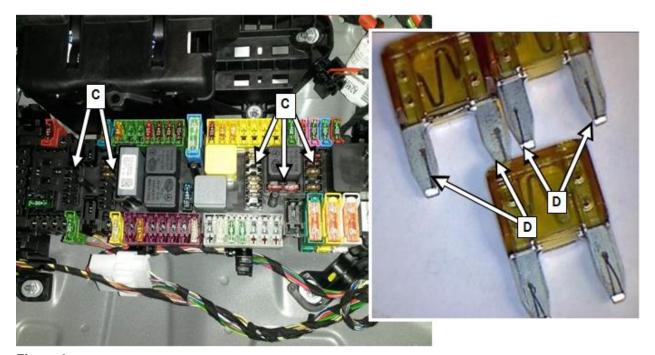
Figure 3

- Scratch marks must be visible at the front and backside of the contact blades. This ensures that the fuse is properly connected.
- Perform work on each fuse slot individually and successively.

- If **no** damage can be found on the slot and scratch marks are visible on both sides of the contact blades of the fuse (**OK**): Procedure is complete. Assemble in reverse order.
- If damage can be found on the slot and **no** scratch marks are visible on both sides of the contact blades
 of the fuse (Not OK): Proceed to Subject B.

3. Remove installed mini fuses (C, Figure 3) and check fuse slots (in fuse box) for visual damage. Check fuses for scratch marks (D, Figure 3) on contact blades at front and backside and then reinstall them.
