**MAZDA DEALER EMAIL**

Subject: CX-9 Control Arms Inspection Prior to Launch of Safety Recall 8515G

Subject vehicles: 2007-2014 model year CX-9 vehicles produced from October 24, 2006 through December 28, 2013.

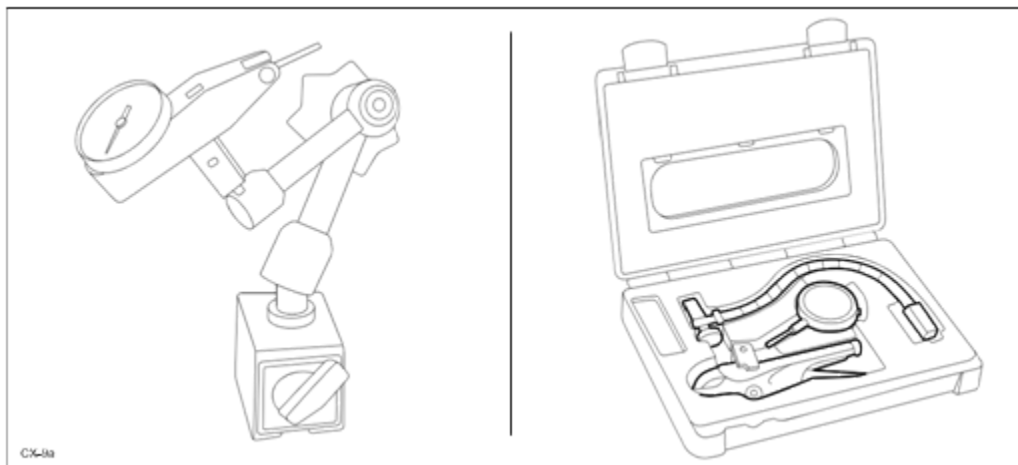
1. Obtain one of the following tools to measure the lower control arm play.

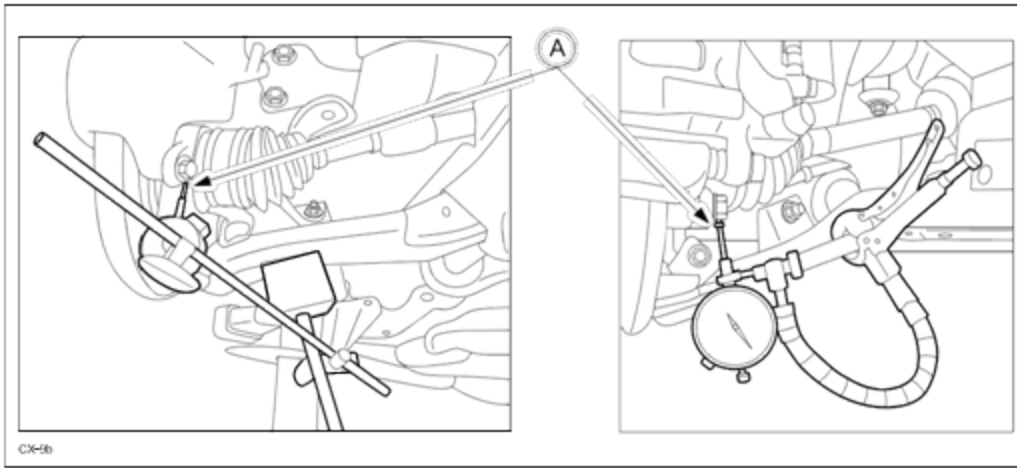
2. Fix magnetic base or locking pliers to the bottom of lower control arm to set the dial gauge.
3. Place the sensing tip of dial gauge on the horizontal flat surface of the bolt hexagonal head (A) which attaches the brake caliper to the steering knuckle.

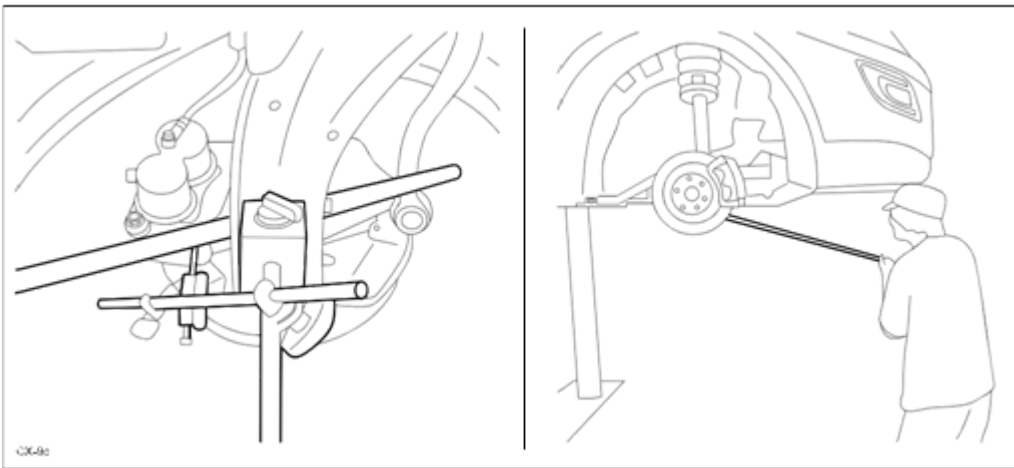
4. Press down on lower control arm with pry bar or metal bar, for example jack handle that is approx. 4 feet long.

5. Measure the play of the ball joint with the dial gauge.

Acceptable play amount: Under 2.0 mm [0.079 (5/64) in]

- If both ball joints pass inspection, inform the customer that they still need to bring their vehicle back for the replacement parts once they receive their official recall notice.
- If one or both ball joints fail inspection, replace the lower control arms and spacers on both sides and perform a front end toe adjustment alignment.
