SAFETY RECALL NOTICE

August, 2015

RE: RAM 5K A-Frame Coupler, P/N: CA-5100

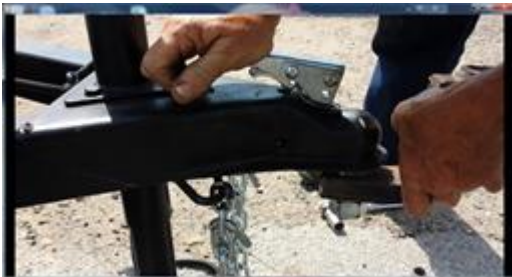
We learnt that numerous RAM 5K 2" A-Frame coupler in certain batches we shipped to Look Trailers from January 2015 are found that the coupler couldn't latch a 2" hitch ball as shown in the enclosed picture. At this moment, these batches are identified with date code (stamped on the frame top, close to the frame tail) 14-10, 14-11 and 15-01. The factory believes that this is because the ball clamp was adjusted too tightly and when the ball was on the coupler the coupler couldn't be latched.

If your dealer or final user encounter the latching issue like described above, the following is our instruction to fix it. The bottom nylon lock nut can be adjusted (while the lever is unlocked and the coupler is not engaged) to open up the coupler ball clamp. We would recommend to try a half turn to loosen the nut as this is how we adjust this coupler in our assembly line. Then try to engage the ball on the coupler and typically it solves the problem. Repeat 1/2 turn again if and only if necessary.

I also wanted to mention that the adjustment process can continue as long as the hitch ball remains tight to the ball clamp while coupler is engaged. There should be some resistance when engaging the lever latch while coupling to a hitch ball. The springs on the spade bolt will function as designed. This type of lever latch coupler also includes a u shaped washer to prevent the nut from turning after coupler is adjusted to fit the ball properly.
