RECALL CAMPAIGN "VS"
Technical Service Bulletin

October 2, 2015
Bulletin No. TS 15 10161

SAFETY RECALL CAMPAIGN "VS" 2012-2013 SX4 POWER STEERING PUMP ASSEMBLY

Affected Models: Certain 2012-2013 SX4 (RW420)
(See Affected Models on Page 2 for affected VIN range)

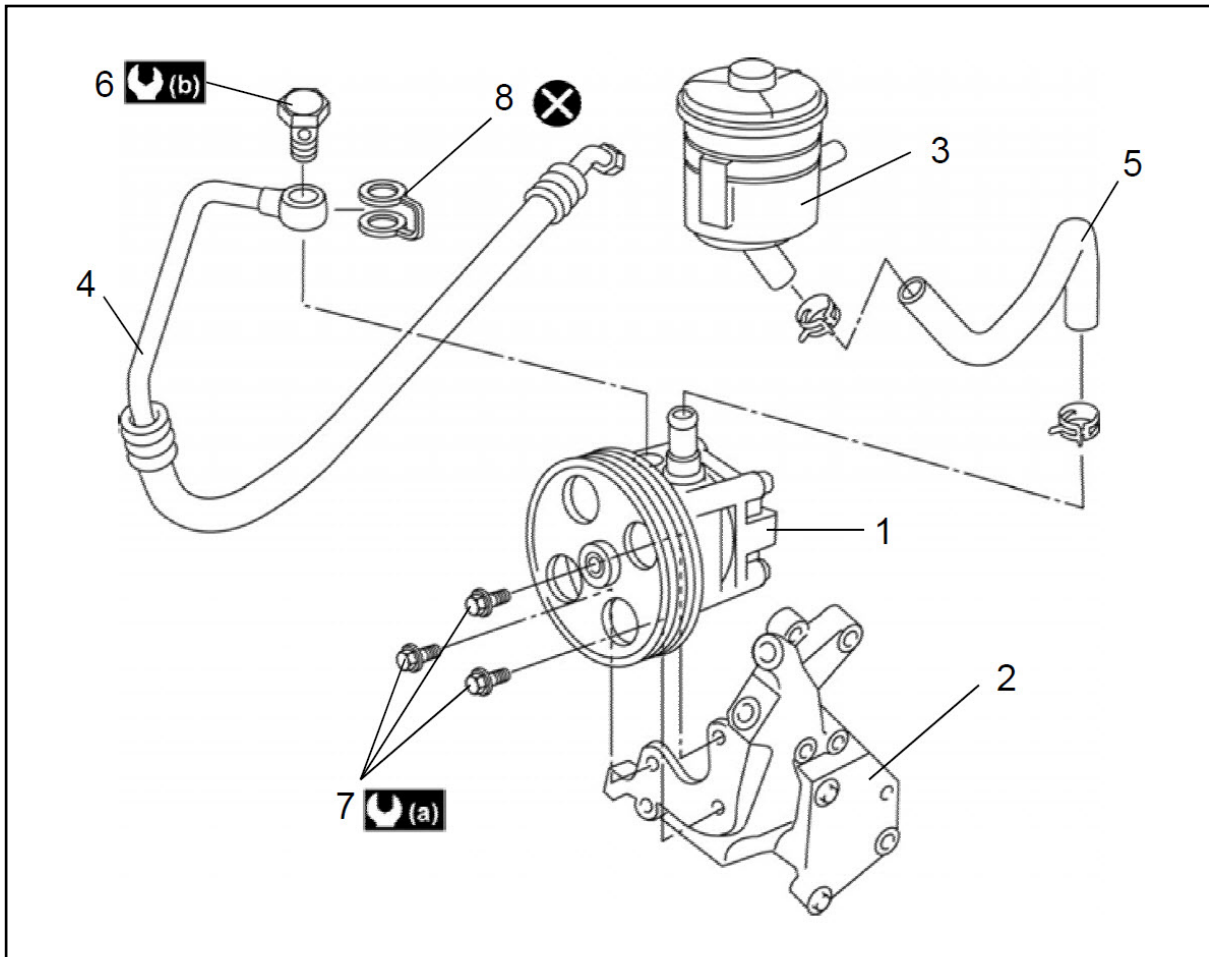
1. Power steering pump assembly	7. Power steering pump mounting bolt
2. Power steering pump bracket	8. Pressure pipe gasket
3. Power steering fluid reservoir	:25 N·m (2.5 kgf-m, 18.5 lbf-ft)
4. High pressure pipe	:65 N·m (6.6 kgf-m, 48.0 lbf-ft)
5. Suction hose	:Do not reuse.
6. High pressure pipe union bolt

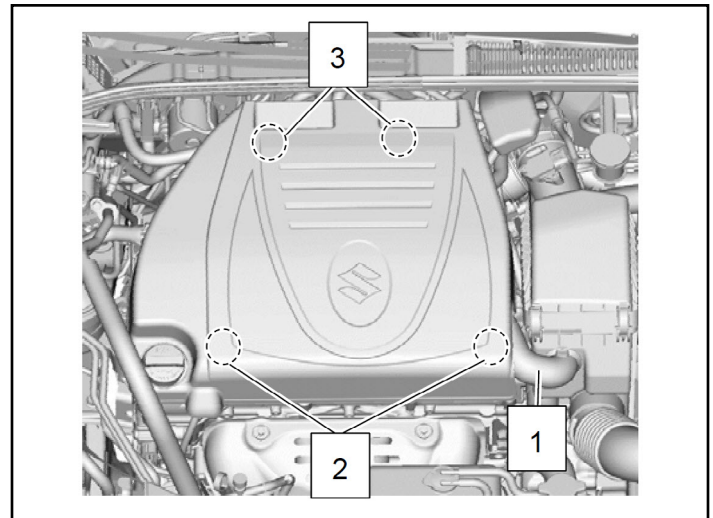
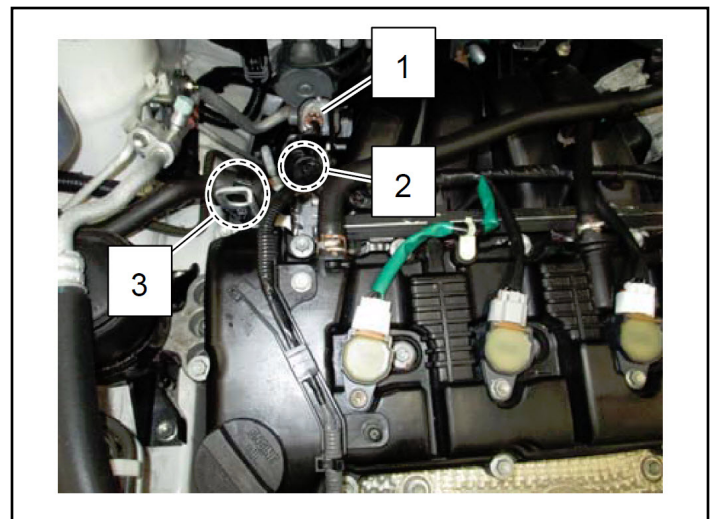
If care is not used when removing the engine cover, it can hit the cowling front panel, and damage the cover.

- 3) Remove the engine cover:
 - A. Disconnect the engine cover hose (1) from the air cleaner assembly. Then disconnect the front (2) and rear (3) side hooks from the engine cover pins.
 - B. Disconnect the IMT valve actuator connector (1) and harness clamp (2).
 - C. Disconnect the suction hose clamp (3).

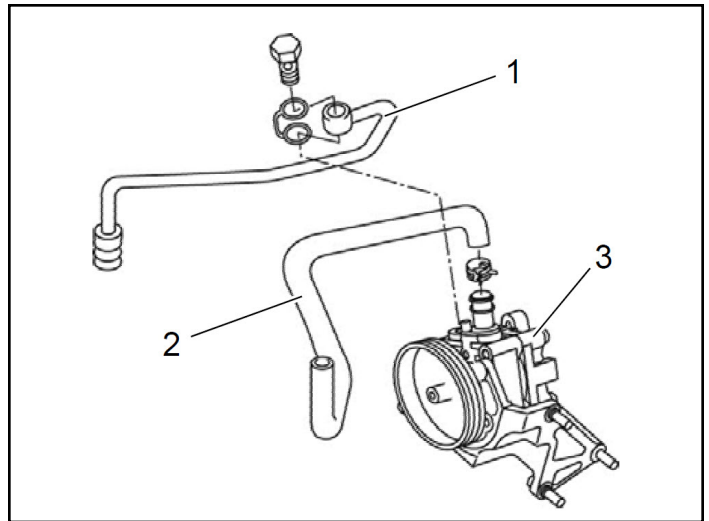
The power steering system can be damaged if foreign material or debris gets in the suction hose.

- 4) Clean the high pressure pipe (1) joints and suction hose (2) before removing them. Then remove the high pressure pipe and the suction hose from the power steering pump assembly (3).

Be sure to immediately plug the suction hose after disconnecting it.

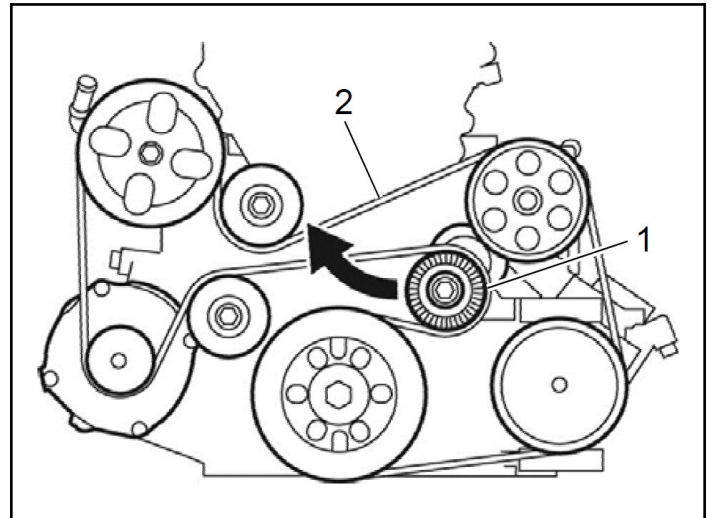
Over-tightening the tensioner may damage it.

- A. Hoist the vehicle.
- B. Loosen the belt tension by turning the tensioner (1) clockwise with a torque wrench.

Be careful not to turn the tensioner pulley more than 59 N·m (6.0 kgf-m, 43.5 lbf-ft) using a torque wrench.

- C. While keeping the tensioner loose, install the accessory drive belt (2).
- D. Install the right engine undercover.

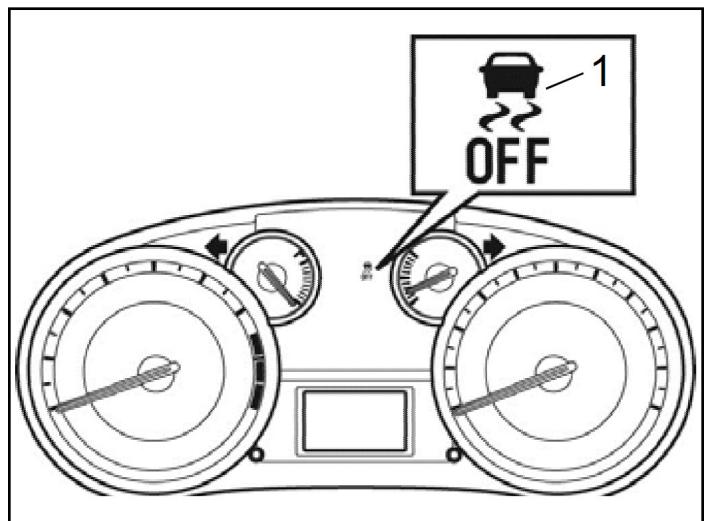
If power to the steering angle sensor is removed, DTC C1075 will be detected and the ESP OFF indicator (1) will turn on. If any other indicator turns on, a DTC other than C1075 may have been detected — diagnose the other DTC before C1075.

- D. Drive straight at approximately 22 mph or more for 10 seconds or more.
