SUBJECT: Safety Recall 15S28

Certain 2001 through 2008 Model Year Ford Escape and Mercury Mariner Vehicles
Equipped with a Remanufactured CD4E Automatic Transmission
Shift Control Lever Bolt Torque

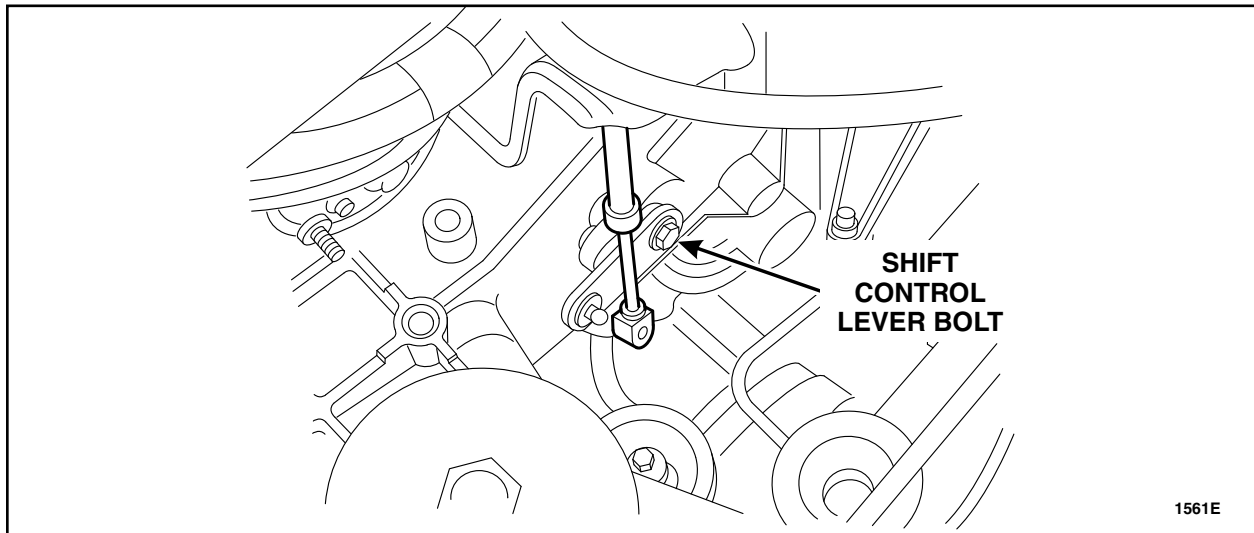
FIGURE 3

Ford remanufactured CD4E transmissions installed in some vehicles, may have a shift control lever bolt that may not have been installed to the proper torque specification. If the shift control lever bolt becomes loose, the shift control lever may disengage from the transmission without warning and the transmission may not respond to operator gear selection. This can result in possible vehicle roll-away, increasing the risk of an injury or crash. Dealers are to torque the shift control lever bolt to the proper specification using a torque wrench.

4. Tighten the shift control lever bolt to 27 Nm (20 lb-ft). See Figure 3.
