SUBJECT: Safety Recall 15S27

Certain 1998-2003 Model Year Windstar Vehicles Repaired Under Safety Recall 10S13

with Rear Axle Reinforcement Brackets

Rear Axle Inspection

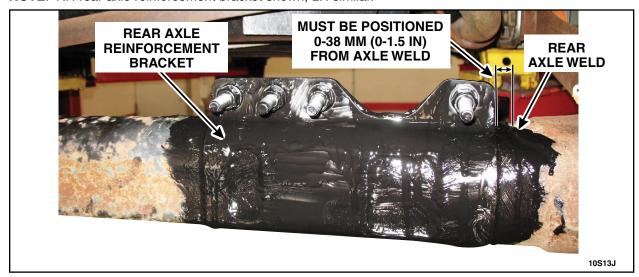
FIGURE 1

- 1. Inspect and verify both rear axle reinforcement brackets are positioned within 0 to 38 mm (0 to 1.5 in) from the top of the rear axle weld on each side of the axle. Inspect for evidence that adhesive was used during rear axle reinforcement bracket installation. See Figures 1 and 2.

NOTE: RH rear axle reinforcement bracket shown, LH similar.

- If either rear axle reinforcement bracket <u>is not</u> positioned within 0 to 38 mm (0 to 1.5 in) from the top of the rear axle weld and/or the use of adhesive <u>is not</u> evident, the inspection has failed. Photograph the rear axle reinforcement bracket(s) and/or missing adhesive for dealer records. Use a tape measure to illustrate the incorrect rear axle reinforcement bracket-to-axle weld distance in the photograph. Proceed to Rear Axle Replacement on Page 3.

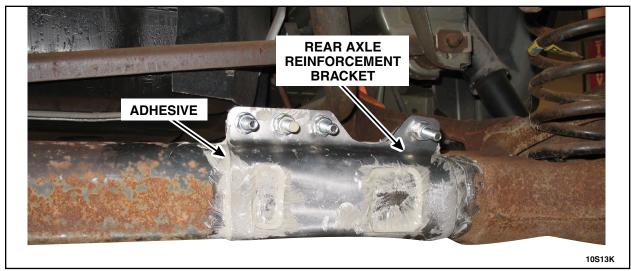
FIGURE 2

NOTE: RH rear axle reinforcement bracket shown, LH similar.

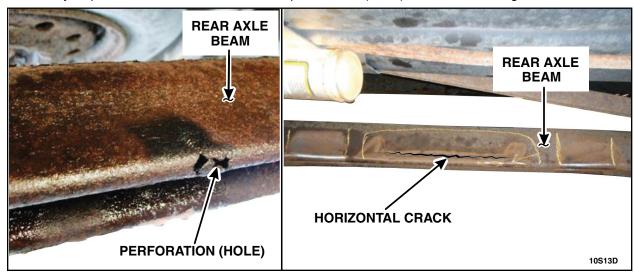
FIGURE 3

1. Visually inspect the entire rear axle beam for perforations (holes) or cracks. See Figure 3.

- 2. Are any cracks and/or perforations present on the rear axle?
 - **NO**, vehicle passed inspection. Return the vehicle to the customer unless rear axle replacement is desired under program **15N02**.
 - YES, cracks and/or perforations <u>are</u> found in the rear axle. Advise customer of the condition and the discounted axle replacement cost available under program 15N02. Record on the Repair Order if customer accepts or declines rear axle replacement.

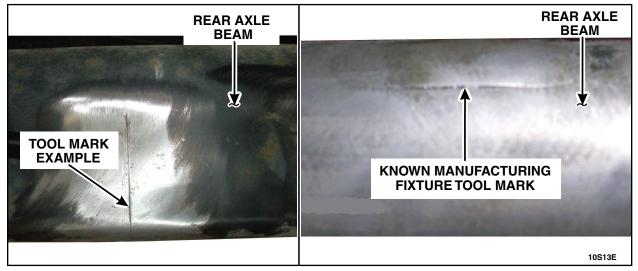
FIGURE 4

NOTE: Vertical tool marks are possible anywhere along the bottom edge of the rear axle beam.

NOTE: The manufacturing fixture tool marks are present on every rear axle beam.

NOTE: When inspecting the rear axle beam, please be aware that surface marks, tool marks, or coating imperfections are acceptable. See Figure 4.
