IMPORTANT SAFETY RECALL

Airstream Interstate Motorhome

NHTSA Recall Number 15V-658

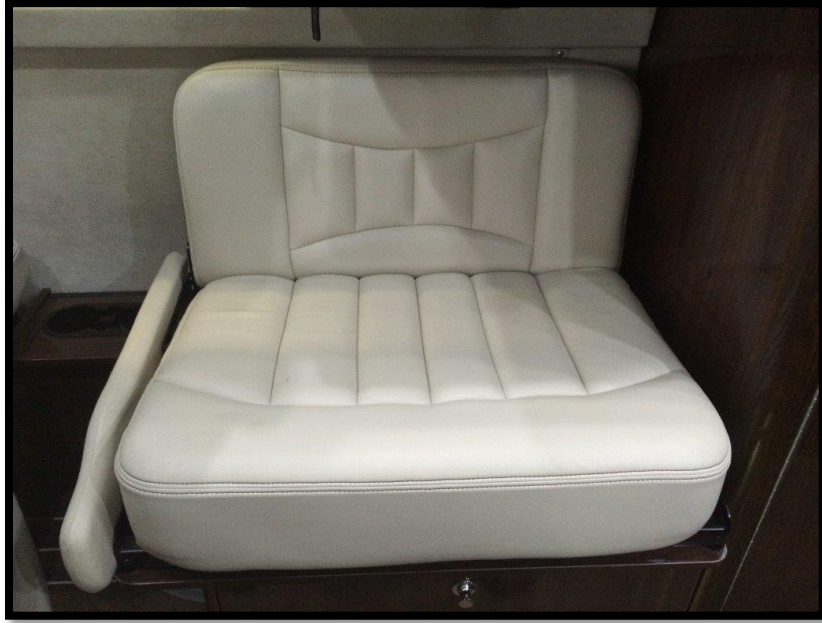
Step 1: Locate the Magnum Inverter/Converter compartment in the unit underneath the Roadside Lounge seat.

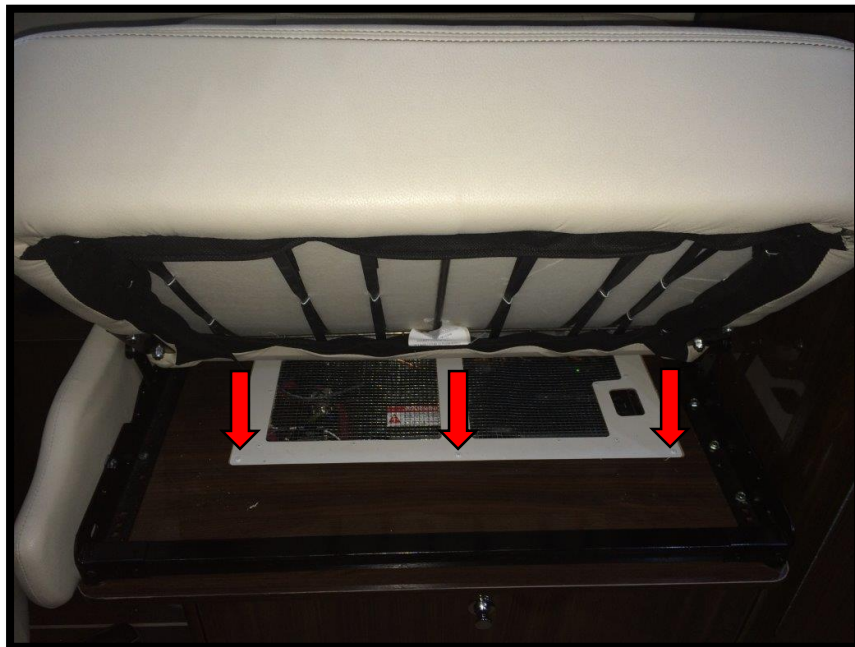
Step 2: Lift up lounge seat and remove the six Phillips head screws to remove the panel covering the Magnum Inverter/Converter. (three in front, three in back)

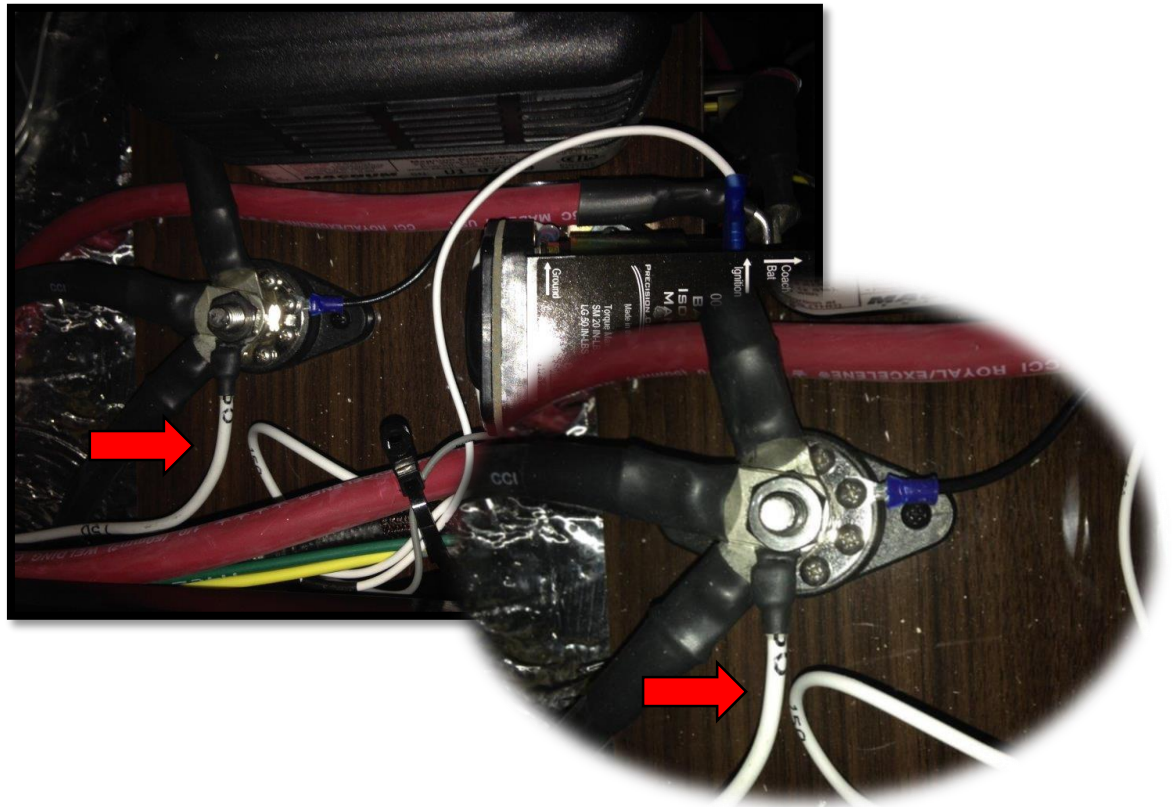
Step 3: Locate the bundle of wires grounded to the left of the Magnum. Remove the 8Ga. white wire labeled #150, identified below.

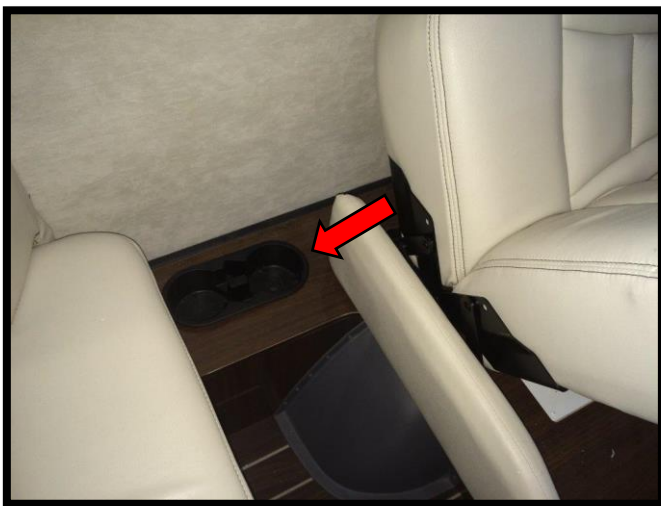
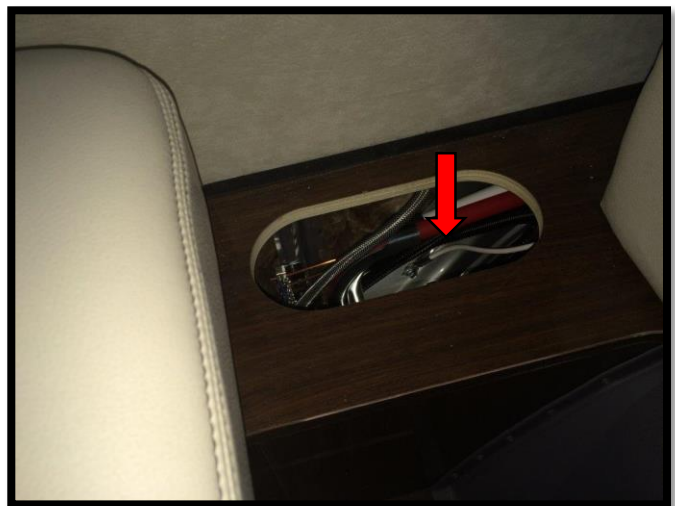
Step 4: Remove the roadside cup holder from behind the jack knife seat. Pull the white wire removed from the bundle form under the jack knife seat, to the roadside wall under the cup holder.
