TO: ALL U.S. FCA DEALERSHIPS
ATTN: DEALER PRINCIPAL, SERVICE MANAGER & PARTS MANAGER
SUBJECT: R59 RAM AXLE BEARING JOURNAL HARDNESS *REVISION NOTIFICATION*

R59 RAM Truck Axle Bearing Journal Hardness Overview

R59 Revised Service Instructions

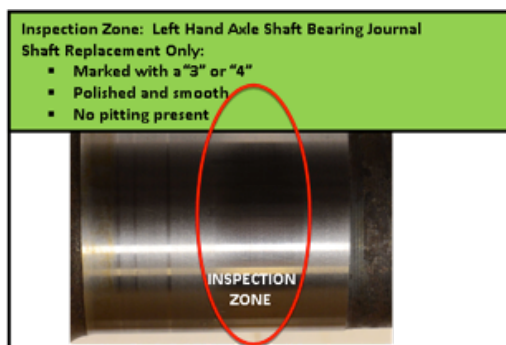
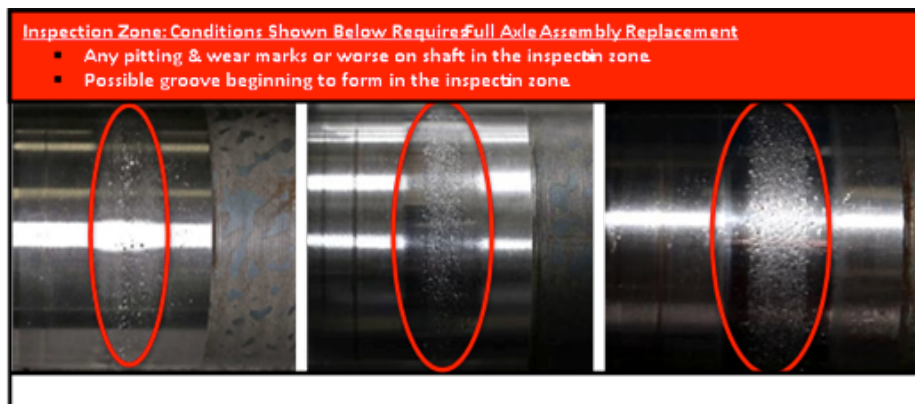
- Technicians should review the new information and pictures found under **step 14** in the Service Procedure. Pictures found in the service procedure are shown below for additional reference.
- It is imperative that all axle shafts be inspected and compared to the pictures found in the service procedures. Any pitting or wear marks found require **full axle assembly replacement**.
- Any copies of the previous service instructions should be discarded
