**DEMONSTRATION / DELIVERY HOLD - Safety Recall 15S25**

Certain 2016 Model Year F-53 and F-59 Vehicles  
Transmission Shift Cable Bracket Replacement

## CERTAIN 2016 MODEL YEAR FORD F-53 MOTORHOME AND F-59 STRIPPED CHASSIS VEHICLES — TRANSMISSION SHIFT CABLE BRACKET REPLACEMENT

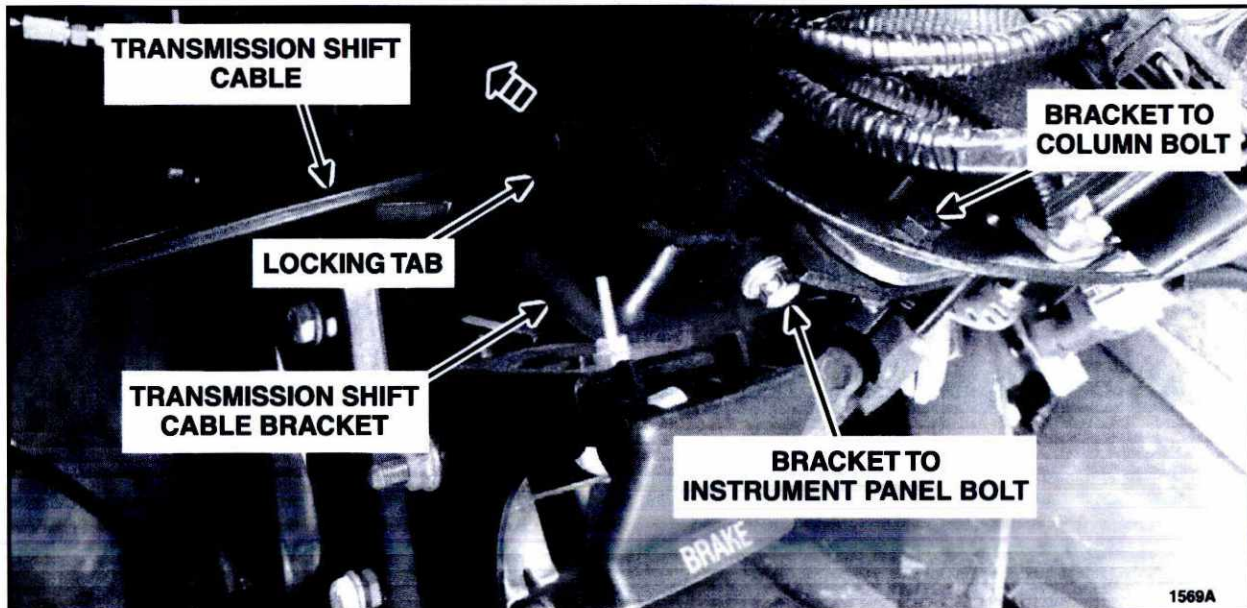
FIGURE 1

In the affected vehicles, the transmission shift cable bracket may have been manufactured out of specification, causing the transmission shift cable to be installed incorrectly. This condition may result in unintended vehicle movement if force is applied to the gear shift lever when in the park "P" position. Unintended vehicle movement may increase the risk of an injury or crash. Dealers are to replace the transmission shift cable bracket and adjust the shift cable (selector lever cable) using the following procedure.

1. Remove the lower steering column trim/knee bolster panel as necessary to gain access to the lower steering column area. Refer to the Coach Builders Repair Manual for additional information if necessary.
2. Remove the transmission shift cable bracket. See Figure 1.
  - a. Carefully lift the locking tab and disconnect the transmission shift cable from the bracket.
  - b. Remove the two bolts and the transmission shift cable bracket.
    - When installing the bolts, torque to the following specifications:
      - Bracket to Column bolt to 36 lb.ft (48 Nm).
      - Bracket to Instrument Panel bolt to 21 lb.ft (28 Nm).

3. To install the *new* transmission shift cable bracket, reverse the removal procedure.
4. Perform the Selector Lever Cable Adjustment procedure. Please follow Workshop Manual (WSM) procedures in Section 307-05.
