**TO:** Mazda Service Managers

**SUBJECT:** Safety Recall 8815J – 2008 Tribute Remanufactured A/T Shift Lever

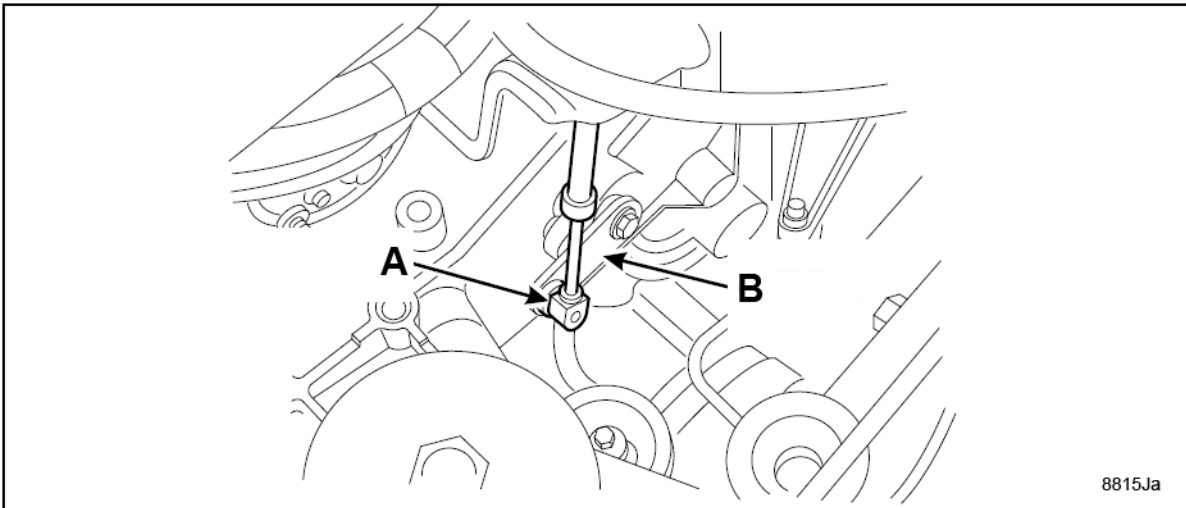
The remanufactured transaxle installed June 20, 2015 through August 11, 2015 may have an under torqued manual control lever bolt. If the manual control lever bolt backs out, the lever may disengage from the transaxle without warning and the transaxle may not respond to the operator shift selection. This can result in the loss of transaxle gear selection, and possible vehicle roll-away. Dealers are to access and torque the manual control lever bolt using a torque wrench.

1. Place tire chocks at one of the wheels to prevent vehicle movement during repair.
2. Disconnect the selector lever cable (A) end from the manual control lever (B) at the transmission.

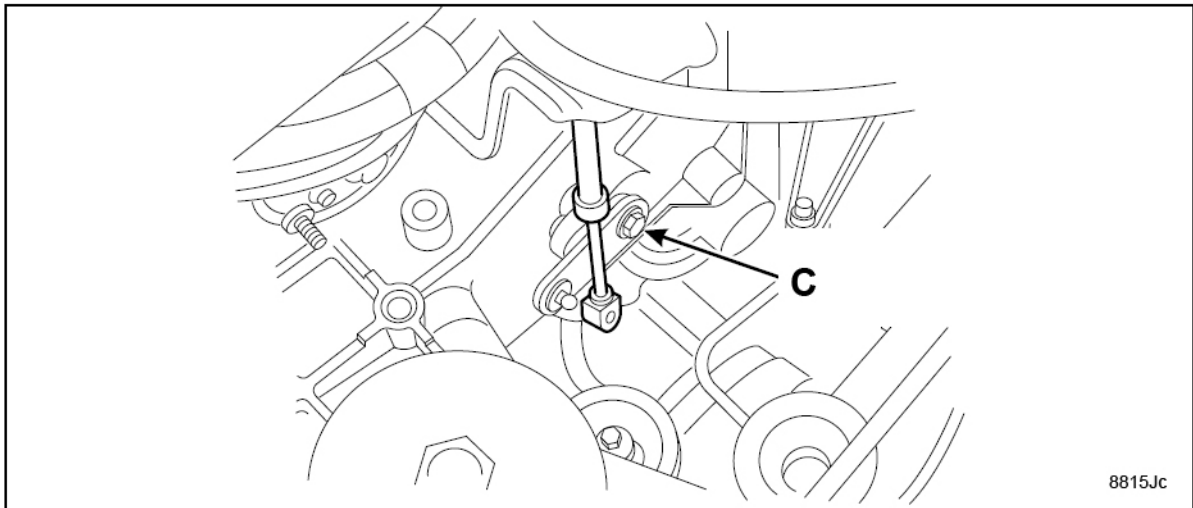
The shift lever bolt of the remanufactured A/T was not tightened to the appropriate torque specification. If the bolt becomes loose, the lever may disengage from the transmission without warning and the transmission may not respond to the driver’s gear selection. This can result in vehicle roll-away and increase the risk of a crash and/or injury.

4. Tighten the manual control lever bolt (C) to 20 lb-ft (27 Nm).
