TO: Mercedes-Benz Dealer Principals, General Managers, Sales Managers, Service Managers, Parts Managers	FROM: Thomas Brunner, Department Manager, Vehicle Compliance and Analysis, Engineering Services
RE: Recall Campaign 2015110004 – Drive Shaft Bolts. Model 292 (GLE Coupe AMG 63 S 4MATIC, GLE450 AMG 4MATIC) Model Year 2016	DATE: November 20, 2015

Campaign No. 2015110004, November 2015

SUBJECT: **Model 292 (GLE Coupe), Model Year 2016**
Correct Torque of Drive Shaft Bolts

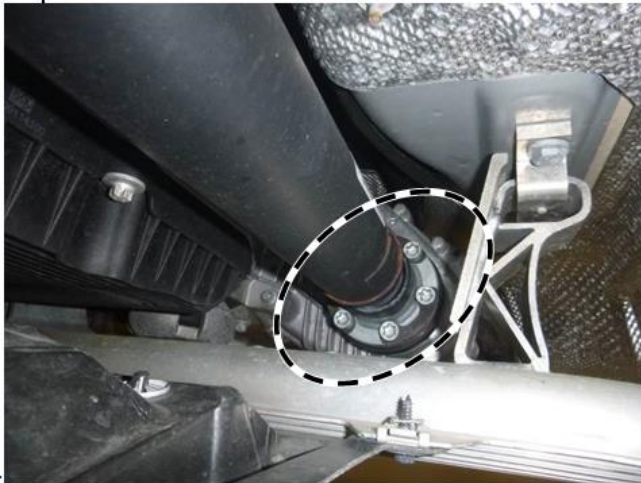
**Figure 1**

This Recall Campaign has been initiated because Daimler AG (DAG), the manufacturer of Mercedes-Benz vehicles, has determined that on certain GLE Coupe vehicles (292 platform), the rear drive shaft bolts might not meet the required internal specification. As a consequence some bolts could become loose resulting in potential noise and vibrations. In the event this noise and vibrations are ignored, the complete bolts could loosen, which could lead to the shaft separating from the transmission or the rear axle differential. This could lead to a loss of vehicle propulsion and cause the vehicle to stall, which may increase the risk of a crash.

1. Correct torque (50 Nm) of drive shaft bolts in front of (6 pcs., Figure 1) and behind (6 pcs., Figure 2) the transfer case; refer to WIS: AR41.10-P-0070-03GZ.

When checking the drive shaft bolts with 50 Nm torque, these bolts must not turn. If the bolt(s) continues turning before reaching 50 Nm, the affected bolt(s) must be replaced. New bolt(s) are to be tightened to 40 Nm + 90°.
