NISSAN BULLETIN

Torque Member Bolt Voluntary Safety Recall Campaign

Reference: PC412
Date: November 4, 2015

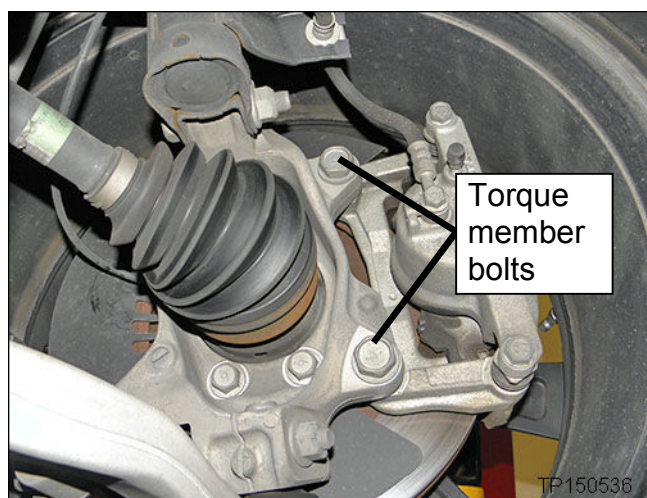
A. On certain Altima and Maxima vehicles manufactured in Smyrna, Tennessee between October 6th and October 7th, 2015 the front caliper torque member bolts may be under torqued.

A. Due to a manufacturing process error, the front caliper torque member bolts may be under torqued. If left uncorrected over time, the brake caliper assembly may become loose or in extreme cases, separate from the vehicle. This can result in reduced braking performance and could potentially lead to a crash.

1. Lift the vehicle.
2. Locate and torque the two (2) torque member bolts on each front wheel hub assembly (see Figure 1).
 - Figure 1 shows the Driver side; the passenger side is a mirror image.
 - Turning the wheel to the left (for the left side), or to the right (for the right side) will give better access to the torque member bolts.
 - Torque to 144.5 N·m (15 kg-m, 107 ft-lb)

- Make sure to perform the above torque procedure on **BOTH** (driver and passenger side) front torque members.
- **If a bolt is found missing, Send an E-mail to the below address.**
nafqasupport@nissan-usa.com
- **Include the information listed below:**
 - Dealer Name
 - Dealer Code
 - Dealer Address
 - VIN
 - Contact Person Name
 - Contact Person Phone Number
 - **Provide picture of torque member assembly missing the bolt and washer.**
