Michael A. Berardi
 Director
 Service Engineering Operations
 Ford Customer Service Division

January 20, 2016

SUBJECT: **Safety Recall 15S34 – Supplement #1**
 Certain 2010-2011 Model Year Fusion and Milan Vehicles Equipped with 2.5L or 3.0L Engines
 Fuel Tank and Canister Purge Valve Inspection and Repair

REF : **Safety Recall 15S34**
 Dated December 16, 2015

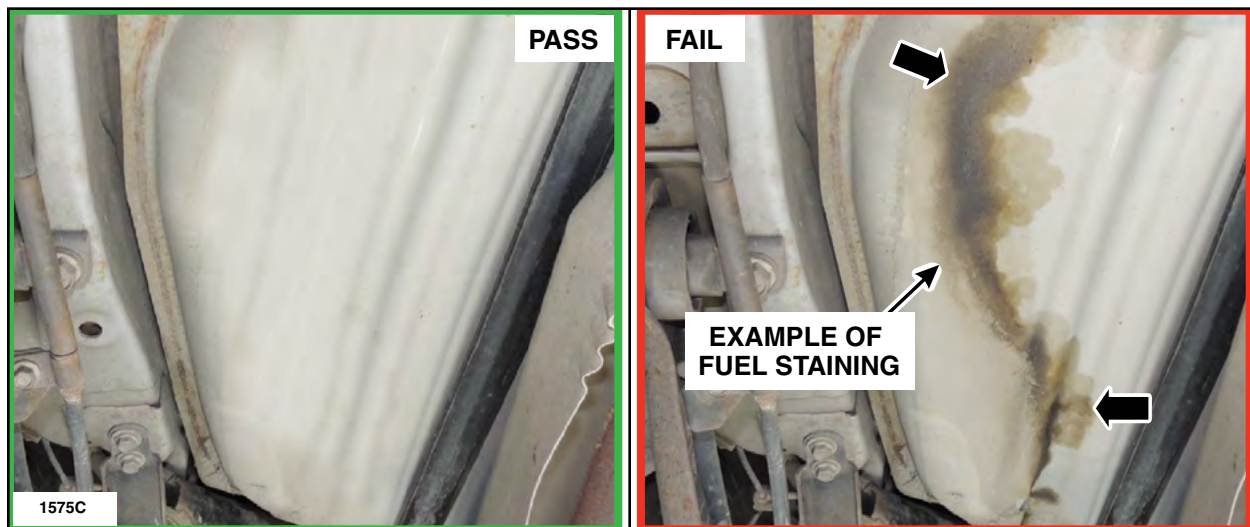
FIGURE 1

1. Inspect the fuel tank for any signs of fuel staining on the bottom of the fuel tank.
See Figure 1. Is fuel staining present?

NOTE: Some fuel staining may be present on the top of the fuel tank if the fuel pump has been replaced previously. Fuel staining on the top of the fuel tank caused by prior fuel pump service is not an indication of a fuel tank leak.

YES - The fuel tank must be replaced. Replacement fuel tanks are not available at this time. Contact the Special Service Support Center (SSSC) using a Parts Order contact to place an order for a fuel tank and to request a rental vehicle, if needed. Photos of the fuel staining will be needed when submitting the request.

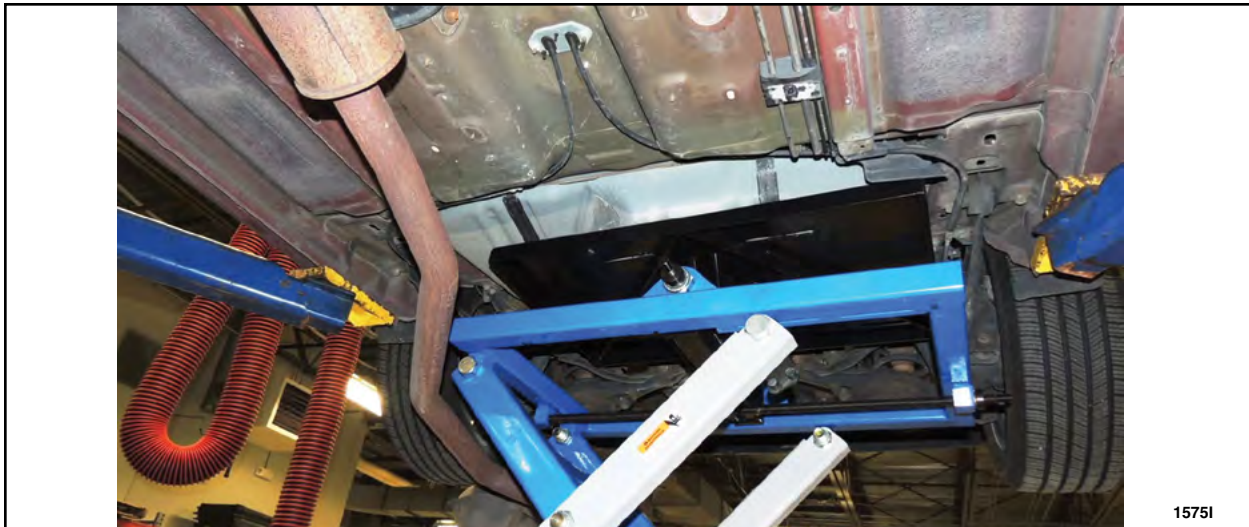
FIGURE 2

2. Partially lower the fuel tank to inspect the top of the fuel tank for any signs of fuel staining.
See Figures 2 and 3.
 - a. Detach the exhaust isolators. Position aside and support the exhaust assembly.
 - b. Remove the fuel tank heat shield.
 - b. Use a suitable powertrain lift to support the fuel tank.
 - c. Remove the four fuel tank bolts and lower the fuel tank approximately 1.75 in (44.45 mm).
See Figure 3 on Page 5.

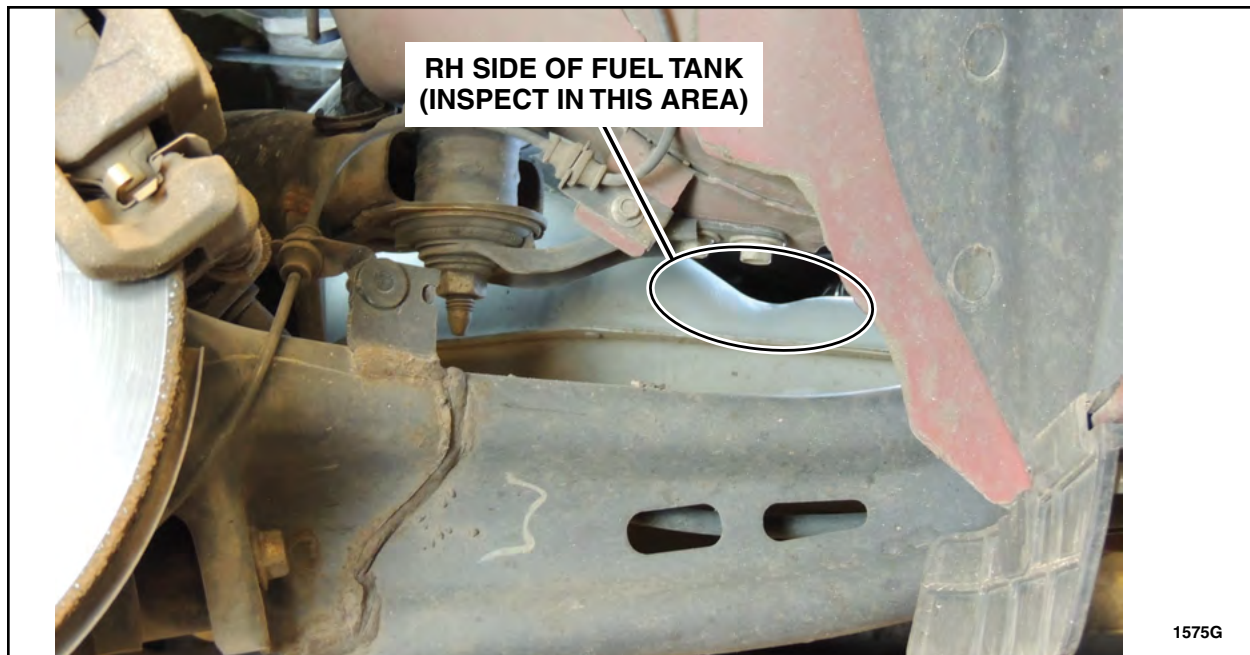
FIGURE 3

3. Check the top RH side of the fuel tank for signs of cracks. See Figures 3 and 4. Is cracking present?

YES - The fuel tank must be replaced. Because fuel tanks are not available, reinstall the fuel tank and contact the Special Service Support Center (SSSC) using a Parts Order contact to place an order for a fuel tank and to request a rental vehicle, if needed. Photos of the cracking will be needed when submitting the request.

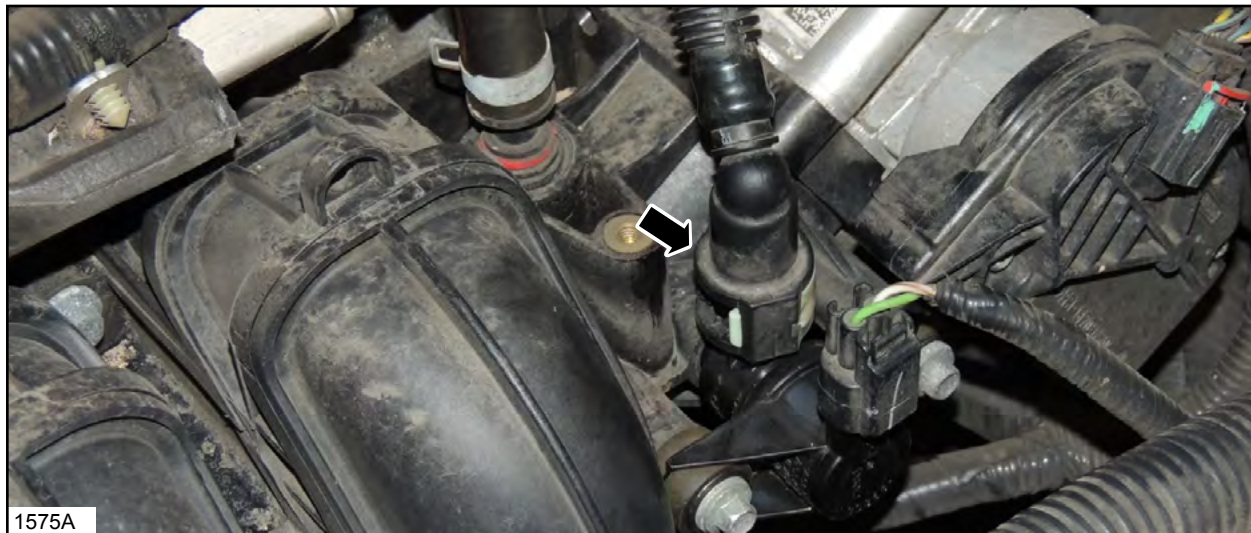
FIGURE 5

2. Disconnect the vapor tube-to-CPV quick connect coupling. Please follow the WSM procedures in Section 310-00. See Figure 5.

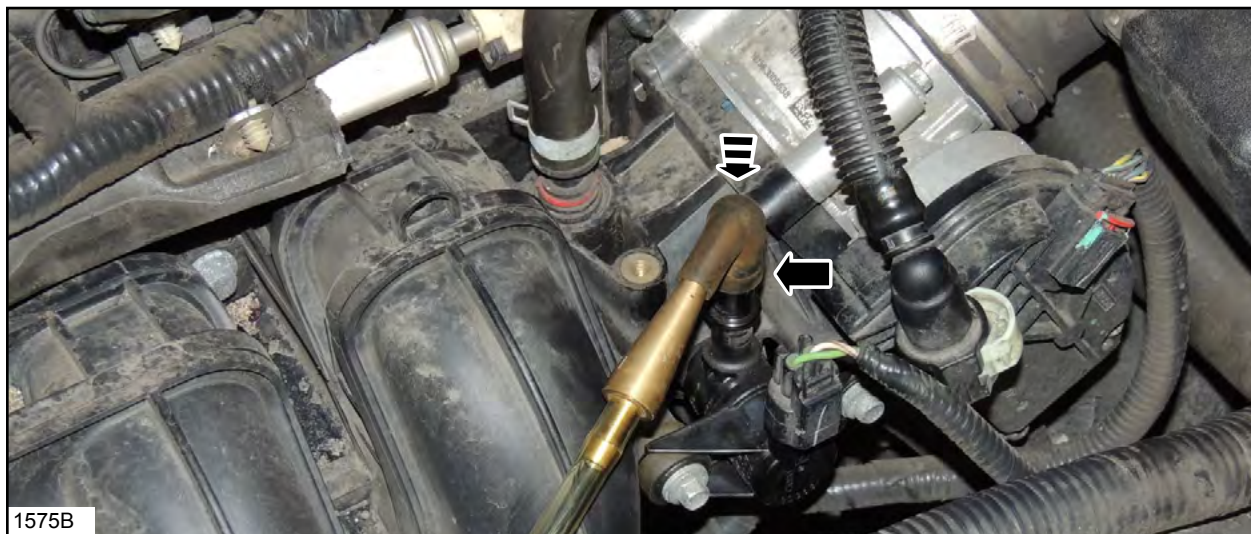
FIGURE 6

3. Using suitable adapters, connect the VACUTEC® Smoke Machine Fuel Evaporative Emission System Tester or equivalent to the port on the CPV. See Figure 6.

4. With the ignition in the "OFF" position, test the CPV for leaks by applying pressure from the tester and monitoring for air flow on the gauge. A good CPV will register a leak rate of less than 0.020".

NO - Replace the CPV following the WSM procedures in Section 303-13, then proceed to Vapor Canister Inspection on Page 8.

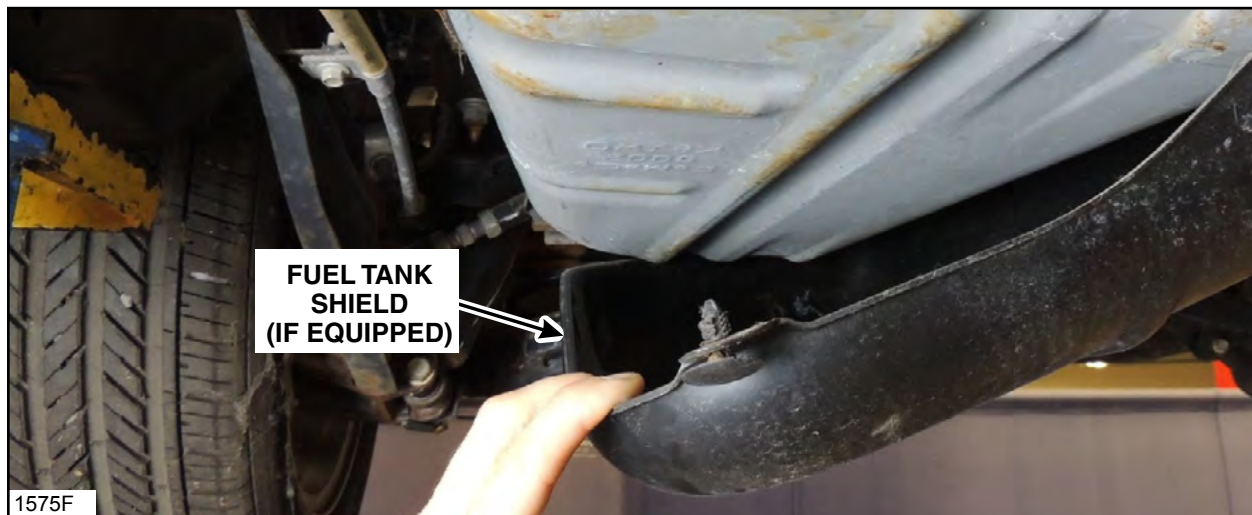
FIGURE 1

- **AWD Vehicles Only** - Fuel tanks come equipped with a plastic shield covering the tank. See Figure 1.
 - a. Remove the fuel tank strap bolts and strap from the RH side of the fuel tank.
 - b. Remove the two push pins and bend the plastic shield downward to inspect the RH side of the fuel tank.
 - c. Reinstall the fuel tank strap, bolts and shield push pins. Perform the same inspection steps for the LH side of the fuel tank (Steps a-c).
 - d. If fuel tank replacement is not required, tighten the fuel tank strap bolts to 40 Nm (30 lb-ft).

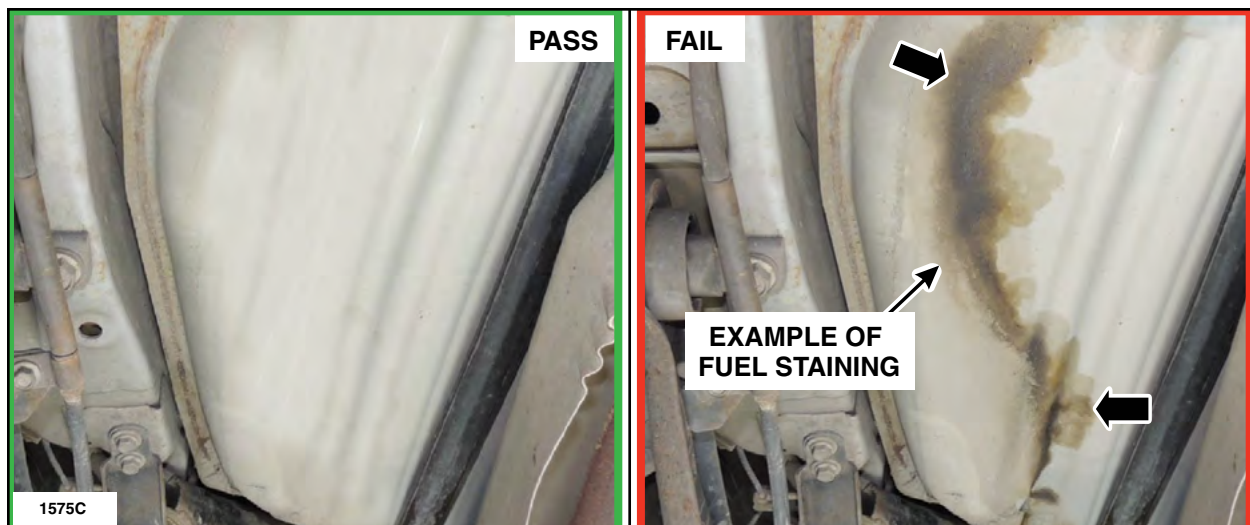
FIGURE 2

1. Inspect the fuel tank for any signs of fuel staining on the bottom of the fuel tank. See Figure 2.

2. Is there fuel staining on the bottom of the fuel tank?

YES - The fuel tank must be replaced. Replacement fuel tanks are not available at this time. Contact the Special Service Support Center (SSSC) using a Parts Order contact to place an order for a fuel tank and to request a rental vehicle, if needed. Photos of the fuel staining will be needed when submitting the request.

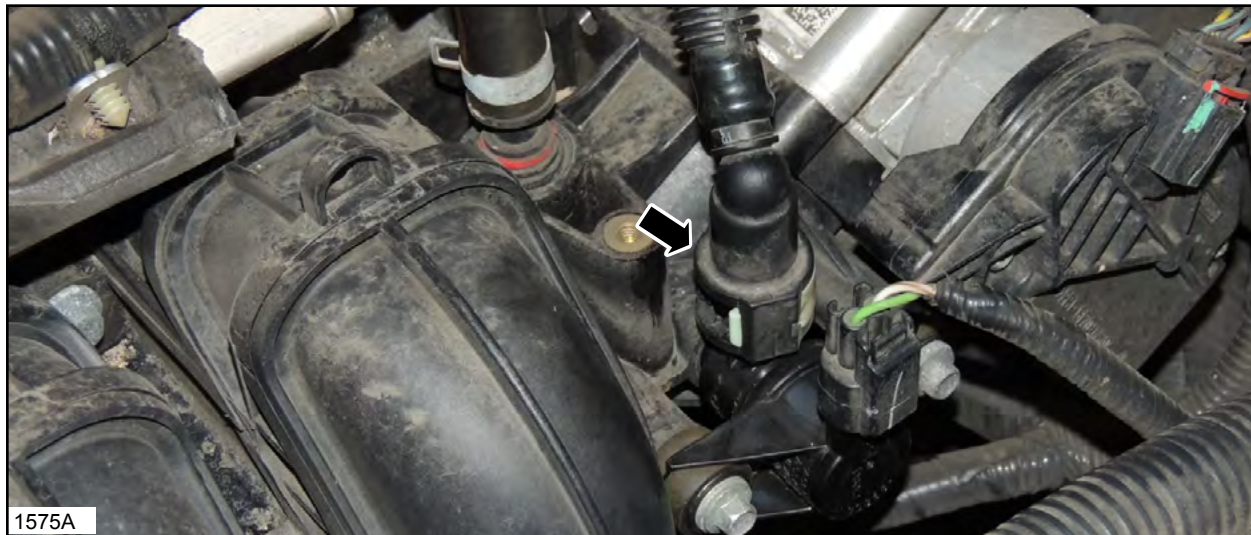
FIGURE 3

2. Disconnect the vapor tube-to-CPV quick connect coupling. Please follow the WSM procedures in Section 310-00. See Figure 3.

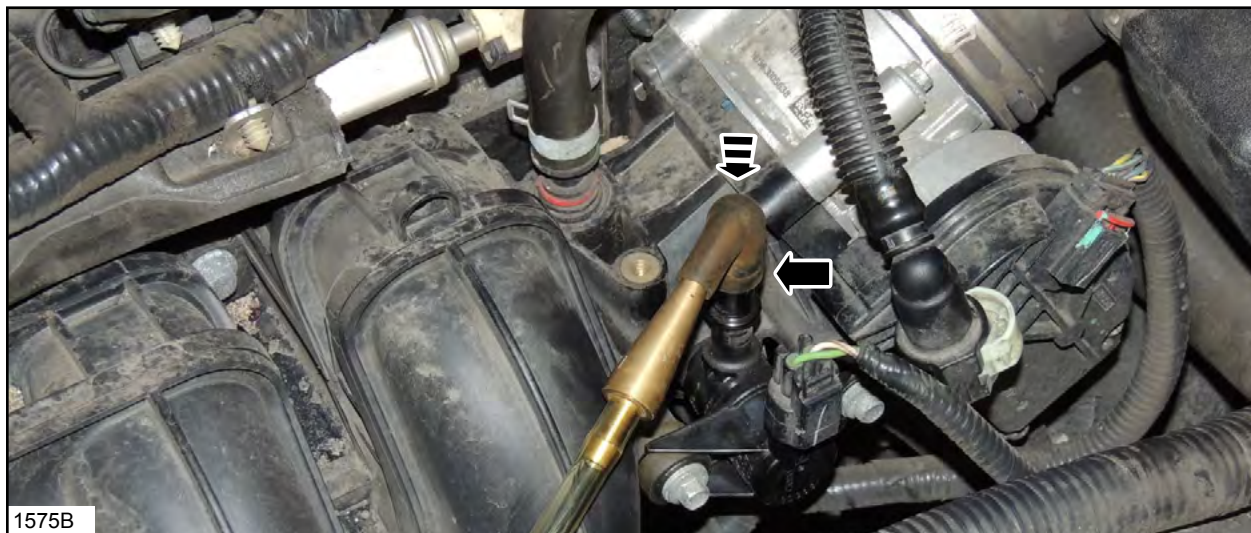
FIGURE 4

3. Using suitable adapters, connect the VACUTEC® Smoke Machine Fuel Evaporative Emission System Tester or equivalent to the port on the CPV. See Figure 4.

4. With the ignition in the "OFF" position, test the CPV for leaks by applying pressure from the tester and monitoring for air flow on the gauge. A good CPV will register a leak rate of less than 0.020".

NO - Replace the CPV following the WSM procedures in Section 303-13, then proceed to Vapor Canister Inspection on Page 7.
