SAFETY RECALL CAMPAIGN

TITLE: Hood Latch Replacement - North America

RECALL REFERENCE 010

DOCUMENT NUMBER: 12 A 006

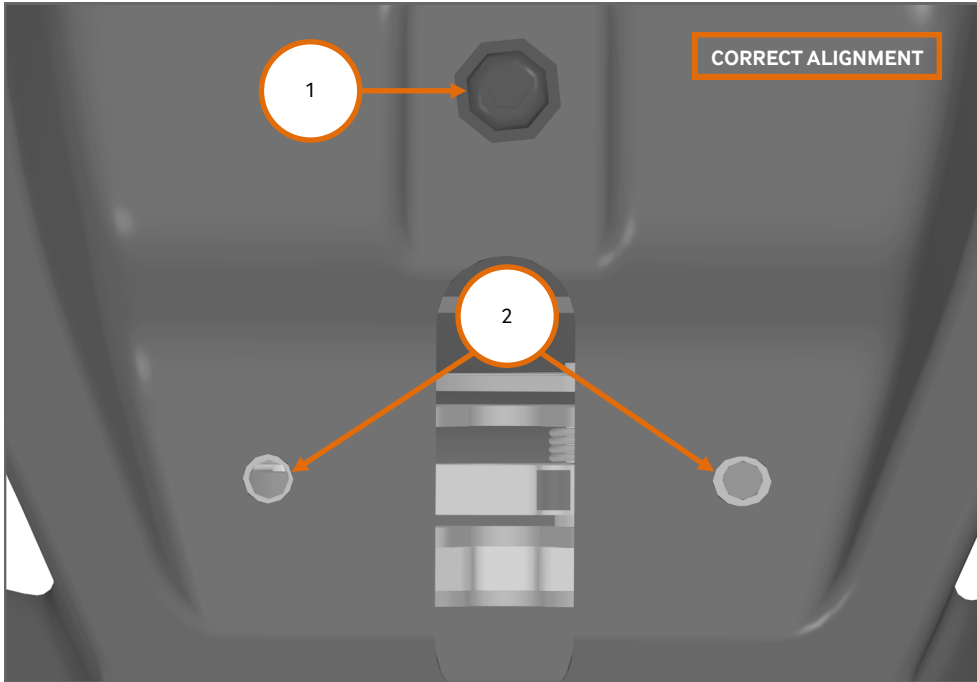
1. Please refer to BA-RM-02A052-03-001 Remove/install latch - Luggage compartment lid, to remove the hood latch.
2. Check for correct alignment of the new hood latch by fitting the top fixing bolt (1) and checking if the lower fixing points (2) of the latch are fully aligned with the holes in the front clam.
3. If the lower fixing holes (2) of the latch fully align with the clam fixing holes then proceed and install the new hood latch. Please refer to Step 8.

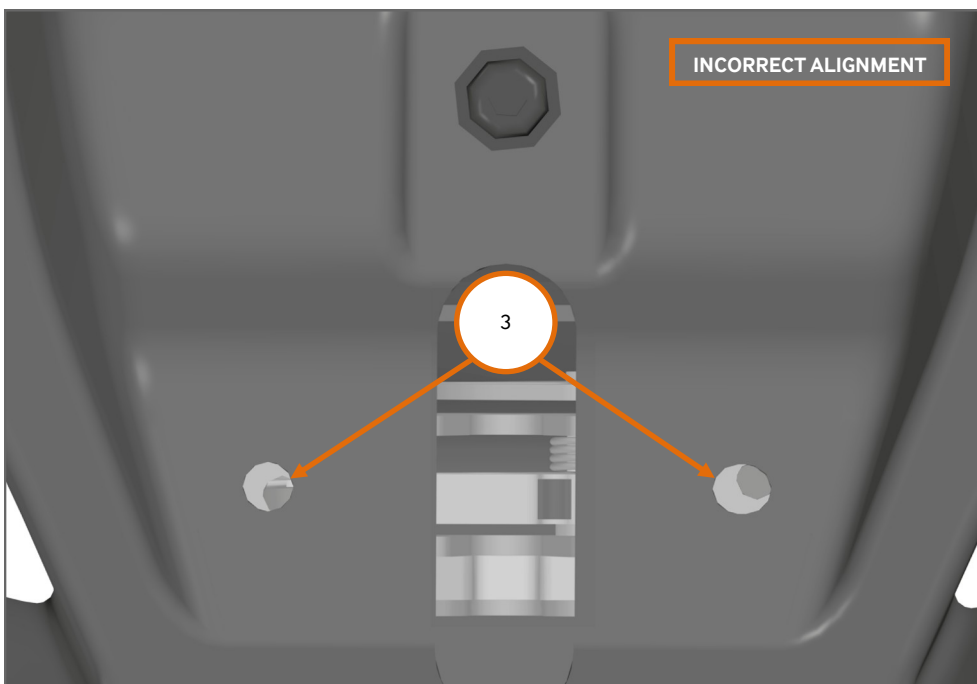
4. If the fixing holes of the latch are **not** fully aligned (3) with the clam fixing holes please refer to Step 5.

Care Point: Do not attempt to install the remaining two fixing bolts if the lower fixing holes are not aligned.
