Michael A. Berardi  
Director  
Service Engineering Operations  
Ford Customer Service Division

**SUBJECT:** **Safety Recall 15S39**  
2003-2005 Model Year Crown Victoria and Grand Marquis Vehicles  
Headlights Inoperative

## 2003 - 2005 MODEL YEAR CROWN VICTORIA AND GRAND MARQUIS VEHICLES — HEADLIGHTS INOPERATIVE

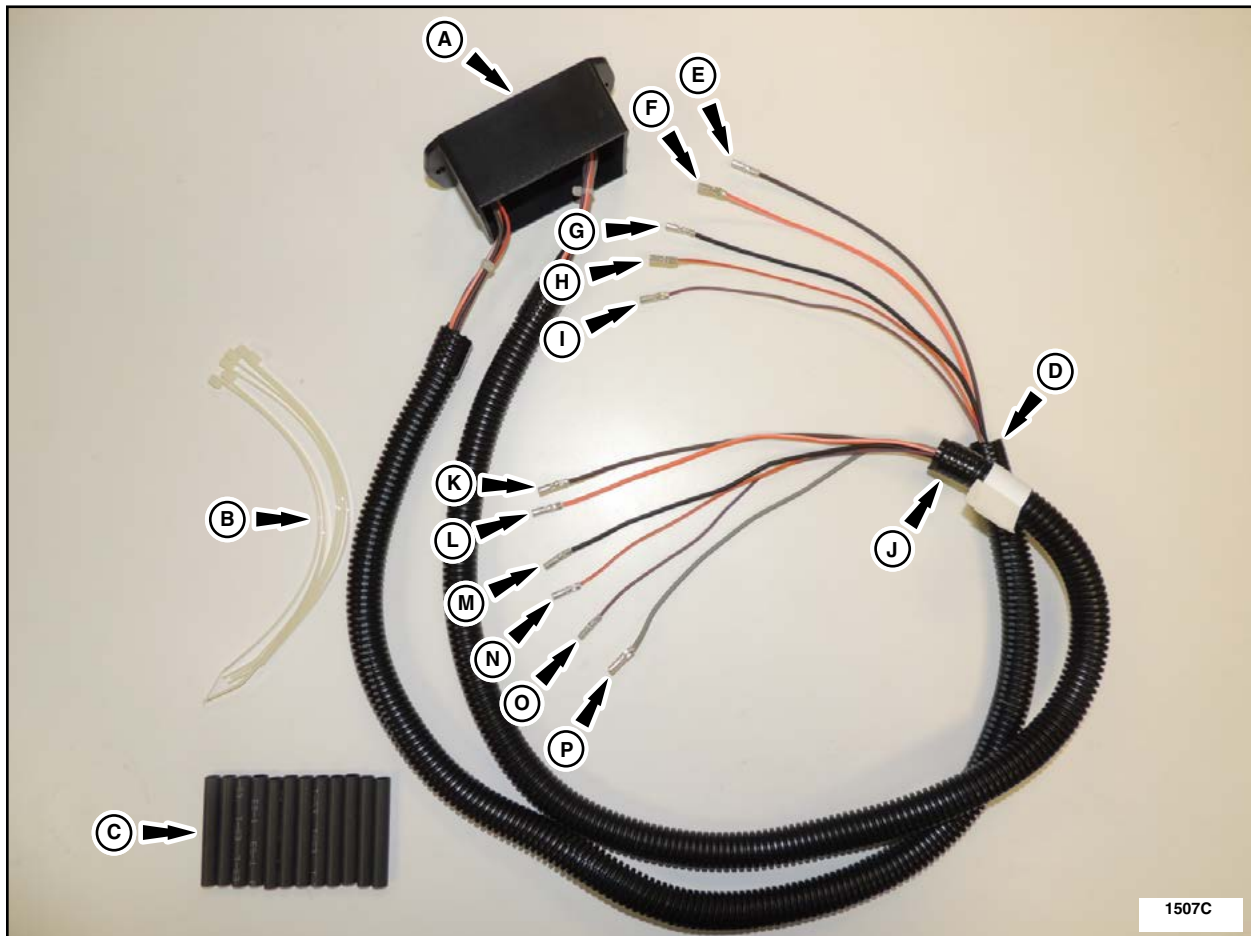
**FIGURE 1**

- A. LCM Bypass Module
- B. Zip Ties
- C. Heat Shrink Tubing
- D. 5-Wire Side of Harness
- E. Brown (BN) wire
- F. Orange/White (OG/WH) wire
- G. Black (BK) wire
- H. Red/Yellow (RD/YE) wire
- I. Violet/Orange (VT/OG) wire

- J. 6-Wire Side of Harness
- K. Brown (BN) wire
- L. Orange/White (OG/WH) wire
- M. Black (BK) wire
- N. Red/Yellow (RD/YE) wire
- O. Violet/Orange (VT/OG) wire
- P. Gray (GY) wire

**NOTE:** The 5-wire side of the LCM bypass module must be connected to the LCM (component) side of the harness.  
The 6-wire side of the LCM bypass module must be connected to the vehicle side of the harness.  
The 6-wire side of the LCM bypass module harness has a part identification label attached near the end of the convolute.

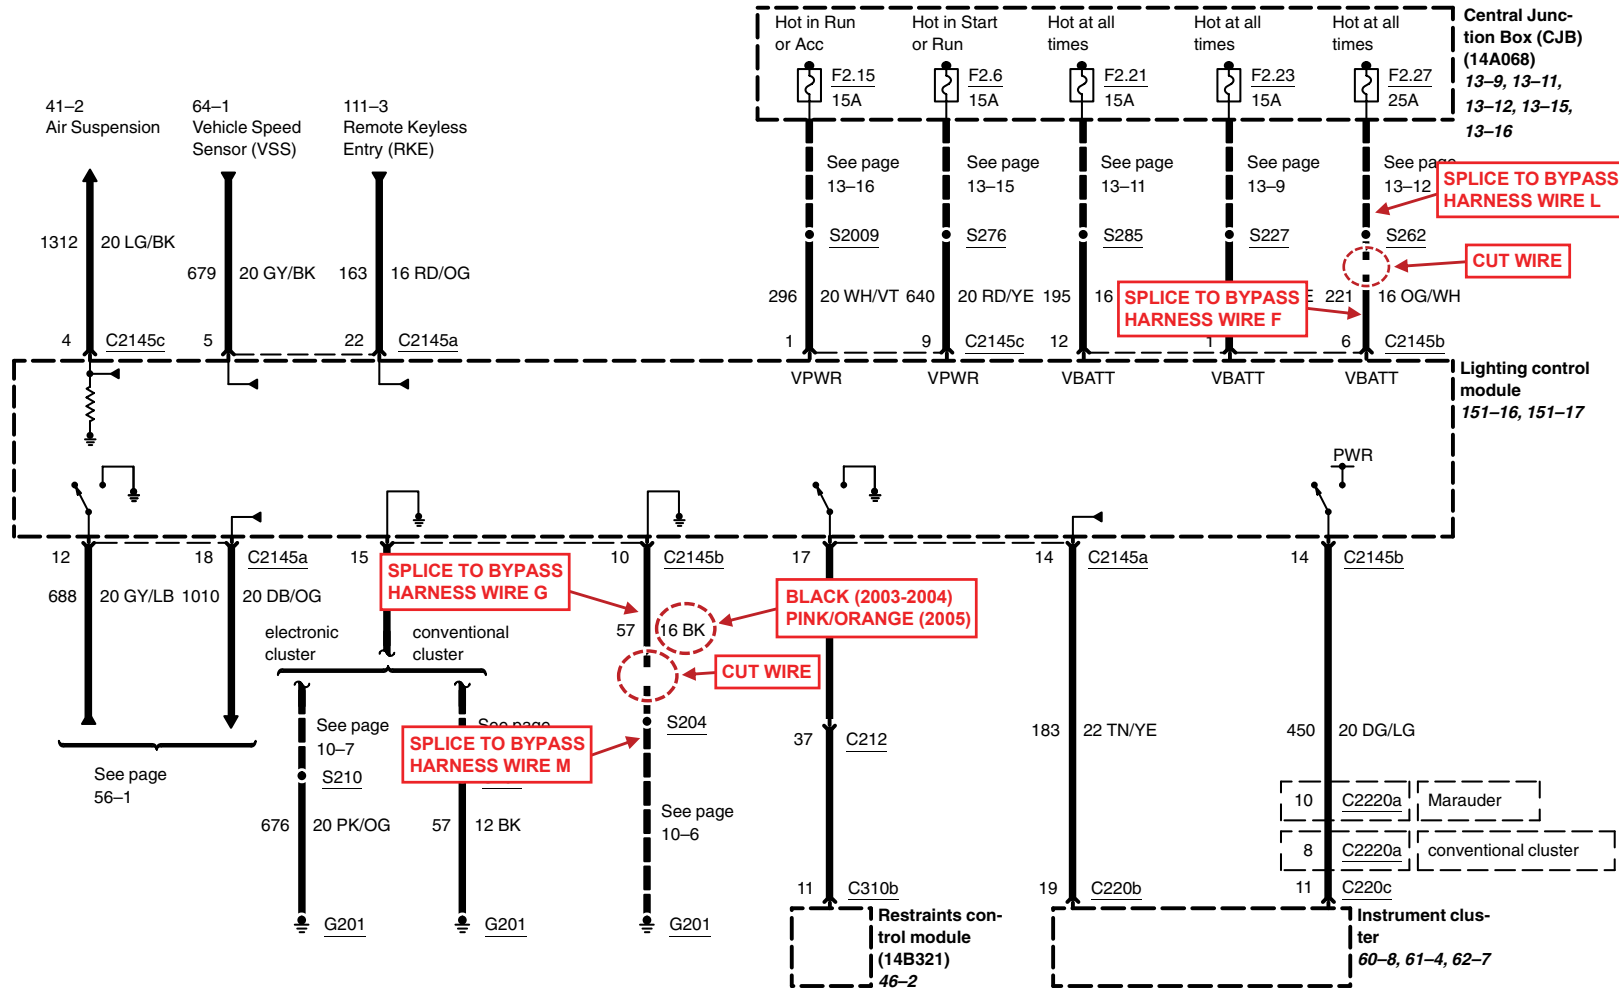
The 5-wire side of the bypass module will ALWAYS be connected to the LCM (component) side of the harness.  
The 6-wire side of the bypass module will ALWAYS be connected to the vehicle side of the harness.  
The black wire from the bypass module will be connected to circuit 57 (C2145b pin 10).  
In the vehicle, circuit 57 will be black for model years 2003-2004 or pink/orange for model year 2005.

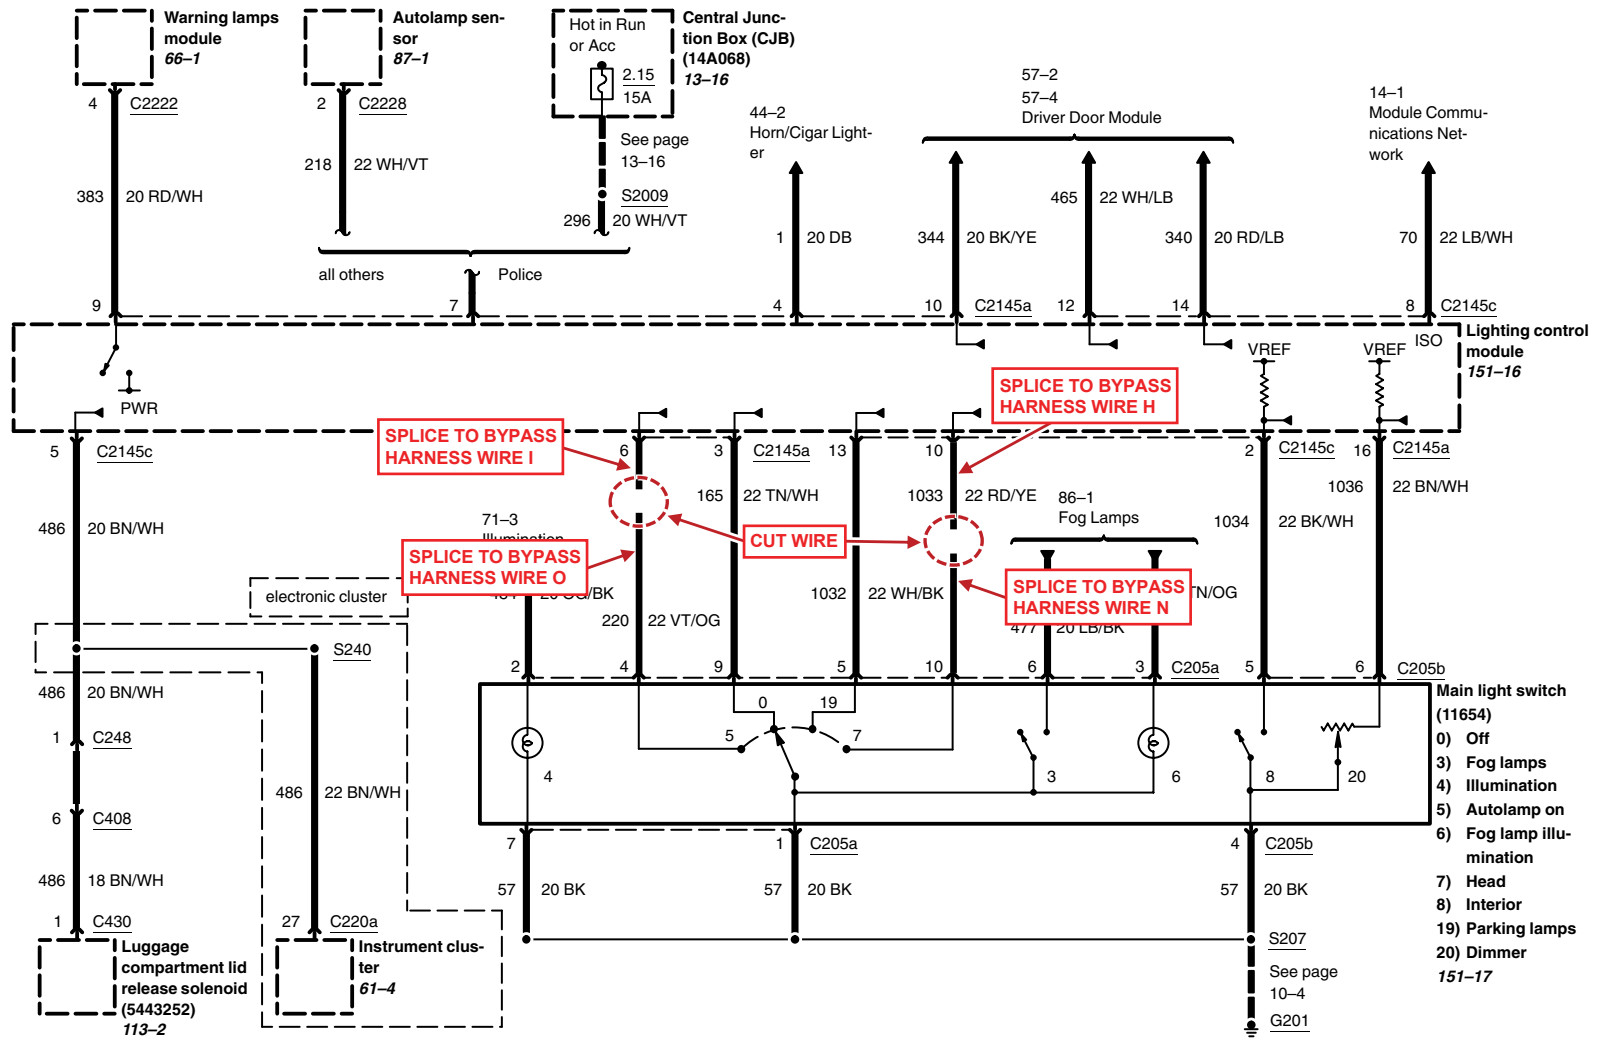
The 5-wire side of the bypass module will ALWAYS be connected to the LCM (component) side of the harness.  
The 6-wire side of the bypass module will ALWAYS be connected to the vehicle side of the harness.

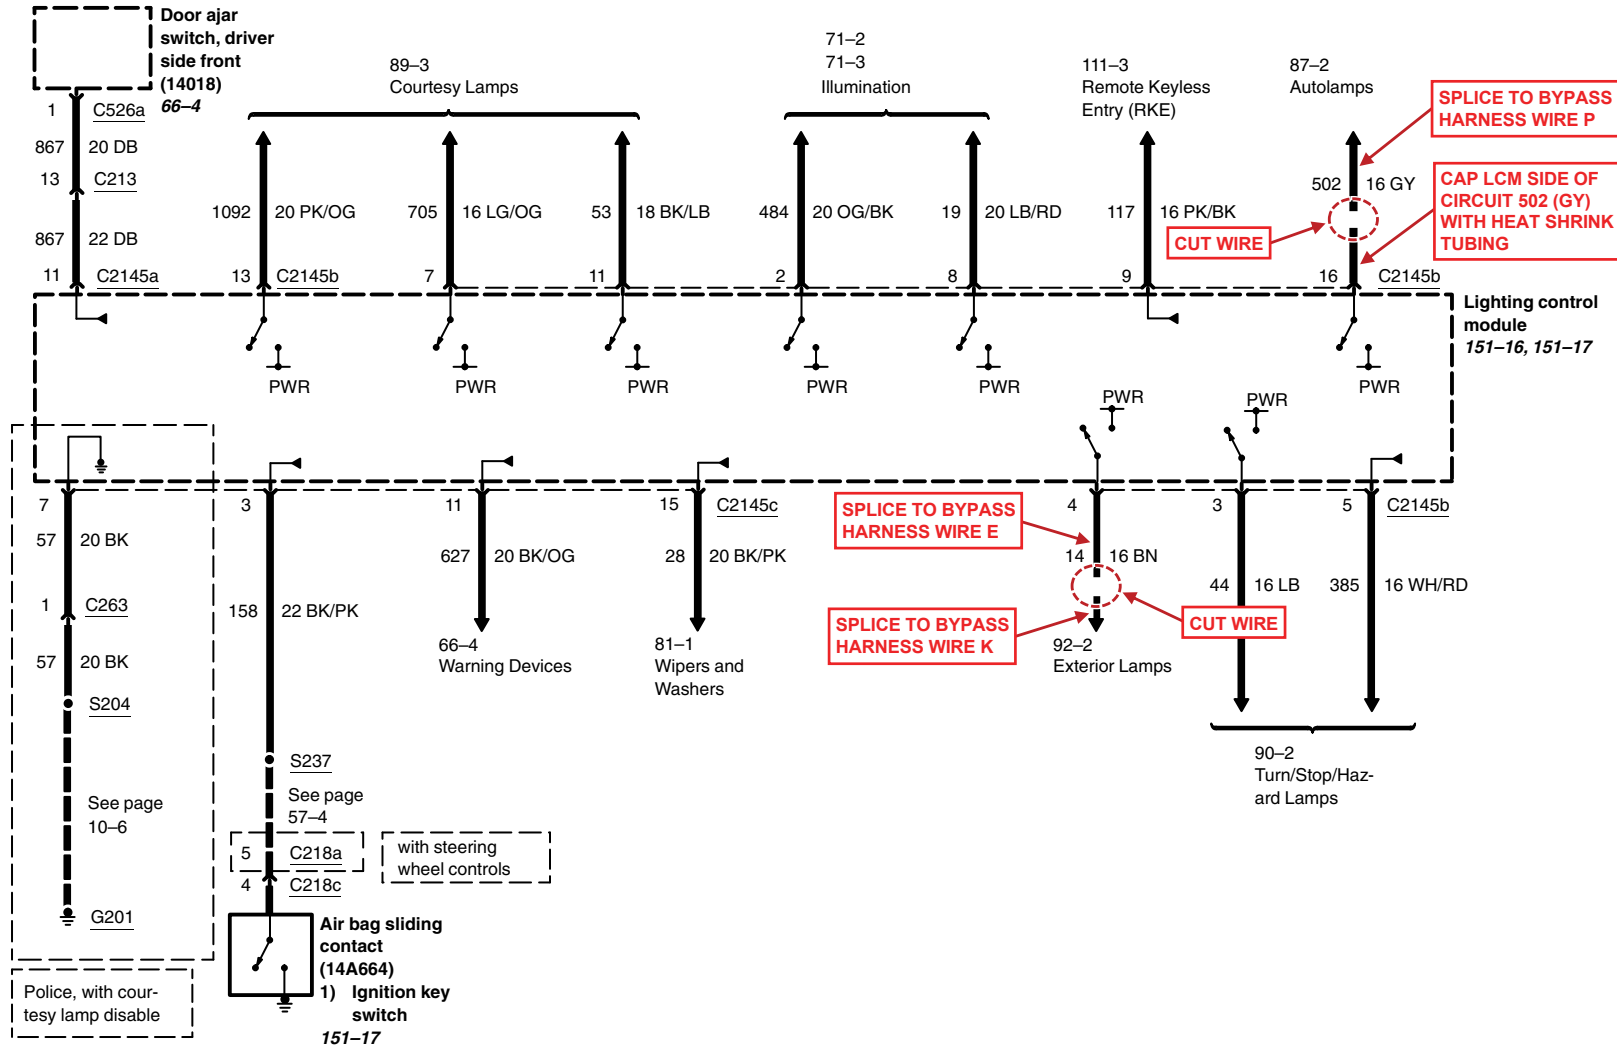
The 5-wire side of the bypass module will ALWAYS be connected to the LCM (component) side of the harness.  
The 6-wire side of the bypass module will ALWAYS be connected to the vehicle side of the harness.
