NHTSA Safety Recall 15V-010

SUBJECT: Campaign #001 – LP Line Bump Stop

Winnebago Towables has decided that a defect which relates to motor vehicle safety exists on certain 2013 to 2015 model year Winnebago Minnie and Sunny Brook Remington (Models 2201DS, 2200DS, 2450BHS and 2451BHS) travel trailers.

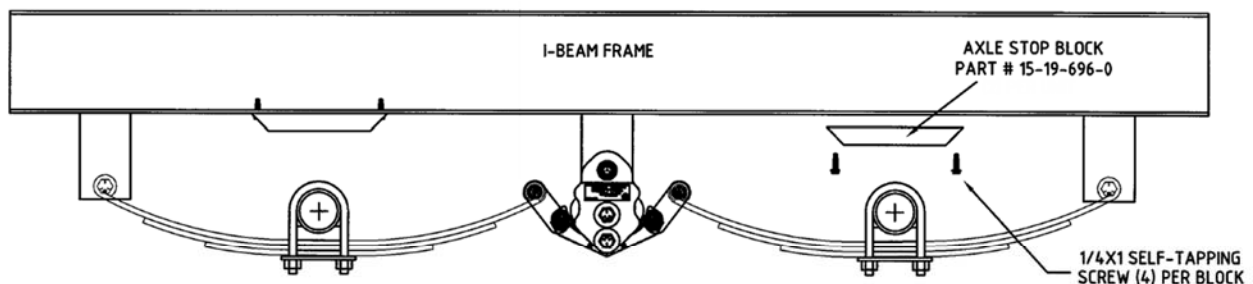
If the inspection determines the LP line pipe fitting may encounter contact with the axle:

1. Hold or clamp bump stop to frame rail to protect LP fitting as shown in image below.
2. Attach 4- 1/4x1 self-tapping screws into the pre-designated holes tightening down until snug.

**PLACE AXLE STOP BLOCK DIRECTLY ABOVE THE AXLE AND
SCREW IN PLACE WITH (4) 1/4X1 SELF-TAPPING SCREWS
ONLY NEEDED ON THE DOOR SIDE**
