## **IMPORTANT SAFETY RECALL – 15V-058**

# SN-614-14

Models Affected: HR, HRX, TC, TCX, OM, TLM, Units with side mount rotating platform

SUBJECT: Platform rotate cylinder

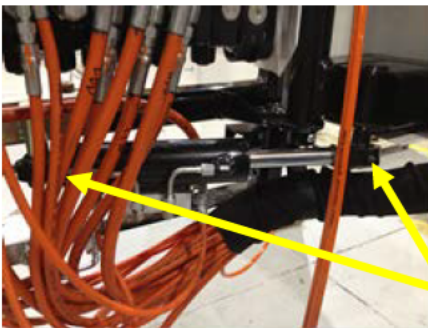
Cylinder with covers removed.

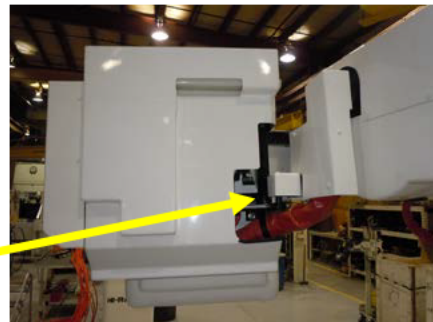
Location at boom tip behind cover

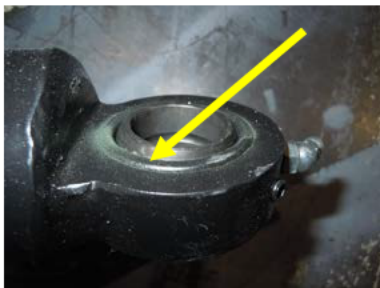
1. Immediately inspect the platform rotation cylinder ball bushings at the boom tip on all affected machines. Verify that the ball bushing outer race is centered in the cylinder rod and base ends. The base end will be flush and the rod end will be recessed .13 inch on each side as shown in the pictures below.

Base end - bearing outer race flush

2. If the ball bushing is not centered in the cylinder rod or base ends, or the ball bushing is loose in either the cylinder rod or base ends and has moved so that the ball bushing are not in the positions shown above do not operate the unit, take it out of service immediately. Contact your local Terex dealer or TEREX Utilities at 605-882-4000 or email machine information to [utilities.warranty@terex.com](mailto:utilities.warranty@terex.com) to arrange repair before further use.
3. Return the affected cylinder once the replacement cylinder has been installed.

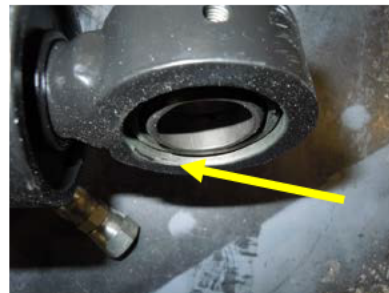
Rod end - recessed .13 inch each side
