IMPORTANT SAFETY RECALL

SUBJECT: SAFETY RECALL: RECARO ERGO M DRIVER SEAT

Ref.: **NHTSA # 15V-183**

Service Bulletin No. 422

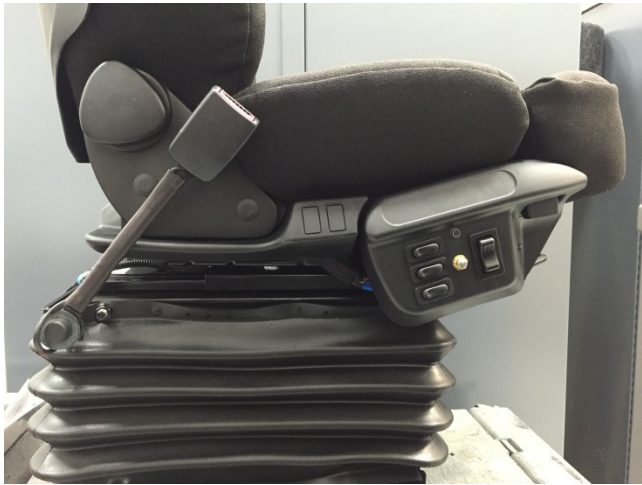
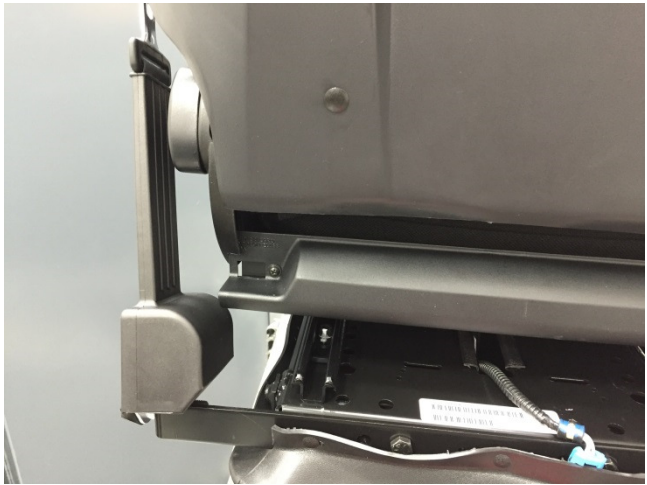
1. Adjust the seat to full up and full forward position.
2. Check to see if the seat has the “reverse mount retractor” configuration with 6 washers between the retractor and tether bar.

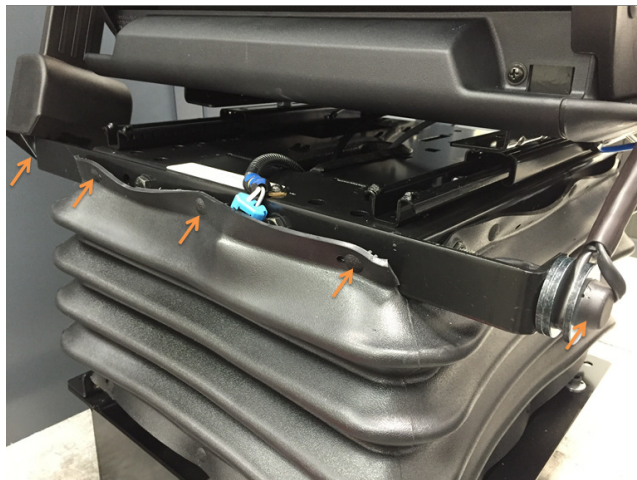
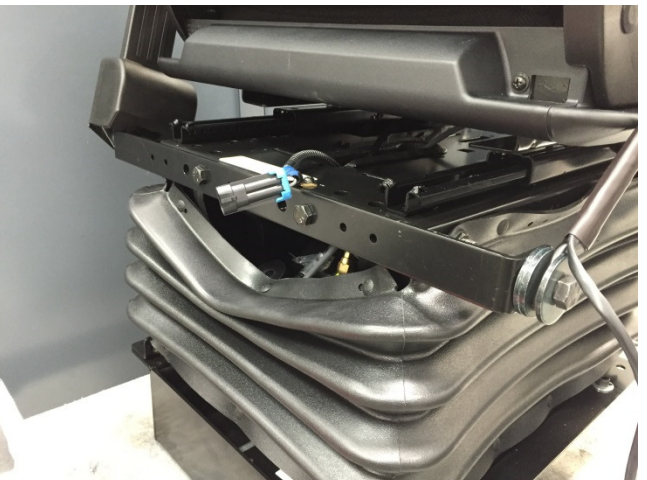
3. Inspect the seat belt retractor cover to determine if it has been damaged or reworked in the field. If so, plan to replace with part number 30822207. Inspect the shrink tubing on the seat belt buckle assembly. If there is wear from the contact point on the plastic side panel, plan to replace. To determine which buckle is required, check the 4th digit of the seat end item part number and refer to the chart below:

4. Remove the boot pins and bolt caps and unplug the buckle wire harness. Remove the bolt caps with a pick or flat head screwdriver from both the buckle and belt retractor bolts.
