IMPORTANT SAFETY RECALL

SUBJECT: SAFETY RECALL: MERITOR TIE ROD END CASTELLATED NUT

Service Bulletin No. 421

Checking the Tie Rod End Castle Nut Torque on Meritor Bus and Coach Non-Drive Steer and Tag Axles

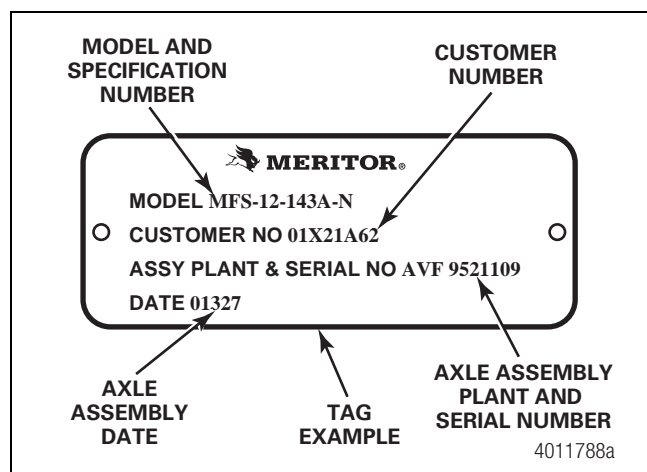
Figure 1

This technical bulletin provides instructions to check the torque and, if required, tighten the tie rod end castle nuts on FH941KX15, FH941KX16, FH941KX17, FH946KX22 and FH946KX36 models produced from 7-19-2014 through 12-5-2014. Instructions are also provided to inspect and replace the tie rod arms and tie rod ends, if required. Figure 1.

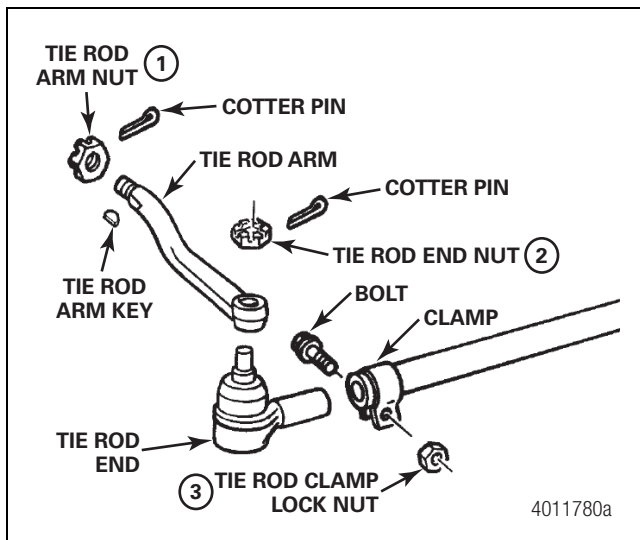
Figure 2

1. Wear safe eye protection. Park the vehicle on a level surface.
2. Place blocks under the wheels not being serviced to keep the vehicle from moving.
3. Raise the vehicle so that the wheels you will service are off the ground. Support the vehicle with safety stands.
4. Remove the cotter pin that secures the tie rod end castle nut to the tie rod arm. Figure 2.

Item	Description	Size	Torque Range in Lb-Ft (N•m)
1	Tie Rod Arm Nut	1.250"-12	775-1450 (1051-1965)
2	Tie Rod End Nut	0.875"-14	160-300 (217-407)
3	Tie Rod Clamp Lock Nut	0.750"-10	155-175 (210-237)

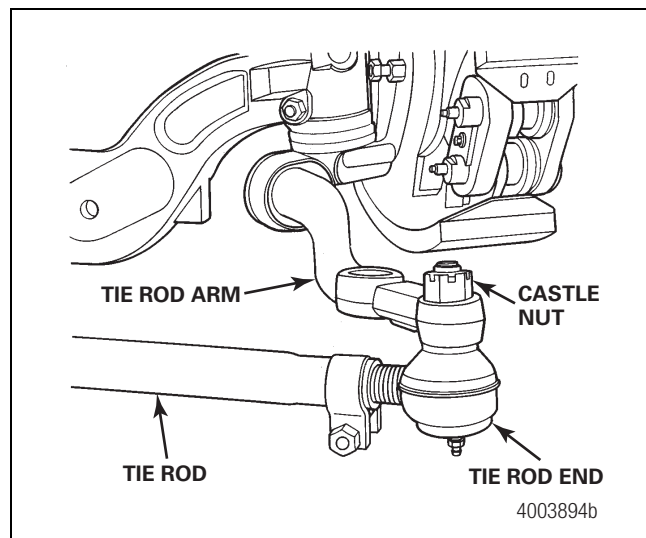
Figure 3

5. Place a calibrated torque wrench on the tie rod end castle nut.
6. As a verification check to ensure the castle nuts are not hand loose or below 25 lb-ft (34 N•m), set the torque wrench to 25 lb-ft (34 N•m). Rotate the tie rod end castle nut in a clockwise direction and note if the nut turns before reaching the set torque. Figure 3.

- **If the tie rod end castle nut does not rotate prior to reaching 25 lb-ft (34 N•m):** Proceed to Step 7.
- **If the tie rod end castle nut rotates prior to reaching 25 lb-ft (34 N•m):** Remove the castle nut and tap the tie rod arm with a brass or leather mallet to check the taper lock. Note it is not necessary to strike the tie rod arm hard to perform this check. On some axles, the ball stud may be mounted above the tie rod arm. In such case, lift up on the tie rod end to verify the taper lock. The taper lock should not separate when the tie rod arm is tapped. The two parts should be locked together.
 - **If the joint separates easily when tapped:** Proceed to the Inspect the Tie Rod Stud and Tie Rod Arm Bore, If Required procedure in this technical bulletin.
 - **If the joint does not separate when tapped:** Proceed to Step 7.

7. Install the tie rod castle nut and tighten to 160 lb-ft (217 N•m).
