IMPORTANT SAFETY RECALL

Subject: Fontaine Ultra LT Fifth Wheel

Subject: Service Bulletin - Ultra LT Fifth Wheel Damage Caused by Improper Coupling

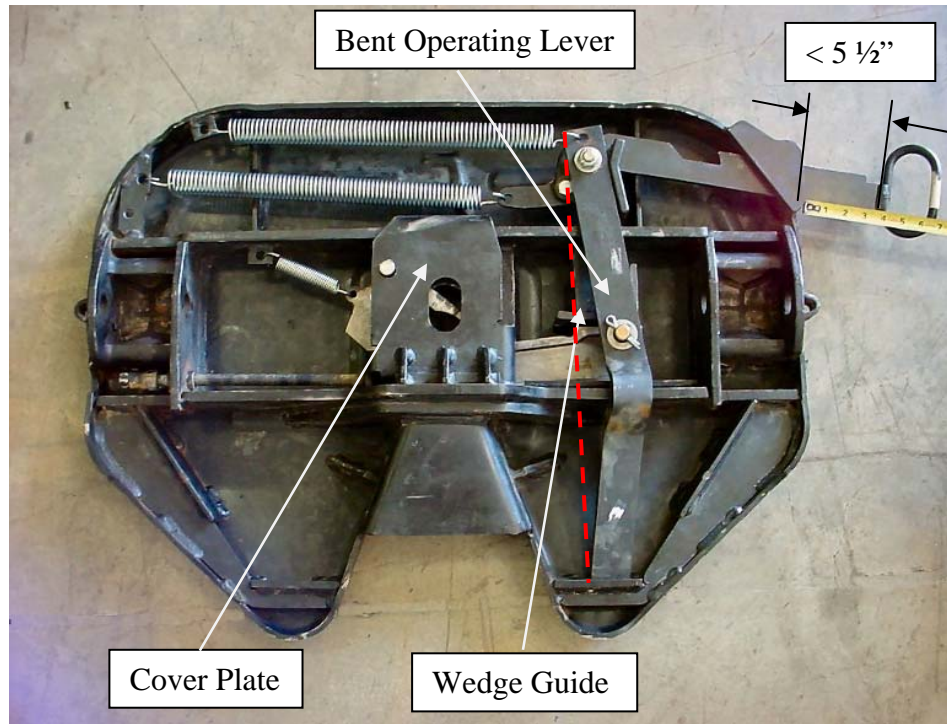
1) Perform a thorough visual inspection of the fifth wheel, including underneath, looking for bent or damaged components. Pay particular attention to the operating lever (Figures 1 & 2), the rotating jaw and cover plate (Figures 3, 4, & 5), and the wedge guide (Figure 6). If any components are bent or damaged replace the fifth wheel.

Bent Operating Lever – Pull Handle Dimension $< 5 \frac{1}{2}$ "
Figure 1

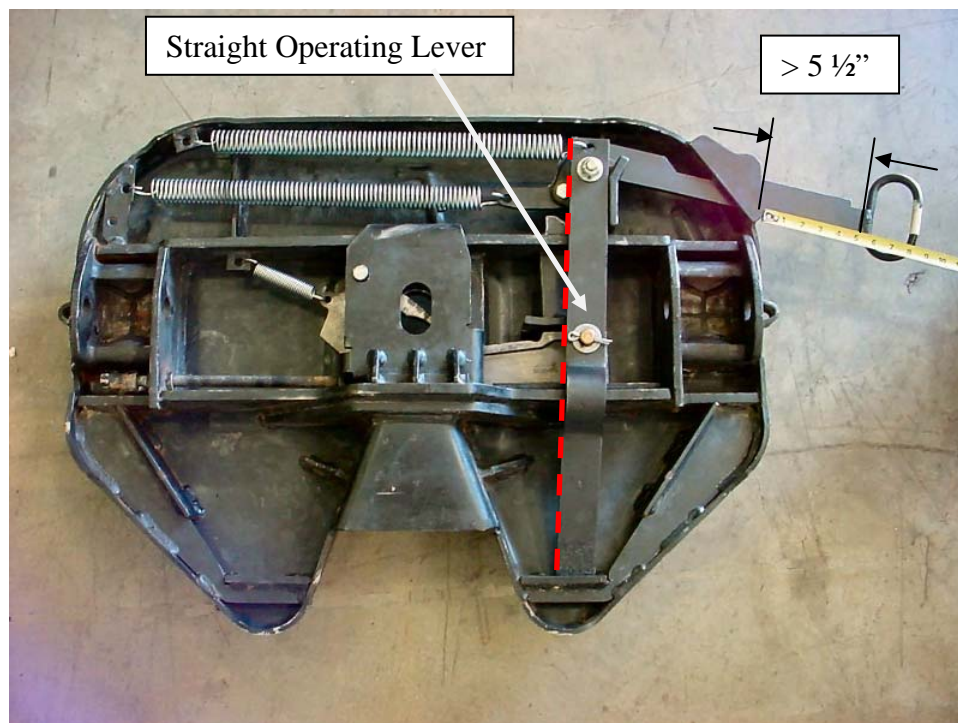
Undamaged Operating Lever – Pull Handle Dimension $> 5 \frac{1}{2}$ "
Figure 2
