MACK TRUCKS, INC.  
PO BOX 26115  
GREENSBORO, NC 27402-6115

**IMPORTANT SAFETY RECALL SC0395  
NHTSA RECALL # 15V-644**

Subject: Service Bulletin - Ultra LT Fifth Wheel Damage Caused by Improper Coupling

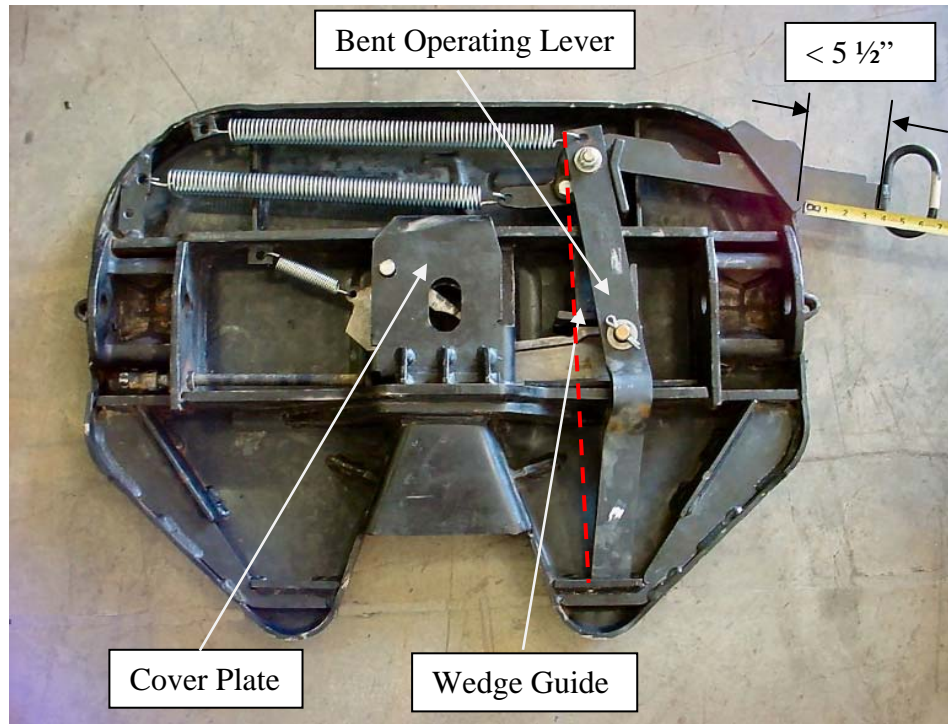
Bent Operating Lever – Pull Handle Dimension < 5 1/2”  
Figure 1

1) Perform a thorough visual inspection of the fifth wheel, including underneath, looking for bent or damaged components. Pay particular attention to the operating lever (Figures 1 & 2), the rotating jaw and cover plate (Figures 3, 4, & 5), and the wedge guide (Figure 6). If any components are bent or damaged replace the fifth wheel.

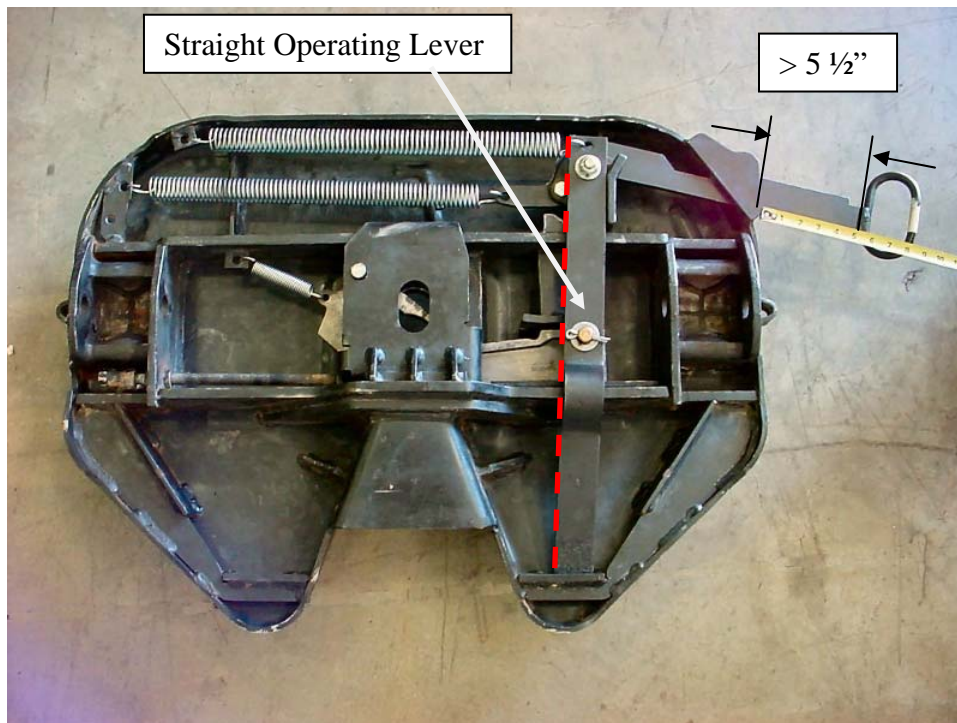
Undamaged Operating Lever – Pull Handle Dimension > 5 1/2”  
Figure 2

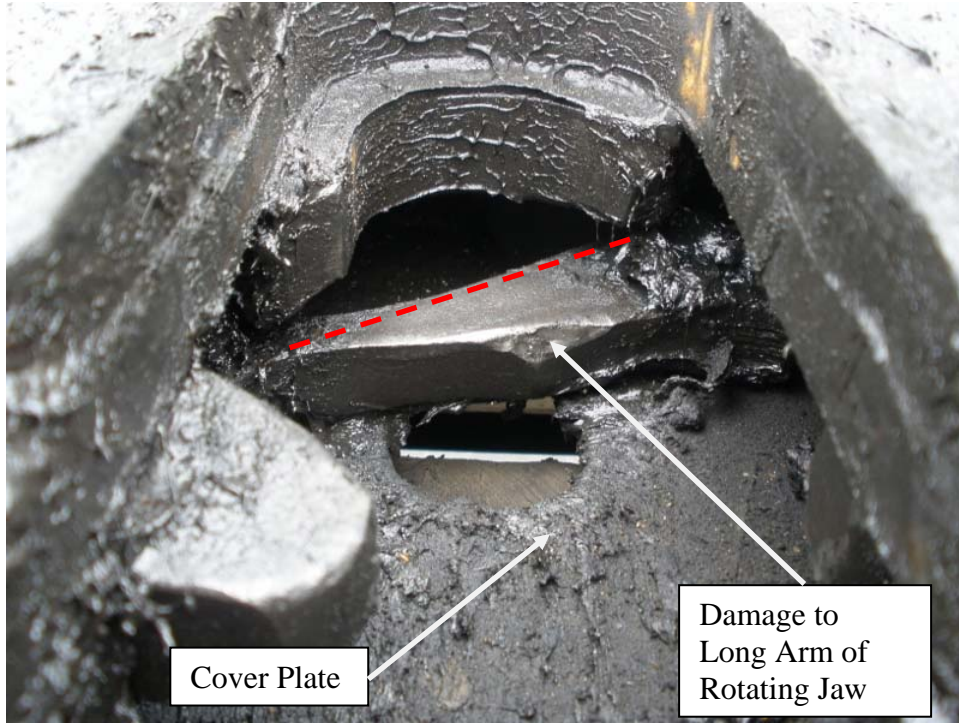
Damage to Rotating Jaw Caused By High Coupling, Resulting in a Bent Cover Plate  
Figure 3

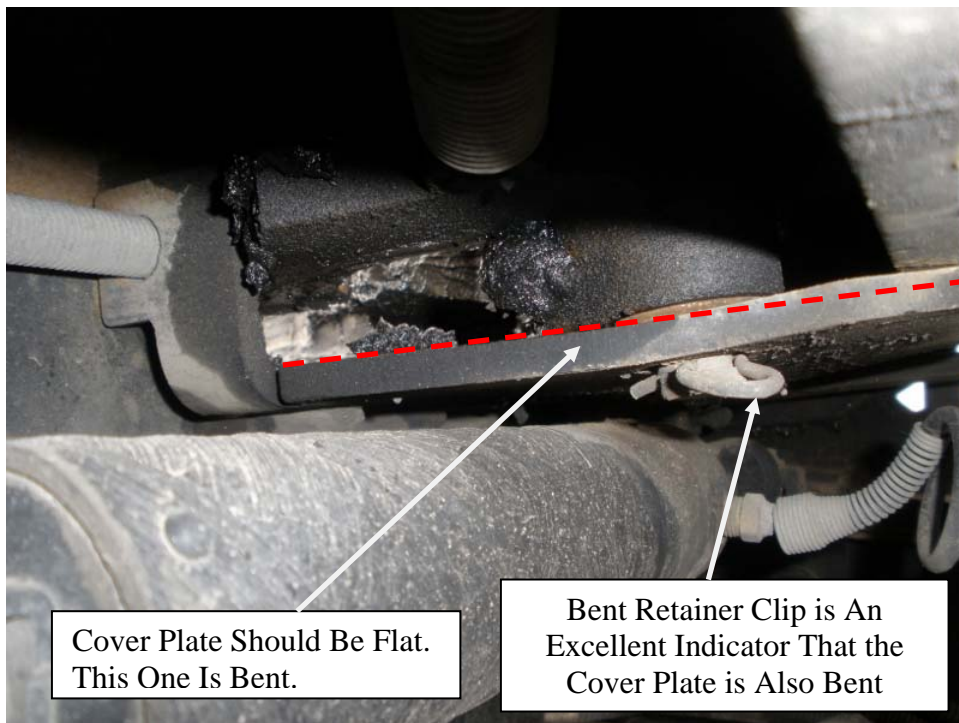
Bent Cover Plate  
Figure 4

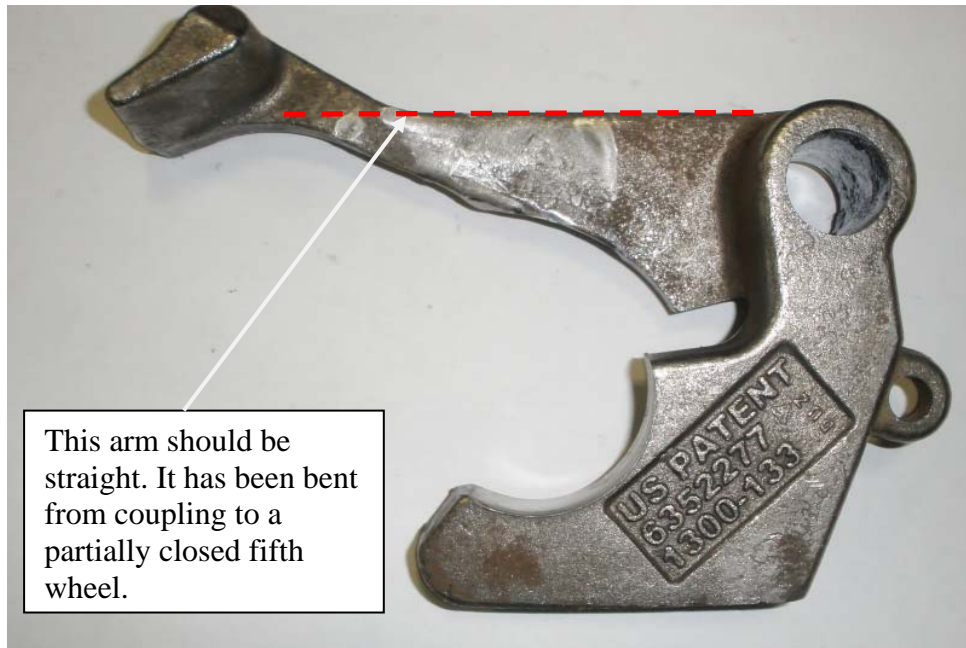
Damaged Rotating Jaw Caused By Improper Coupling  
Figure 5

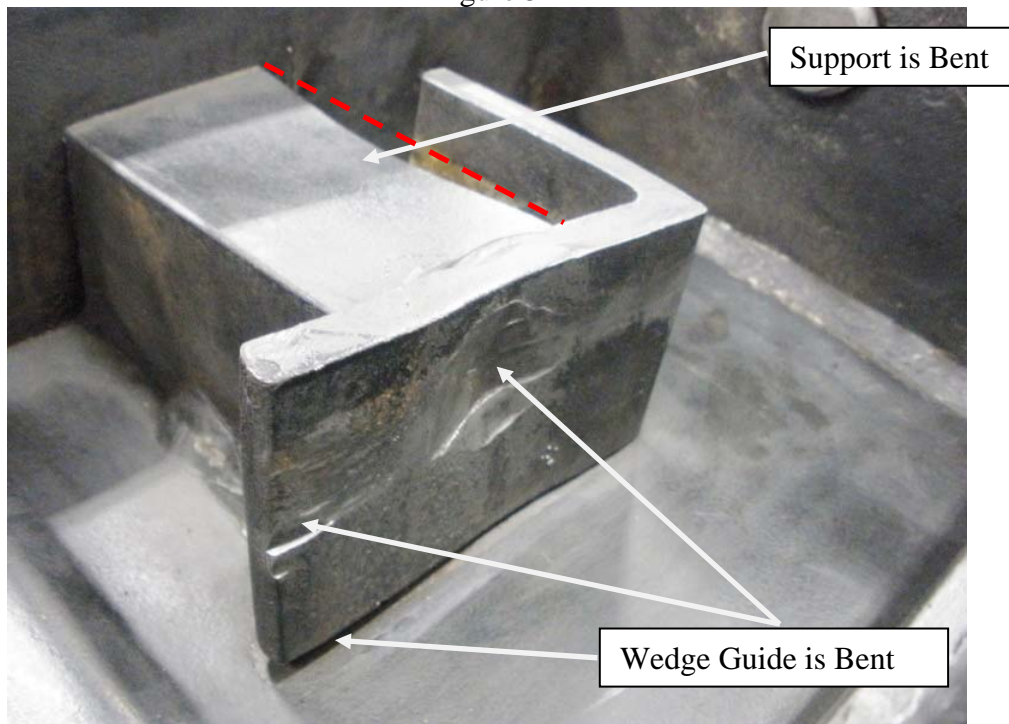
Wedge Guide Damage  
Figure 6
