NISSAN NORTH AMERICA, INC.

DEFECT INFORMATION REPORT

Certain MY 2014 Nissan Versa Sedan and MY 2013-2014 Nissan Cube and Juke vehicles equipped with Nissan Intelligent Key[®] with Push Button Ignition shown in the table below:

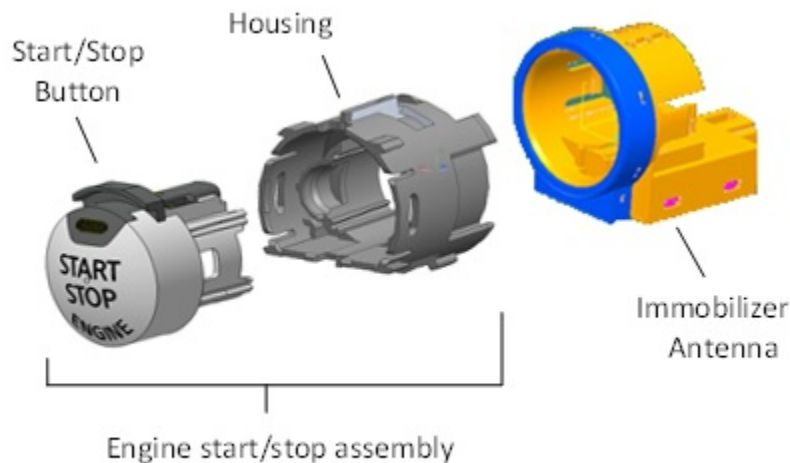
Figure 1 – Engine Start/Stop Assembly and Immobilizer Antenna Diagram

Due to manufacturing issues that have since been corrected, the casting of the immobilizer antenna housing did not meet design specification. As a result, on some of the affected vehicles, the antenna housing can shrink due to environmental exposure to hot temperatures which cause the engine start/stop button to potentially stick inside its housing (see Figure 1).

This stuck condition alone does not affect drivability or engine operation. However, in extremely rare instances, the start/stop button can become stuck in a halfway depressed position inside the housing. If the vehicle experiences mild vibrations (but not severe enough to release the button from the halfway position) from uneven road surfaces while in this position, it can cause the electrical components inside the button to contact repeatedly in quick succession which initiates the designed emergency engine shut off procedure (the subject vehicle is designed such that if the start/stop button is pressed three times in rapid succession or the button is continually pressed while driving, the engine will shut off).

If this rare combination of events occurs, the engine may shut off while the vehicle is in motion. If this occurs, it may increase the risk of a crash.

Nissan also identified that a modification of the production die used to mold the start/stop button assembly in May 2013 could have contributed to potential for interference between the inside of the immobilizer antenna and the outside of engine start/stop switch housing.

Owners of all potentially affected vehicles will be notified to bring their vehicle to a Nissan dealer for repair. The dealer will modify the engine start/stop switch housing to prevent interference from the immobilizer antenna at no charge to the owner for parts or labor.
