Subject: NHTSA Recall # for Shiver 750 **PENDING**
NHTSA Recall # for Caponord 1200 **PENDING**

**2015-001:** Safety recall campaign for sprocket fastener

Affected Models: Certain range of 2014-2015 Shiver 750 and 2015 Caponord 1200 models.

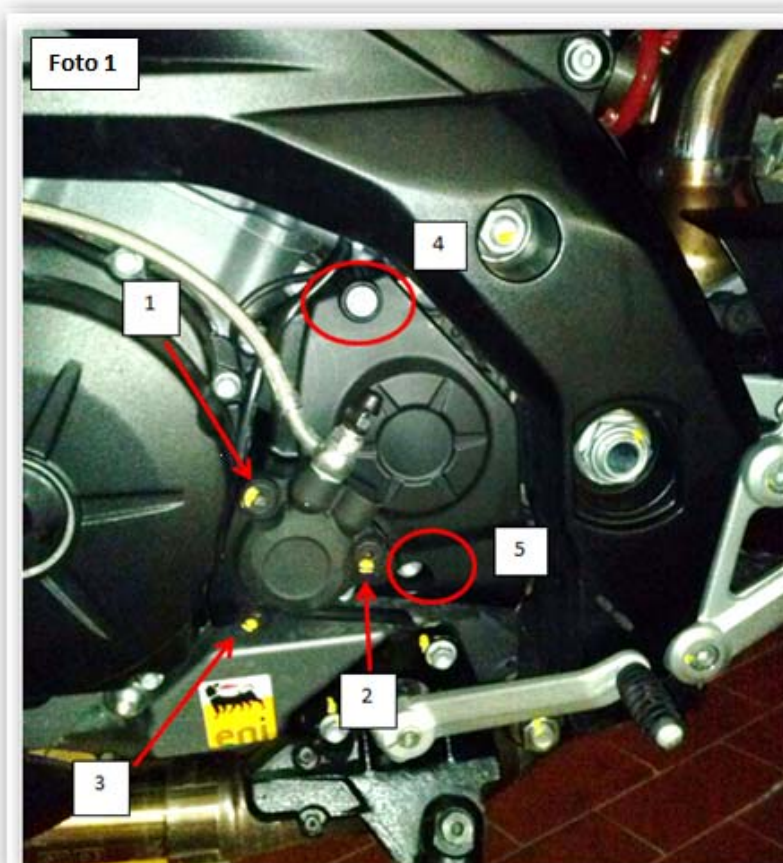
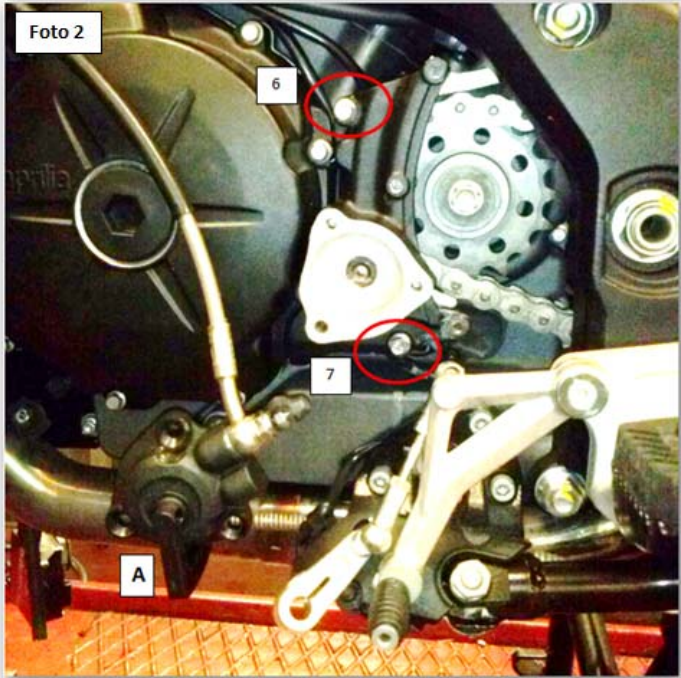
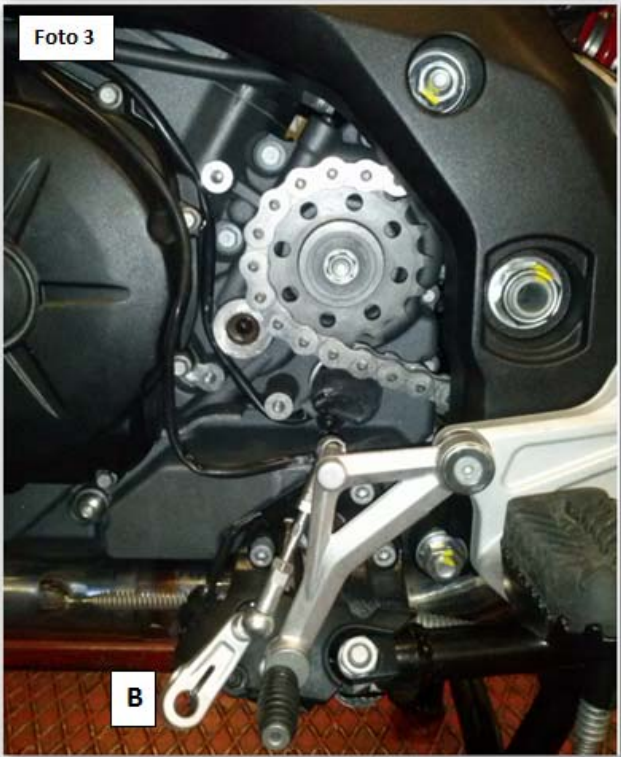
- Undo the screws 1, 2 and 3 fastening the clutch actuator cylinder and remove the cylinder from its mounting, immobilizing the actuator piston securely in its seat (see photo 1);
- Undo the gear lever link fastener screw and remove the link (photo 3, detail B);
- Undo screws 4 and 5 fastening the sprocket cover (see photo 1);
- Undo screws 6 and 7 fastening the clutch disengagement flange (see photo 2);
- Undo the screw fastening the sprocket.

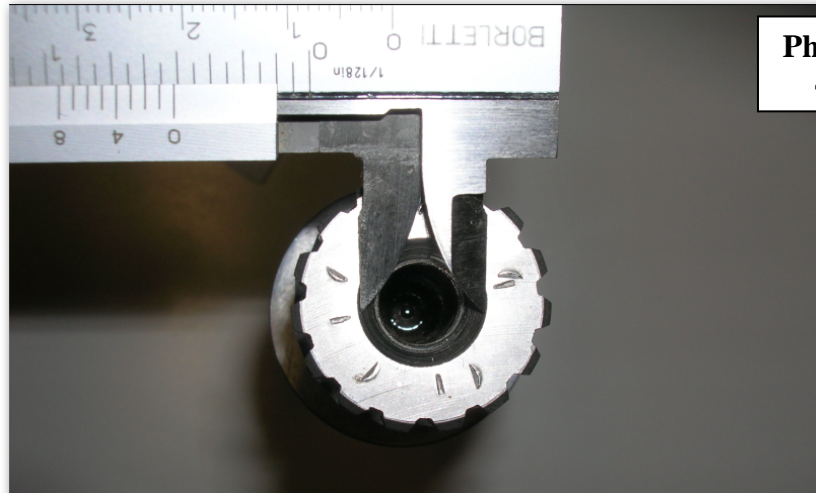
**Photo
4**

- Measure the outer diameter of the recess on the end of the secondary shaft as shown in photos 4 and 5. **Note: For the procedure to be effective, the measurement must be made with absolute accuracy.**

To reduce measurement error, set the calliper to 15.5 mm and lock in this position, then check if the two jaws of the calliper are inside (photo 4) or outside (photo 5) the diameter of the recess on the end of the output shaft.

If the diameter of the recess is equal to or less than 15.50 mm, clean the thread on the shaft thoroughly following the procedure indicated below:

Select the recall campaign coupon “**Diameter recess check – installing revised sprocket fastener kit**”. Please order sprocket fastener kit P/N **2R000246** (pre-coated screw, P/N B043047, Belleville washer P/N 2B002193, bush P/N 2B002191).
