Safety Recall - USA ONLY

Code: 24BK

Subject: Certain 2012 MY Touareg Hybrid

Fuel Injection System Leak March 17, 2015

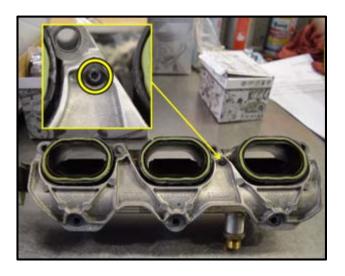
The replacement procedure depicted here shows the passenger side fuel rail. Replacement of the driver side fuel rail is nearly identical.

- Disassemble the mounting bracket, fuel rail, and intake manifold <as shown>.
- Remove the brass union nut and the fuel rail pressure sensor (driver side only) from the fuel rail.
- Install the fuel rail pressure sensor (driver side only) into the new fuel rail and fingertighten.
- Install the replacement brass union nut, P/N 06E127065G.
