Recall Bulletin

SUBJECT: Rear Adjust Link Loose

MODELS: 2015 Chevrolet Corvette

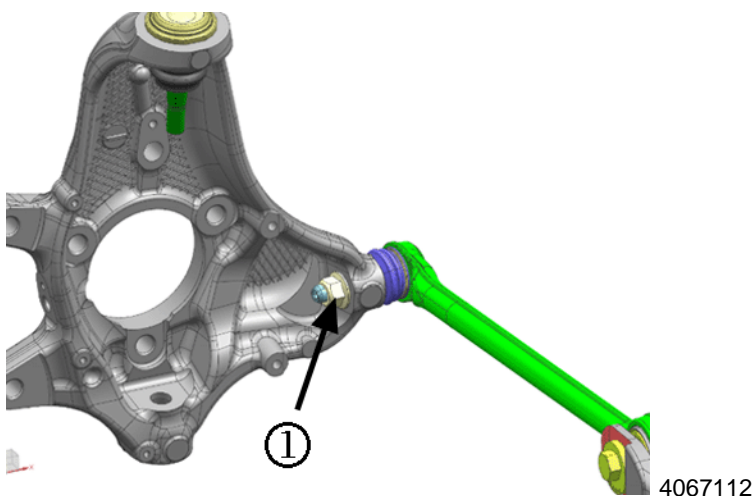
- 4.2 Loosen the adjust link nut (1) at the knuckle. The adjust link should separate from the knuckle.
- 4.3 Remove and discard the adjust link nut (1).

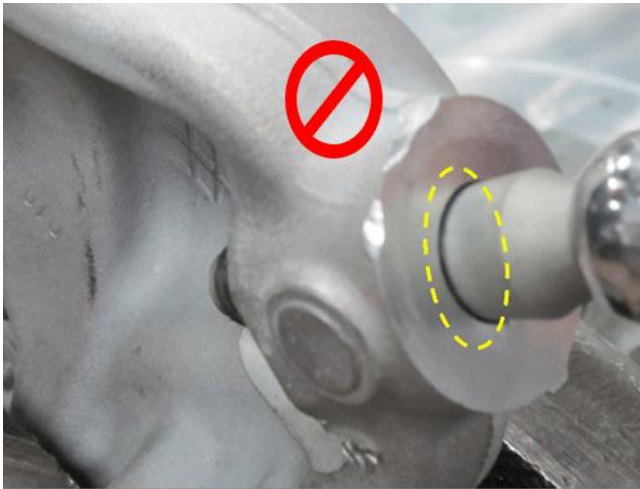
4067115

- 4.4 Visually inspect the round hole (1) in the knuckle, looking for evidence of oblong wear/damage (2).
 - If taper on the knuckle and ball stud shows NO evidence of damage (1), continue on to step #5 of this inspection procedure.
 - If taper on the knuckle or ball stud DOES show evidence of damage, it will be necessary to replace the link and knuckle. Proceed to *Adjust Link and Knuckle Replacement Procedure*.
5. Re-seat the ball stud.
6. Install the NEW adjust link nut (1) and tighten to:
 - First Pass, **30 N*m (22 lb ft)**
 - Final Pass, **plus 120 degrees**
7. Reinstall the tire and wheel assembly.
8. Lower and remove vehicle from hoist.
