# Recall Bulletin

**SUBJECT:** Rear Adjust Link Loose

**MODELS:** 2015 Chevrolet Corvette

GM Recall #14857

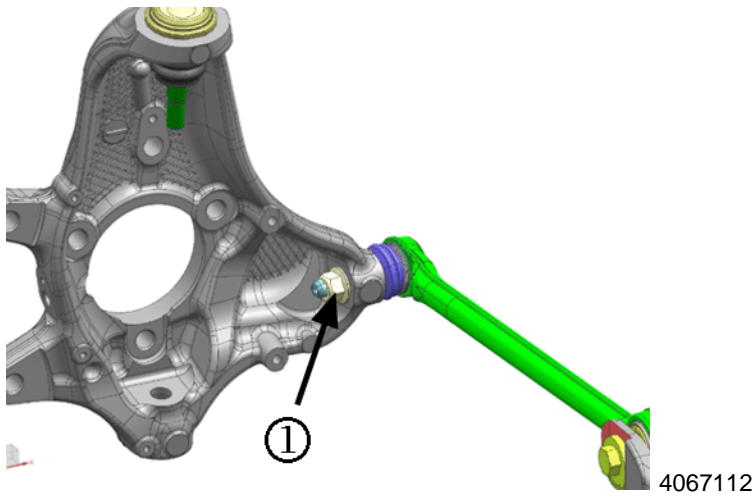
4.2 Loosen the adjust link nut (1) at the knuckle. The adjust link should separate from the knuckle.

4.3 Remove and discard the adjust link nut (1).

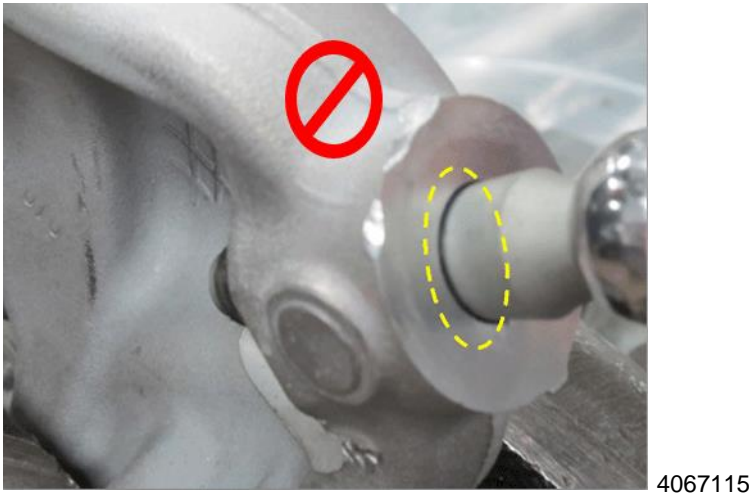
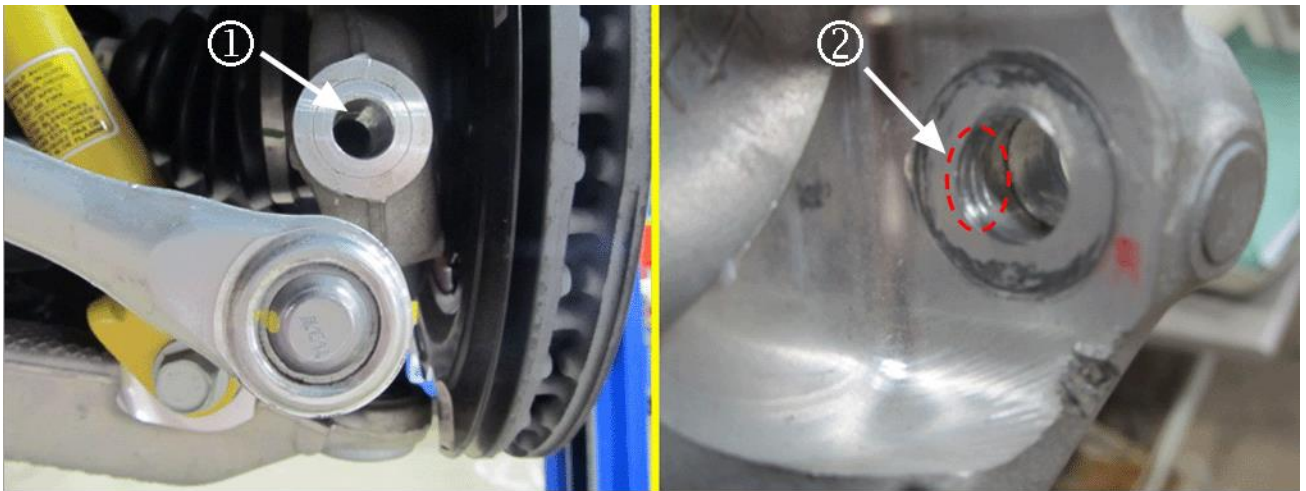
4.4 Visually inspect the round hole (1) in the knuckle, looking for evidence of oblong wear/damage (2).

- If taper on the knuckle and ball stud shows NO evidence of damage (1), continue on to step #5 of this inspection procedure.

- If taper on the knuckle or ball stud DOES show evidence of damage, it will be necessary to replace the link and knuckle. Proceed to *Adjust Link and Knuckle Replacement Procedure*.
5. Re-seat the ball stud.
  6. Install the NEW adjust link nut (1) and tighten to:
    - First Pass, **30 N\*m (22 lb ft)**
    - Final Pass, **plus 120 degrees**
  7. Reinstall the tire and wheel assembly.
  8. Lower and remove vehicle from hoist.
