TECHNICAL BULLETIN

P052NAS4 24 SEP 2015

SECTION: 206-07

Safety Recall: Vacuum Hose Incorrectly Routed

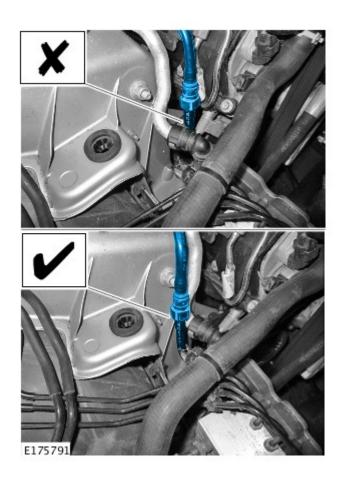
2 Check to see if the vacuum pipe is correctly routed.

- If the vacuum pipe is correctly routed (), install the air cleaner and release the vehicle.
- If the vacuum pipe is not correctly routed (), disconnect the vacuum pipe connection and continue to Step 3.

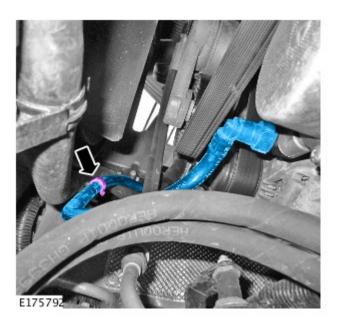
5 Inspect the vacuum pipe for any wear and/or damage.

- ${f 3}$ Remove the undershield (see TOPIx Workshop Manual, section 501-02).
- 4 Release the clip, disconnect the vacuum pipe connection, and remove the vacuum pipe from the vehicle.

- If no wear and/or damage is evident, install the vacuum pipe.
 - Reverse the removal procedure, making sure the vacuum pipe is routed correctly.
