TECHNICAL BULLETIN  
P052NAS1  
24 FEB 2015

Safety Recall: Vacuum Hose Incorrectly Routed

**Range Rover Sport (LW)**

**Range Rover (LG)**

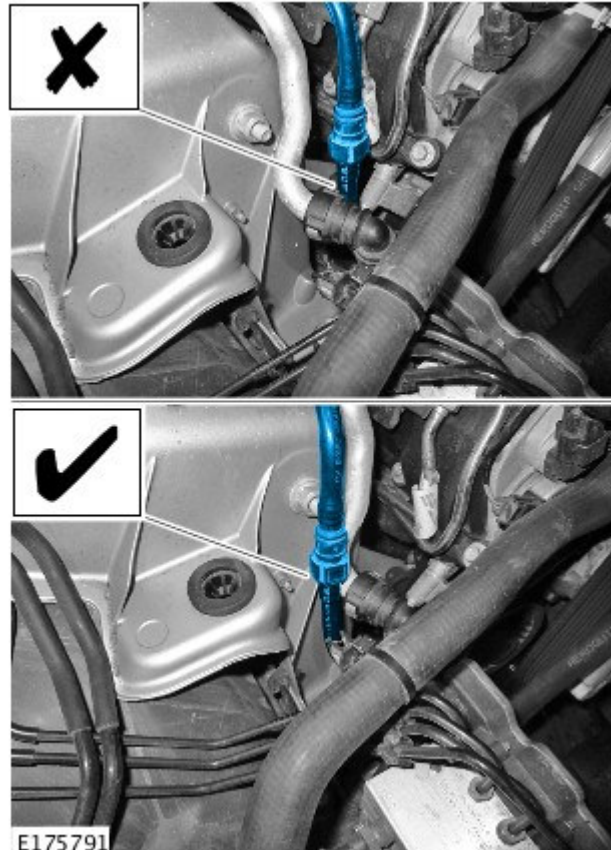
1. Remove the right-hand (RH) air cleaner (see TOPIx Workshop Manual, section 303-12).
2. Check to see if the vacuum pipe is correctly routed.

- If the vacuum pipe is correctly routed, install the air cleaner and release the vehicle.
- If the vacuum pipe is not correctly routed, disconnect the vacuum pipe connection and continue to Step 3.

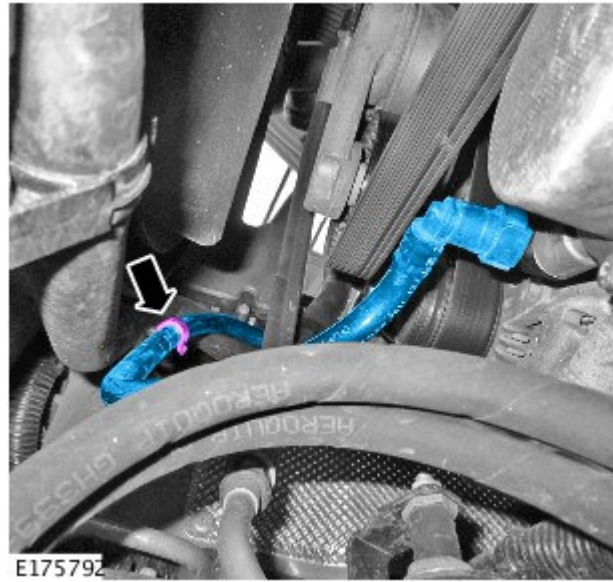
3. Remove the undershield (see TOPIx Workshop Manual, section 501-02).
4. Release the clip and disconnect the vacuum pipe connection and remove the vacuum pipe from the vehicle.
  - Inspect the vacuum pipe for any wear and/or damage.
    - If no wear and/or damage is evident, install the vacuum pipe.
      - Reverse the removal procedure, making sure the vacuum pipe is routed correctly.

- If any wear and/or damage is evident, install a **NEW** vacuum pipe.

- Reverse the removal procedure, making sure the vacuum pipe is routed correctly.
