TECHNICAL BULLETIN
P052NAS2
13 MAR 2015

SECTION: 206-07

Safety Recall: Vacuum Hose Incorrectly Routed

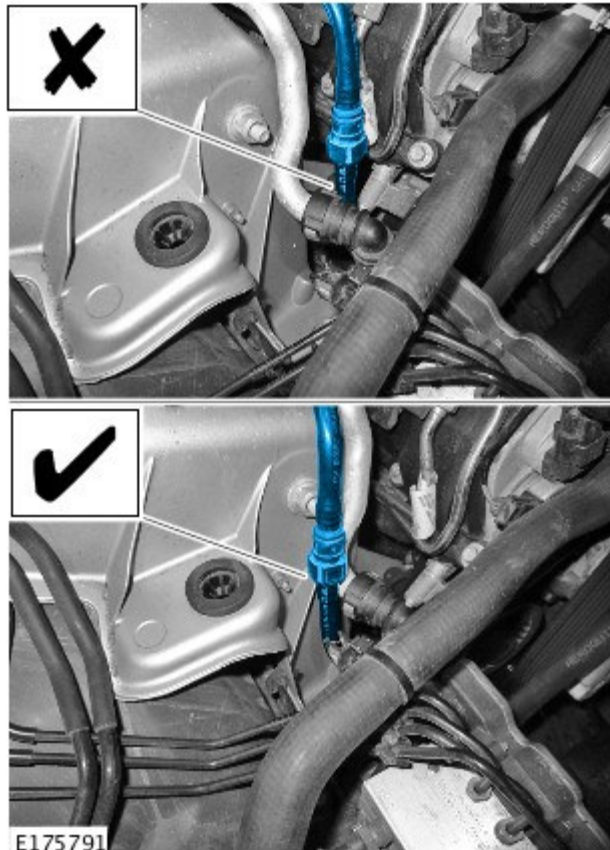
2. Check to see if the vacuum pipe is correctly routed.

- If the vacuum pipe is correctly routed, install the air cleaner and release the vehicle.
- If the vacuum pipe is not correctly routed, disconnect the vacuum pipe connection and continue to Step 3.

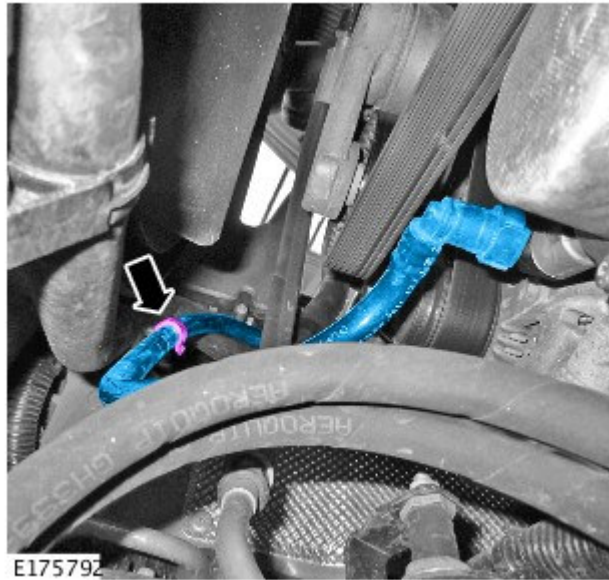
4. Release the clip and disconnect the vacuum pipe connection and remove the vacuum pipe from the vehicle.

- Inspect the vacuum pipe for any wear and/or damage.
 - If no wear and/or damage is evident, install the vacuum pipe.
 - Reverse the removal procedure, making sure the vacuum pipe is routed correctly.
- If any wear and/or damage is evident, install a **NEW** vacuum pipe.
 - Reverse the removal procedure, making sure the vacuum pipe is routed correctly.
