October 9, 2015

01465 Version 2

Safety Recall: SRS Unit

Year	Model	Trim	VIN Range
2003–04	Odyssey	ALL	Check the iN VIN status for eligibility

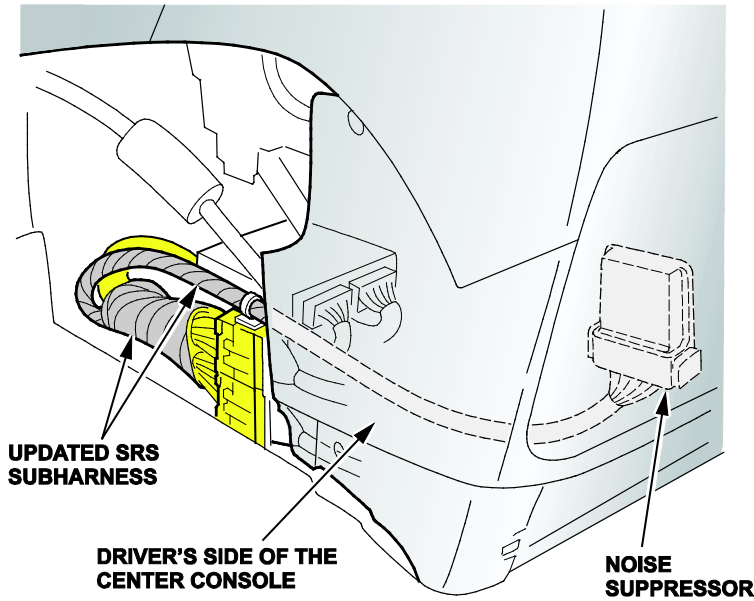
UPDATED SRS SUBHARNESS WITH NOISE SUPPRESSOR

- The original subharness is installed in the vehicle.
- There is an updated subharness connected to the noise suppressor.
- There is an updated subharness that has been taped up as shown and the noise suppressor has been removed.

SRS Unit P/N	Subharness Arrangement	Repair Action
77960-S0X-L81X-XX	Original subharness is installed.	REPAIR PROCEDURE B
77960-S0X-L81X-XX	Updated subharness with a noise suppressor installed.	REPAIR PROCEDURE A
77960-S0X-407X	Original subharness is installed.	The vehicle is OK; no further action needed.
77960-S0X-407X	Updated subharness with a noise suppressor is installed.	REPAIR PROCEDURE B
77960-S0X-407X	Updated subharness with the connector taped up and the noise suppressor was removed.	The vehicle is OK; no further action needed.
