PRODUCT SAFETY RECALL

SUBJECT: Electric Power Steering Assist

MODELS: 2006-2007 Chevrolet Malibu, Malibu Maxx
2006-2007 Pontiac G6
Equipped with Electric Power Steering

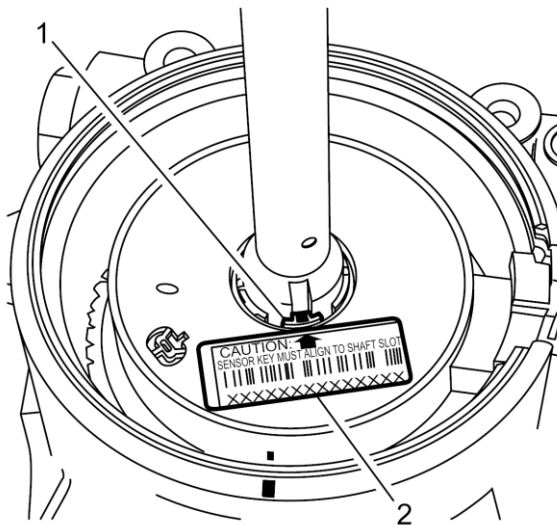
3. Document the last 9 digits of the NEW steering shaft torque sensor on the vehicle repair order. The serial number is located on the bottom of the caution label (2).

1. Remove the steering shaft torque sensor. Refer to *Steering Shaft Torque Sensor Replacement* in SI.
2. Install a new steering shaft torque sensor. Refer to *Steering Shaft Torque Sensor Replacement* in SI.
