Recall Campaign Bulletin

Campaign No. 2015020001, March 2015

SUBJECT: Models 212 (E-Class), 218 (CLS-Class), Model Years 2013-2015

Secondary Rubber Hood Seal, Model 212 (E-Class)

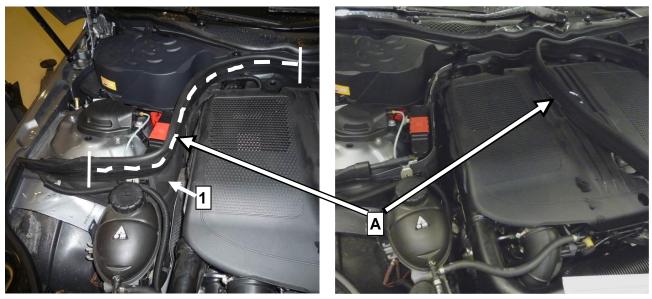
Figure 1

Daimler AG (DAG), the manufacturer of Mercedes-Benz vehicles, has determined that on certain Model Year 2013 - 2015 E-Class and CLS vehicles, the rubber seal on the top edge of the secondary bulkhead in the engine compartment may not be secured properly and may temporarily adhere to the engine hood when the hood is opened. If this occurs, a portion of the seal might be lifted from the secondary bulkhead, and under adverse circumstances, may drop into the area between the engine and the secondary bulkhead and contact parts of the exhaust system, specifically the catalytic converter. Should the catalytic converter be sufficiently hot at the time of contact with the seal, the potential risk of fire cannot be excluded. An authorized Mercedes-Benz dealer will attach four additional retaining clips on the rubber seal in the engine compartment.

1. Open hood then loosen approx. 0.5 m of edge guard (A, Figure 1) from the right side of secondary engine bulkhead (1) and place to one side.

3. Reinstall edge guard (A, Figure 1) onto upper edge of bulkhead (1).

Edge guard (A) must be installed firmly on the secondary bulkhead (1) edge.
