Mercedes-Benz

Campaign No. 2015020001, February 2015

SUBJECT: **Models 212 (E-Class), 218 (CLS-Class), Model Years 2013-2015
Secondary Rubber Hood Seal, Model 212 (E-Class)**

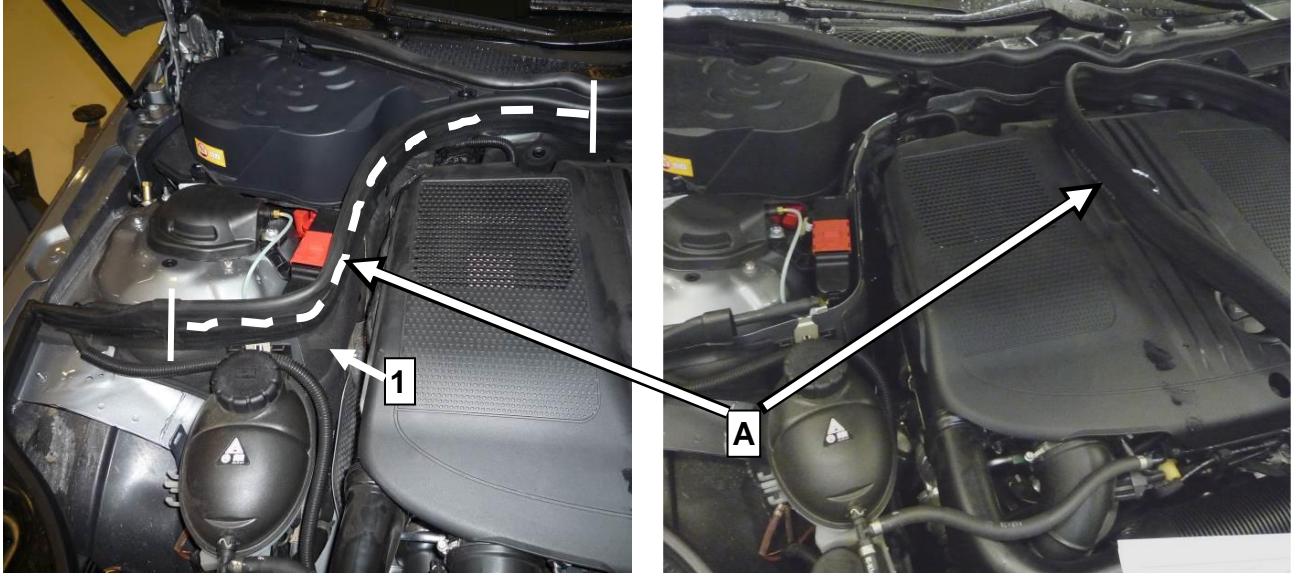
Figure 1

Daimler AG (DAG), the manufacturer of Mercedes-Benz vehicles, has determined that on certain Model Year 2013 - 2015 E-Class and CLS vehicles, the rubber seal on the top edge of the secondary bulkhead in the engine compartment may not be secured properly and may temporarily adhere to the engine hood when the hood is opened. If this occurs, a portion of the seal might be lifted from the secondary bulkhead, and under adverse circumstances, may drop into the area between the engine and the secondary bulkhead and contact parts of the exhaust system, specifically the catalytic converter. Should the catalytic converter be sufficiently hot at the time of contact with the seal, the potential risk of fire cannot be excluded. An authorized Mercedes-Benz dealer will attach four additional retaining clips on the rubber seal in the engine compartment.

Open hood then loosen approx. 0.5 m of edge guard (A, Figure 1) from the right side of secondary engine bulkhead (1) and place to one side.

Reinstall edge guard (A, Figure 1) onto upper edge of bulkhead (1).

Edge guard (A) must be installed firmly on the secondary bulkhead (1) edge.
