TECHNICAL BULLETIN

J051NAS1

Safety Recall: Engine Cut Out When Driving

XF (X250)**Model Year:**

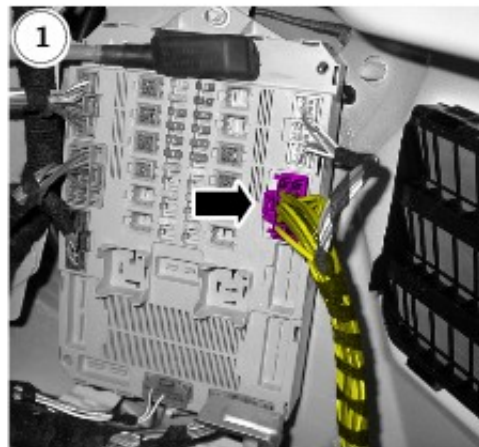
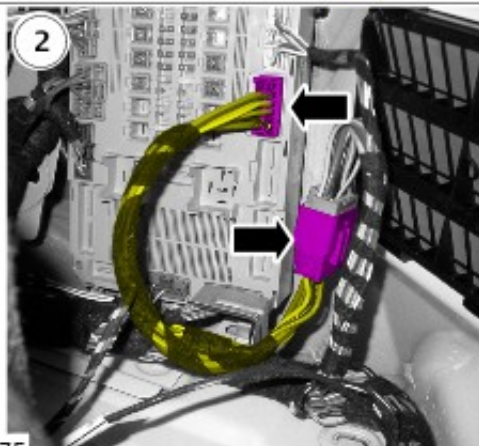
E176975

3. Check to see if the link lead is installed.
 - If the link lead is not installed (1), continue to Step 4.
 - If the link lead is installed (2), reverse the removal procedure and release the vehicle.

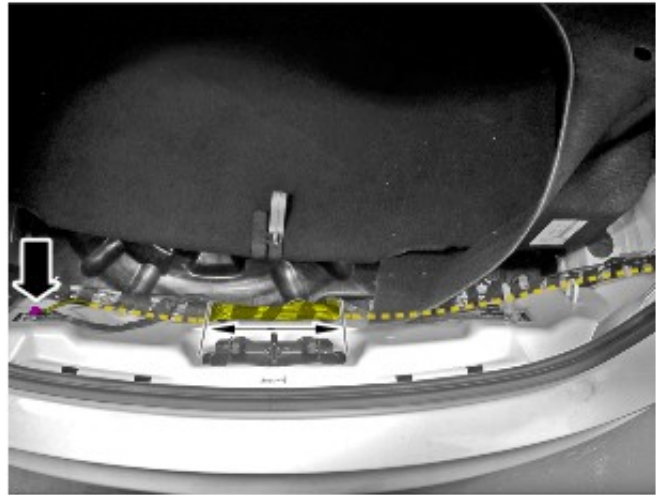
E175231

**CAUTION: Make sure that the ground cable is fully secured in the area of the luggage compartment lid latch, so that the ground cable cannot come in to contact with the latch. Failure to follow this instruction may result in damage to the vehicle.**

Using suitable tape, secure the ground cable to the underside of the existing harness at suitable points along the rear panel of the

luggage compartment.

- Fully secure the ground cable to the existing harness in the area directly below the luggage compartment lid latch.
