Recall 15V-110

Rear Turn Indicators

R nineT (K21)

Service Information No. SI 63 001 16

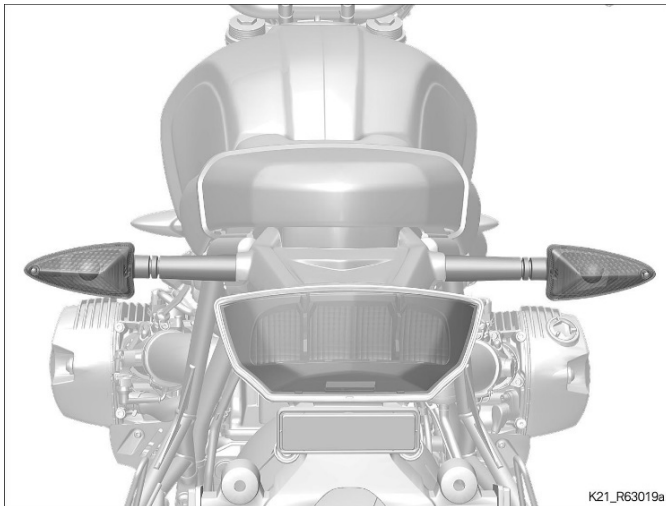
During the course of the quality analysis BMW Motorrad has determined that R nineT models produced between 11/2013 and 01/2015 have a slightly shorter set of rear turn indicators stalks than current production. As a result, in certain conditions, the rear turn indicators may be slightly obscured to a driver behind the bike.

Figure: Motor vehicle with correct rear turn indicators

All vehicles affected by this issue must have turn indicators that comply with statutory requirements installed.

The rear turn indicators are to be renewed according to work item 63 23 012 and 63 23 510.
