CE White Quasi-Static Passenger Seat Gusset Fasteners

RECALL

Models Affected: Vision and All American with Gusset Mounted CE White Quasi-Static Seats

RECALL CAMPAIGN R15YC

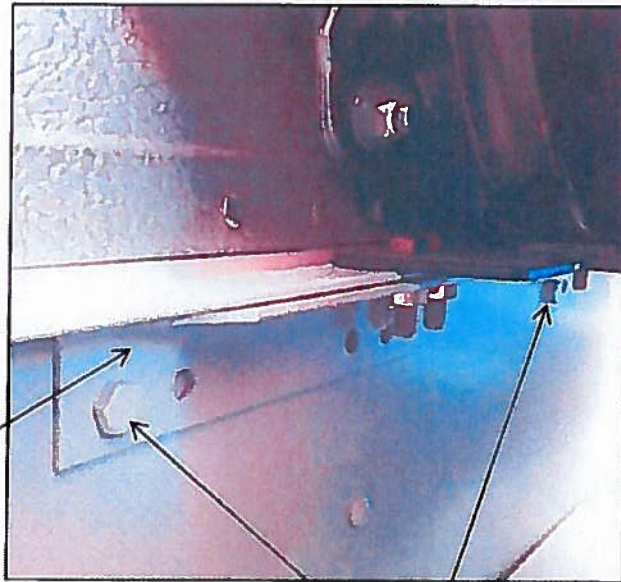
Figure 1

Locate the seat gusset reinforcement bracket for each Quasi-Static, 3-point seat. It will be fastened to the wall, immediately below the seat ledge, with at least two (2) grade 8 bolts. Visually check the bolts for six (6) dashed markings on the head of each bolt as referenced in Figure 1. If these markings are not present or there are other markings, perform the remaining instructions.

Gusset Reinforcement Bracket, wall mounted, under seat ledge
NOTE:
This bracket is ONLY installed on Quasi-Static 3-point seat belt seats

GRADE 8
